BLM Authorized Officer Weekly Report

Project: Ocotillo Wind Energy Facility Project

Weekly Project Update

Reporting Period: 5.21.12 through 5.27.12

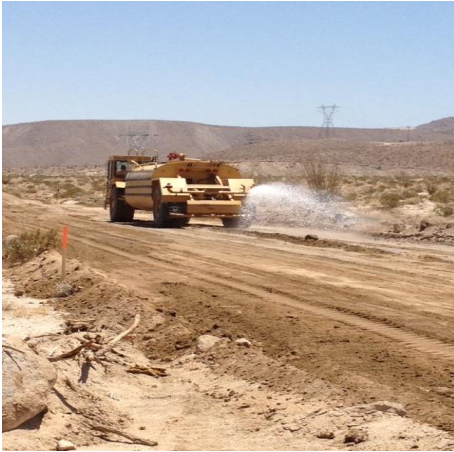
Photo 1: A water truck is utilized for dust suppression and grading compaction purposes along the access road between Dos Cabezas Road and the 30-acre substation/switchyard.

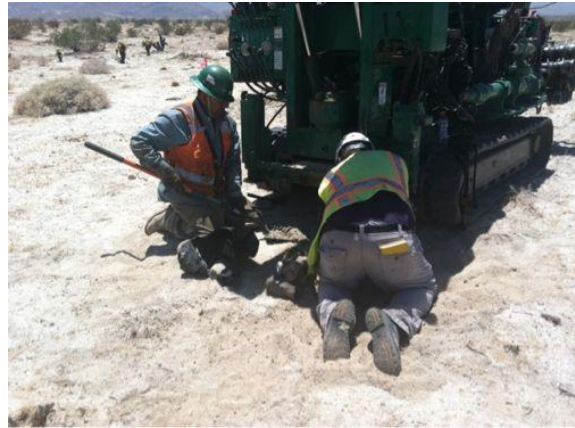
Environmental compliance monitors observed issues/concerns associated with soil stains as a result of leaking construction equipment. The Project Applicant's construction contractor was notified of these areas and the soil stains were cleaned-up in accordance with the project requirements.

Photo 2: A crew repairs a drill rig where a hydraulic hose leak was identified. The hose was repaired and the area was cleaned up in accordance with project requirements.

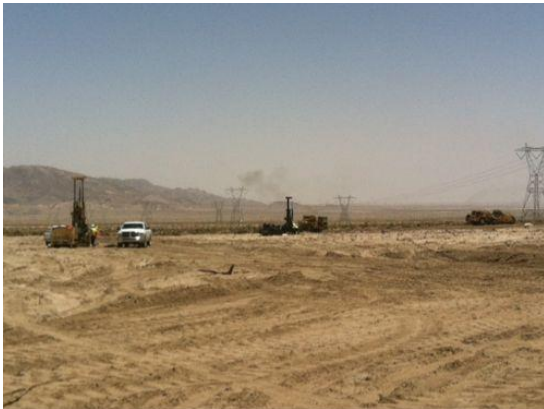
Photo 3: Drill rigs completing geotechnical testing activities at the 30-acre substation/switchyard.

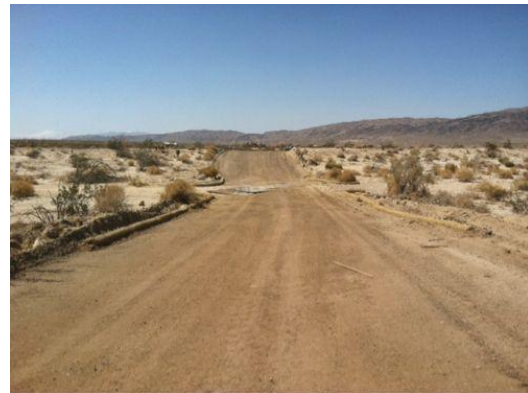
Photo 4: The access road between Dos Cabezas Road and the 30-acre substation switchyard has been completed.

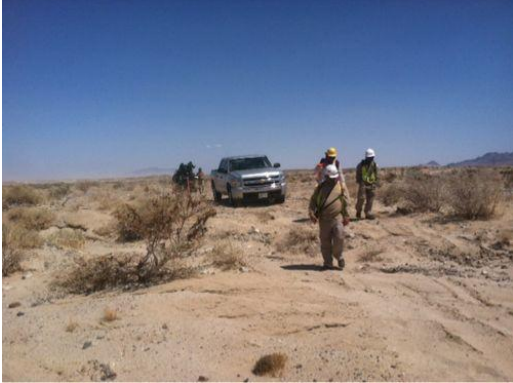
Photo 5: A biological monitor, archeological monitor and Native American monitor escort a geotechnical crew to a turbine pad site. Environmental monitors escort geotechnical crews to ensure crews remain with the approved work limits and avoid sensitive resources.

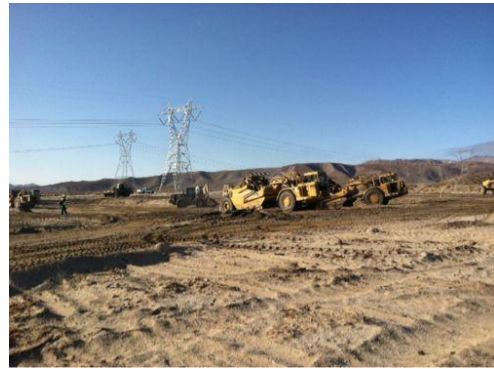
Photo 6: Heavy equipment is utilized to establish the 30-acre substation/switchyard pad site. Transmission towers associated with the Sunrise Powerlink and Southwest Powerlink can be seen in the background of this photo.

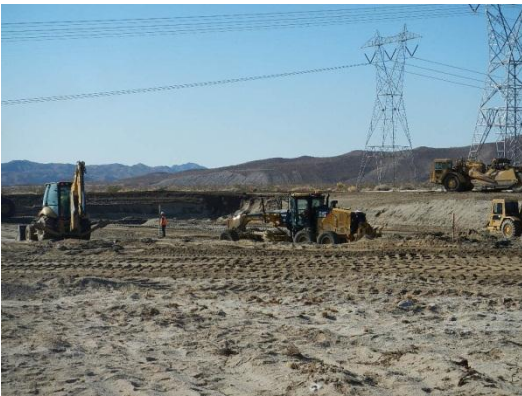
Photo 7: Heavy equipment is utilized to establish the 30-acre substation/switchyard pad site.

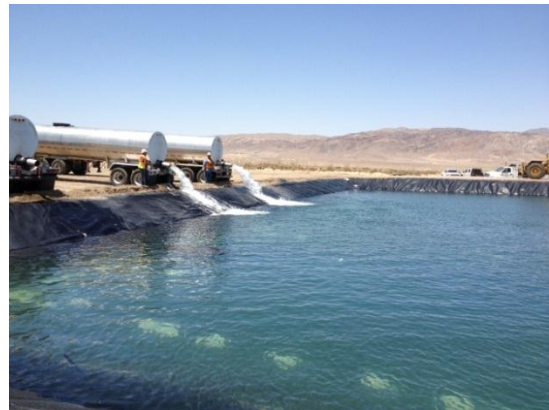
Temporary Water Pond – BLM identified issues/concerns associated with the temporary water pond located at the laydown yard. The temporary water pond does not include a covering or

functional equivalent measures to deter avian activity and appropriate fencing to ensure wildlife is not able to enter into the temporary water pond area. BLM environmental compliance monitors observed gaps in the chain-link fencing and thus a potential for wildlife to enter into the temporary water storage pond area. The Project Applicant's construction contractor responded to these concerns by filling-in the gaps with additional fencing materials. The Project Applicant's lead biological monitor is currently working with BLM resource specialists and the wildlife Agencies to determine appropriate measures to be put in place to deter avian activity. The Project Applicant's lead biological monitor is monitoring avian activity in the interim.

Photo 8: Water trucks placing water within the temporary water storage pond located at the temporary laydown yard.
