## **BLM Authorized Officer Weekly Report**

**Project:** Ocotillo Wind Energy Facility Project

### **Weekly Project Update**

**Reporting Period:** 6.4.12 through 6.10.12

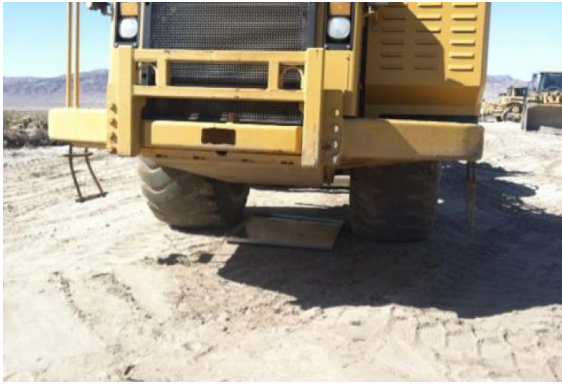
*Absorbent Pads:* BLM third-party environmental compliance monitors (ECM) observed construction crews utilizing absorbent pads beneath the construction equipment to prevent leaking equipment from staining the soils. The absorbent pads presented concerns to the BLM ECM's as they appeared to be ineffective in the windy environment and it was recommended that containment bins be utilized that would not be susceptible to windy environments. BLM ECM's reported the concern to the construction contractor on 6.4.12 and drip pans and similar containment bins, which meet the intent of the SWPPP (MM-Water-1) were being utilized on 6.7.12 (see photo 1).

BLM third-party ECM's observed construction crews utilizing absorbent pads beneath the construction equipment to prevent leaking equipment from staining the soils. The absorbent pads presented concerns to the BLM ECM's as they appeared to be ineffective in the windy environment and it was recommended that containment bins be utilized that would not be susceptible to windy environments. BLM ECM's reported the concern to the construction contractor on 6.4.12 and drip pans and similar containment bins, which meet the intent of the SWPPP (MM-Water-1) were being utilized on 6.7.12 (see photo 1).

**Photo 1:** A drip pan is utilized beneath construction equipment.

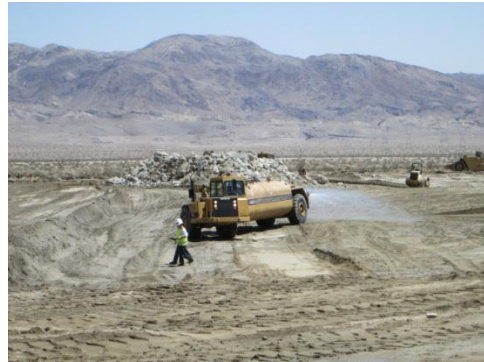
ECM's did not observe excessive amounts of fugitive dust during this reporting period. The construction contractor has been observed actively watering down construction areas during ground disturbance activities in accordance with MM-AIR-1 (see photo 2). Public informational signage has been placed along S-2 and Dos Cabezas Road to provide the public with contact information during construction regarding dust complaints (see photo 3). Signage has also been placed along the access road between the temporary laydown yard and the substation/switchyard to inform construction crews vehicle speeds are limited to 15 miles per hour (see photo 4).

**Photo 2:** Active construction areas are being watered down for dust suppression purposes during grading activities at the substation/switchyard.

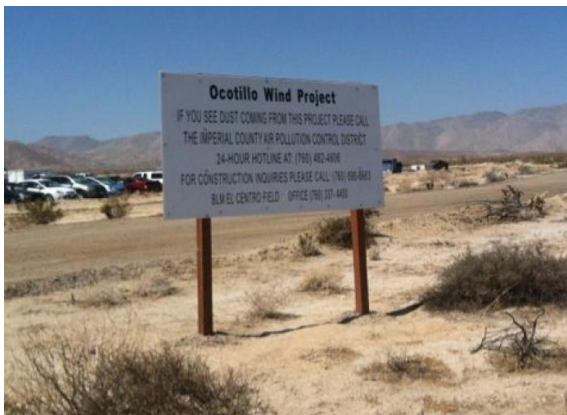
**Photo 3:** Public informational signage has been placed along S-2 and Dos Cabezas Road to provide the public with contact information during construction.

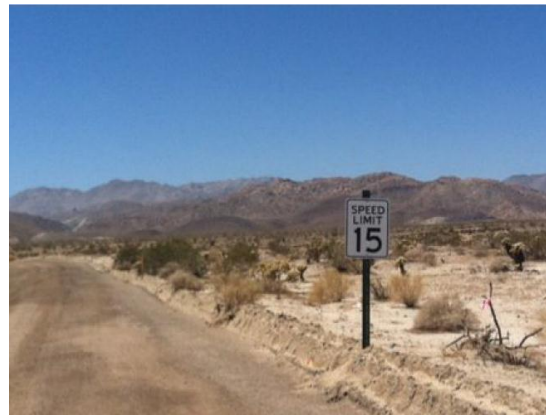
**Photo 4:** Signage is placed along the access road between the temporary laydown yard and the substation/switchyard to inform construction crews vehicle speeds are limited to 15 miles per hour.

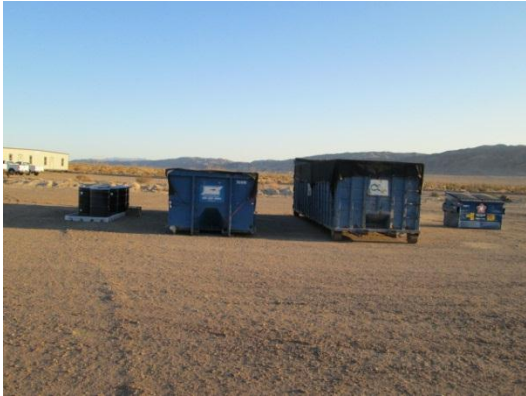
In accordance with the Raven Control Plan (MM-Wild-1J), trash bins are being covered (see photo 5). In addition, armor balls have been placed along the water surface at the temporary water pond per Section 4.2 of the Raven Control Plan (see photo 6). A 10-foot tall chainlink fence has also been erected along the perimeter of the temporary water storage pond per the recommendations of the Wildlife Agencies and BLM (see photo 7).

**Photo 5:** Dumpsters are covered in accordance with Section 4.1 of the Raven Control Plan (MM-Wild-1j).

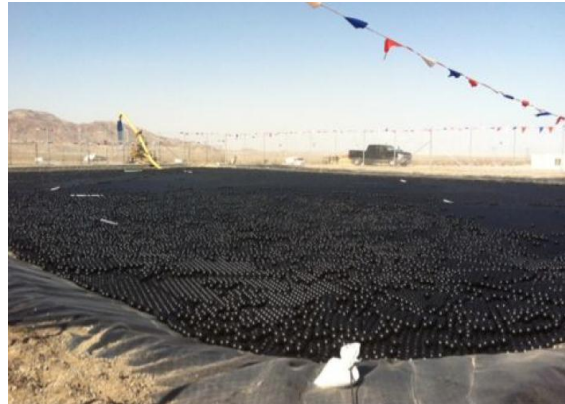
*Armor Balls Movement in High Winds:* A BLM ECM observed portions of the water surface at the temporary water storage pond being exposed during high wind events. The ability for the armor balls to effective in high wind events was communicated to the construction contractor on 6.9.12. The construction contractor identified the issue/concern associated with armor ball movement in the high winds will be remedied by placing a tarp or similar material along the southwest portion of the exclusionary fence, which will reduce the wind strength from disturbing the armor balls. The issue/concern associated with movement of the armor balls in high winds will be resolved by 6.13.12 when the material is put in place to reduce the strength of the wind.

A BLM ECM observed portions of the water surface at the temporary water storage pond being exposed during high wind events. The ability for the armor balls to be effective in high wind events was communicated to the construction contractor on 6.9.12. The construction contractor identified the issue/concern associated with armor ball movement in the high winds will be remedied by placing a tarp or similar material along the southwest portion of the exclusionary fence, which will reduce the wind strength from disturbing the armor balls. The issue/concern associated with movement of the armor balls in high winds will be resolved by 6.13.12 when the material is put in place to reduce the strength of the wind.

**Photo 6:** Armor balls have been placed along the water surface at the temporary water pond in accordance with Section 4.2 of the Raven Control Plan (MM-Wild-1j).

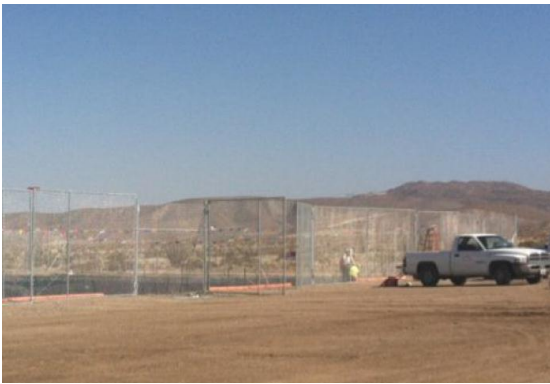
**Photo 7:** A 10-foot tall chainlink fence is constructed along the perimeter of the temporary water storage pond.

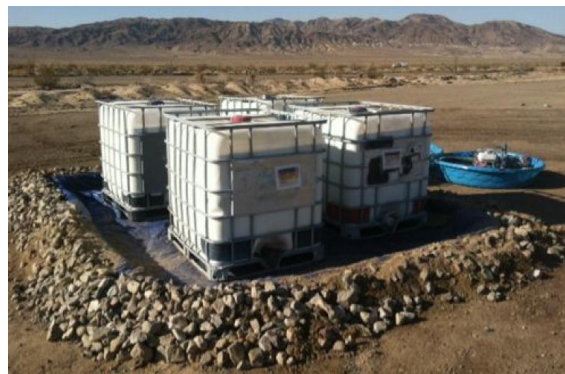
Hazardous materials being stored onsite within the temporary laydown yard are being placed within secondary containment (see photo 8). Portable toilets have also been observed to have secondary containment. Spill clean-up kits are being maintained and utilized by construction crews in accordance with the SWPPP (MM-Water-1).

**Photo 8:** Secondary containment is utilized for storage of hazardous materials onsite during construction.
