BLM Authorized Officer Weekly Report

Project: Ocotillo Wind Energy Facility Project

Weekly Project Update

Reporting Period: 6.25.12 through 7.1.12

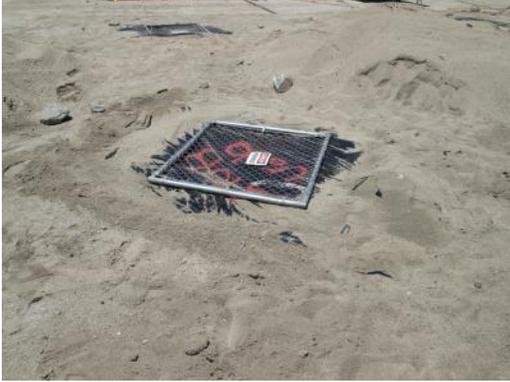
In accordance with MM-Wild 1b, if potential pitfalls will not be immediately backfilled following inspection at the end of each day, the Biological Monitor will ensure that the construction crew slopes the ends of the excavation (3:1 slope) to provide wildlife escape ramps or will ensure that the construction crew completely and securely covers the excavation to prevent wildlife entry. Excavated foundation holes for substation components were observed on 6.26.12 to not have either wildlife escape ramps or covers. An ECM contacted the lead biological monitor at approximately 9:00 AM to determine whether the foundation holes would be covered at the end of the day in accordance with MM-Wild-1b. At 1:15 PM, an ECM observed a crew covering the potential wildlife pitfalls with visqueen.

Photo 1: In accordance with MM-Wild-1b, construction crews place coverings over foundation holes to prevent wildlife entry.

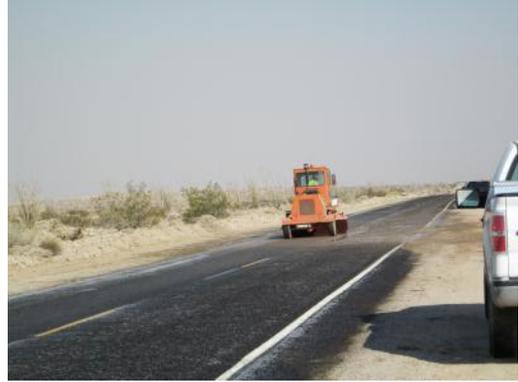
An ECM observed track-out along County Road S2 located immediately adjacent to the main point of ingress/egress to the project site on 6.25.12. The observation was communicated to the lead environmental monitor at 12:30 PM and crews were observed sweeping the track-out along County Road S2 at 1:30 PM (see photo 2).

Photo 2: A mechanical sweeper is utilized to clean trac-out along paved roadways that intersect with access roads for wind turbines.

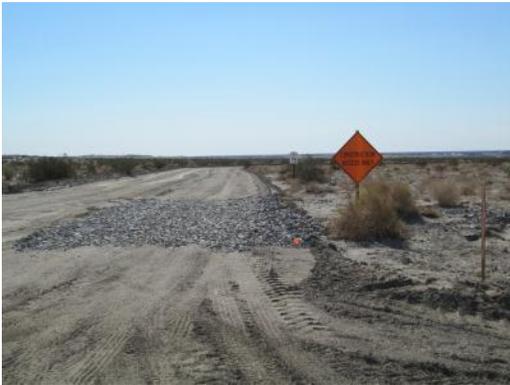
Stabilized construction entrances are being established and maintained at locations where project access roads intersect paved access roads (see photo 3). The stabilized construction entrances consist of rock aprons to minimize track-out from construction equipment along paved access roads. Signage has also been placed at points of ingress/egress to access roads that indicate "construction access only" for public safety.

Photo 3: Stabilized construction entrances are being maintained at locations where project access roads intersect paved access roads.

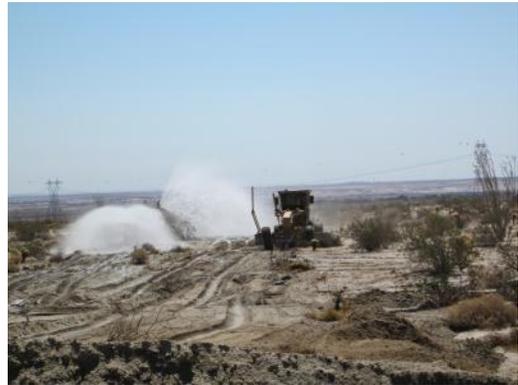
Construction crews were observed utilizing water for dust suppression purposes during the grading of turbine string access roads and the clearing for wind turbine pad sites (see photo 4). Multiple water trucks were observed being present with each excavation crew to ensure dust emissions were minimized during construction in accordance with the dust control plan.

Photo 4: A water truck is utilized during grading activities associated with establishing turbine string access roads.

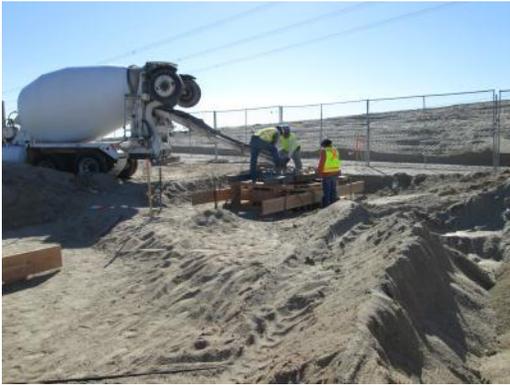
Construction activities occurring at the 30-acre substation/switchyard were observed being completed within the approved work limits (see photo 5). Dust emissions were being monitored on a regular basis and no issues/concerns were reported throughout the week.

Photo 5: Crews place concrete within a foundation that will be utilized to place above grade components associated with the substation.

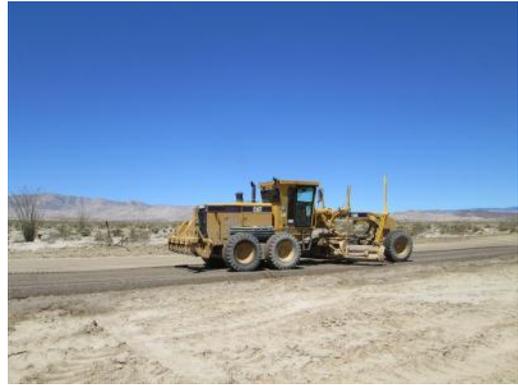
Photo 6: An excavator is utilized to place gravel along turbine access roads. The gravel base roadway will provide long-term access to the project components during operation and maintenance activities.

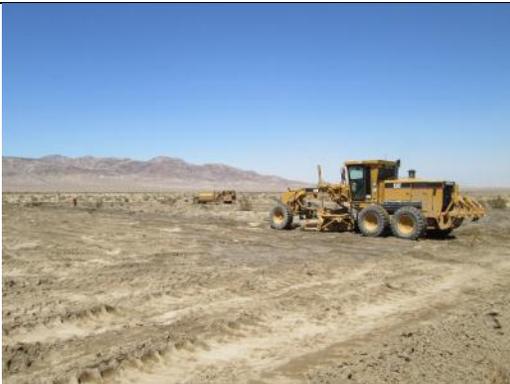
Photo 7: Crews were observed completing grading activities associated with establishing the Operation & Maintenance facility adjacent to Dos Cabezas Road.

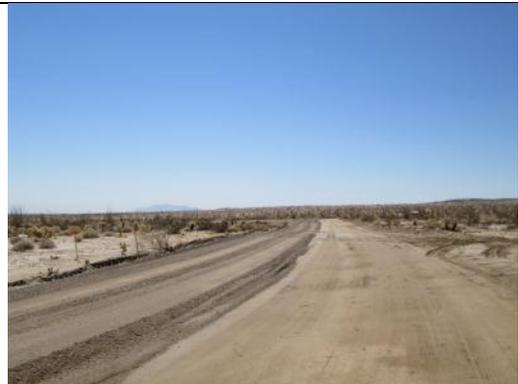
Photo 8: A completed access road between WT 173 and 174. A gravel base can be seen on the left and a compacted base where a tackifier has been placed to minimize dust emissions can be seen to the right.
