## **BLM Authorized Officer Weekly Report**

**Project:** Ocotillo Wind Energy Facility Project

### **Weekly Project Update**

**Reporting Period:** 7.9.12 through 7.15.12

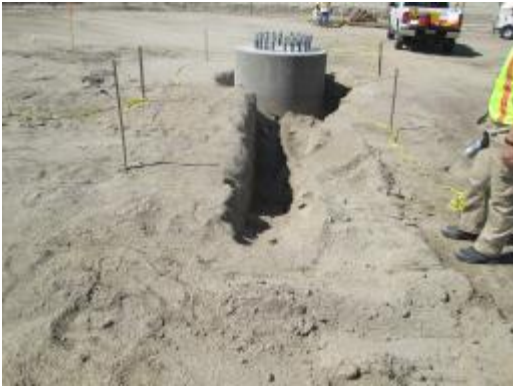
In accordance with MM-Wild-1b, if potential wildlife pitfalls will not be immediately backfilled at the end of the day, the Biological Monitor will ensure that the construction crew slopes the ends of the excavation (3:1 slope) to provide wildlife escape ramps or will ensure that the construction crew completely and securely covers the excavation to prevent wildlife entry. Wildlife escape ramps were observed being constructed at foundations for the substation components in accordance with MM-Wild-1b (see photo 1).

**Photo 1:** Wildlife escape ramps constructed at the 30-acre substation per MM-Wild-1b.

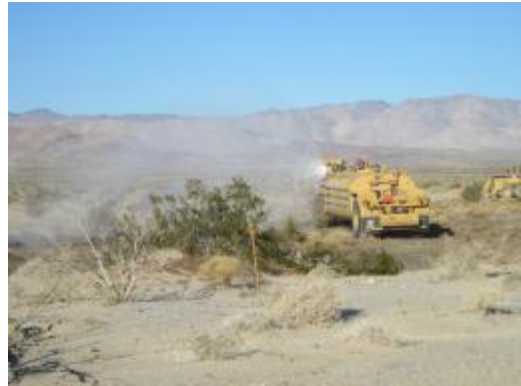
An ECM observed visible dust emissions along the Old Mining Road on 7.15.12 at 3:00 PM. The construction contractor was contacted regarding the dust emissions. Upon the notification being provided water trucks were observed watering down Old Mining Road. The application of water along the roadway was effective in minimizing dust emissions. With the exception of the issue/concern noted above, construction crews were observed utilizing water for dust suppression purposes during the grading of turbine string access roads and construction of the substation/switchyard. Multiple water trucks were observed being present with each excavation crew to ensure dust emissions were minimized during construction in accordance with the dust control plan (see photo 2).

**Photo 2:** A water truck applies water during grading activities to minimize dust emissions in accordance with the Dust Control Plan.

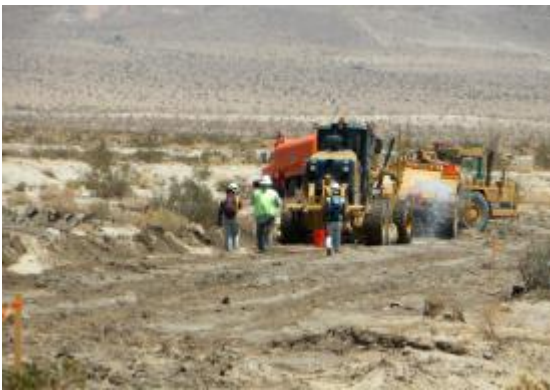
The Project Applicant has contracted with a biological and archeological consulting firm approved by the BLM to complete day-to-day monitoring of the construction activities in accordance with the ECCMP (see photo 3).

**Photo 3:** Archeological and Native American monitors complete monitoring activities during ground disturbance activities associated with establishing the access road along Dos Cabezas Road.

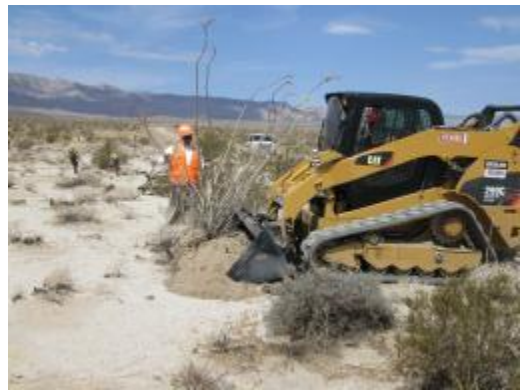
In accordance with Section 4.3.5 of the Revegetation Plan, 250 ocotillo (*Fouquieria splendens*) plants will be salvaged for transplantation into revegetation areas. Crews were observed transplanting ocotillo in accordance with Section 4.3.5 at WT43 (see photo 4).

**Photo 4:** A crew relocates an ocotillo per the requirements included in Section 4.3.5 of the Habitat Revegetation Plan.

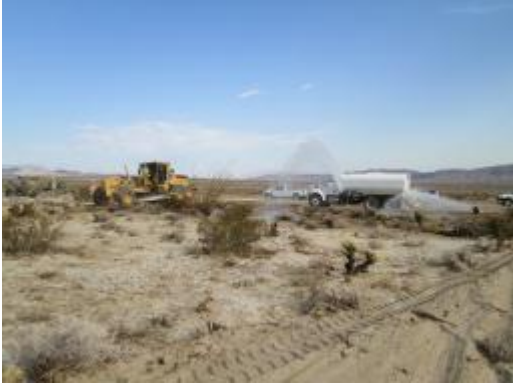
**Photo 5:** Crews complete grading and clearing activities at WT 149. A biologist, archeologist and Native American monitor are present during grading activities per the project requirements.

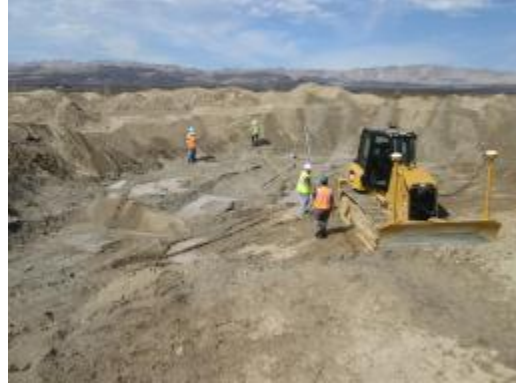
**Photo 6:** Crews excavate a turbine pad foundation at WT 151.

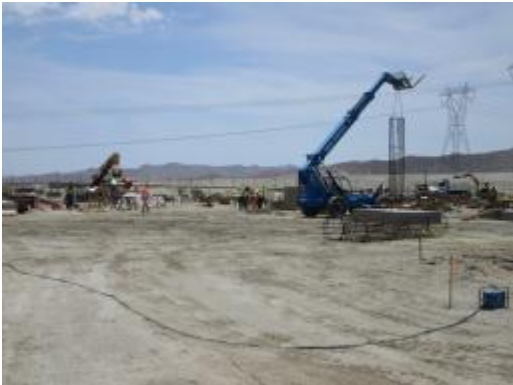
Construction activities occurring at the 30-acre substation/switchyard were observed being completed within the approved work limits (see photo 7). Dust emissions were monitored on a regular basis and no issues/concerns were reported throughout the week.

**Photo 7:** Crews place steel rebar within an excavation for the foundations that will be utilized to construct substation components.

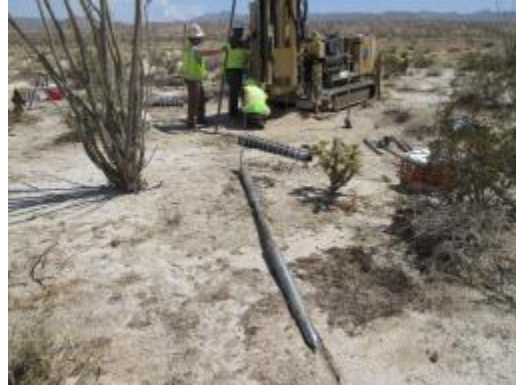
Geotechnical testing activities continued at turbine pad sites throughout the week (see photo 8). Geotechnical testing activities were monitored by a biologist, archeologist and Native American monitor to ensure activities were being completed per the project requirements.

**Photo 8:** A geotechnical rig completes geotechnical testing activities within the approved work limits at Wind Turbine 50.

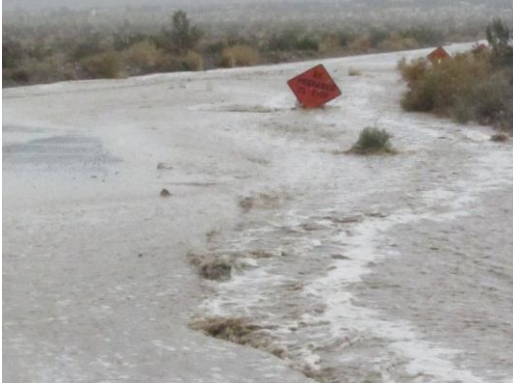
**Photo 9:** The rain event that occurred on 7.13.12 resulted in localized flooding as seen here along County Route S2.

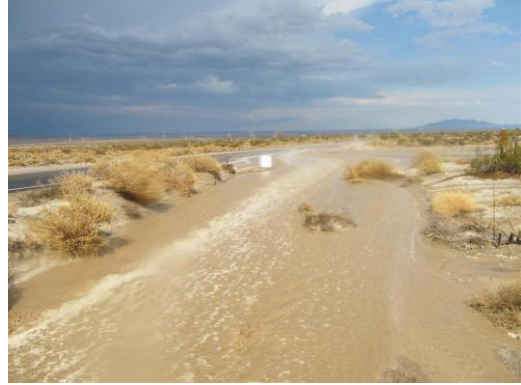
**Photo 10:** The rain event that occurred on 7.13.12 resulted in localized flooding as seen here at the intersection of County Route S2 and Dos Cabezas Road.

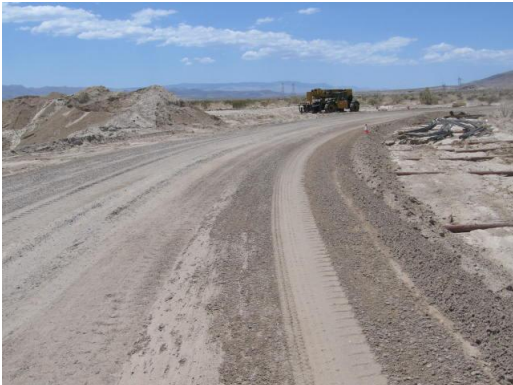
**Photo 11:** Construction crews repair access roads following the rain event that occurred on 7.13.12.

A Storm Water Pollution Prevention Plan (SWPPP) has been prepared for the Ocotillo Wind Project in accordance with the General Permit for Discharges of Storm Water Associated with Construction Activity Construction General Permit Order 2009-0009-DWQ. Construction activity subject to this permit includes clearing, grading and disturbances to the ground such as stockpiling, or excavation. The SWPPP prepared for the project includes Best Management Practices (BMPs) to protect storm water runoff. BMP's being implemented onsite are monitored on a regular basis. A significant rain event occurred at 3:15 PM on 7.13.12, which produced a flash flood. The National Weather Service issued a flash flood warning for the project area at approximately 4:27 on 7.13.12 indicating that severe thunderstorms have produced widespread rainfall of 1 to 2 inches. The BMP's identified in the SWPPP are designed to meet the General Construction Permit requirements, which include an equivalent rainfall under the 10 year 24-hour storm event. The rain event that occurred on 7.13.12 resulted in a flash flood that exceeded the equivalent rainfall where BMP's would be effective as defined in the General Construction Permit (see photos 9 and 10). The rain event resulted in localized flooding that caused damage to nearby roadways including Old Mining Road and County Route S2. BMPs in place on-site were effective in preventing the discharge of non-stormwater pollutants such as concrete waste, chemicals, trash etc. Following the rain event the construction contractor completed repairs to access roads and stockpiles by re-grading, re-applying soil stabilizer and repairing BMP's (see photos 11 and 12).

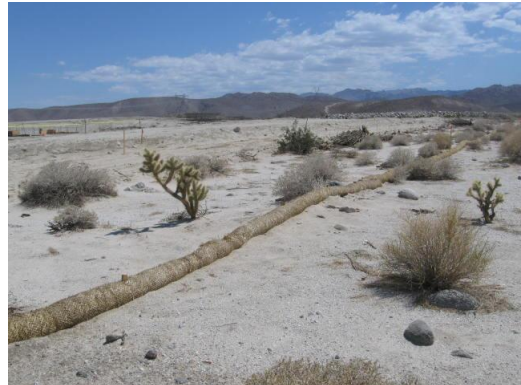
**Photo 12:** Straw wattles are repaired in areas that were damaged during the rain event on 7.13.12.
