## **BLM Authorized Officer Weekly Report**

**Project:** Ocotillo Wind Energy Facility Project

### **Weekly Project Update**

**Reporting Period:** 5.15.12 through 5.20.12

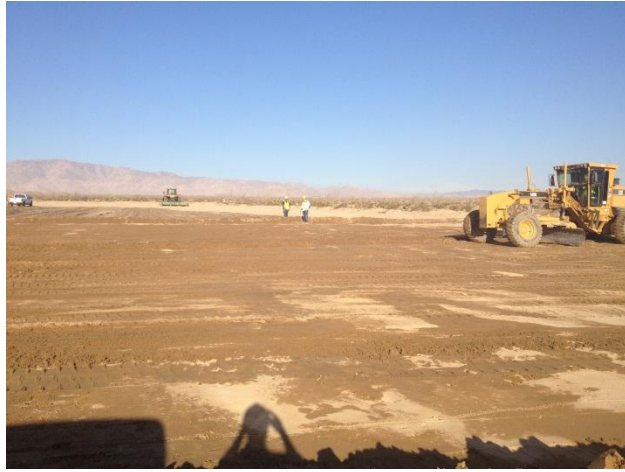
**Photo 1:** A road grader is utilized to construct a level pad site at the temporary laydown yard located adjacent to County Route S2.

*12-acre Temporary Laydown Yard:* Crews initiated construction activities on May 15, 2012, which consisting of mobilizing construction equipment to the temporary laydown yard located at the southwest intersection of County Route S-2 and Dos Cabeza Road. Crews were observed utilizing road graders to establish the finish grade. An excavator was also observed constructing a temporary water pond that will be utilized as a water source for the concrete batch plant and dust suppression. The approved work limits were identified by the surveying team and verified by the lead environmental monitor prior to ground disturbance activities. A rock apron and rattle plate was also constructed at the primary point of ingress/egress to minimize tracking onto County Route S-2. The temporary laydown yard will be utilized to stage construction equipment and the construction contractor's trailers throughout construction.

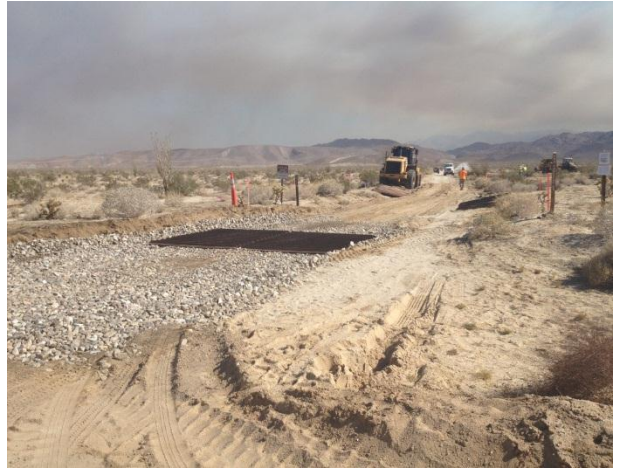
**Photo 2:** A rock apron and rattle plate is constructed at the primary project access point adjacent to County Route S2 and the temporary laydown yard. The rattle plate and rock apron is being utilized to minimize track-out along County Route S2.

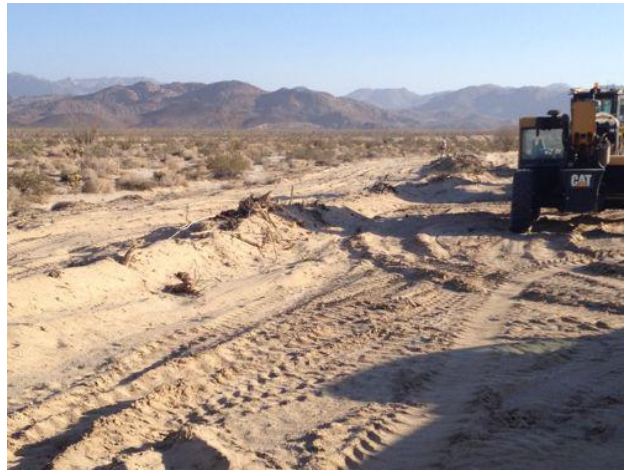
**Photo 3:** Topsoil being salvaged onsite in accordance with MM Veg-2b.

Based on environmental compliance monitors observations, all crew members working on the project site have been WEAP trained and sensitive environmental resources requiring avoidance within proximity to the active construction areas are being identified in accordance with the project requirements. Topsoil in areas being graded is being stockpiled within the approved work limits in accordance with MM Veg-2b. In accordance with MM-Wild-2b, preconstruction migratory bird nesting surveys are being completed by the Project Applicant's designated biologist on a daily basis.

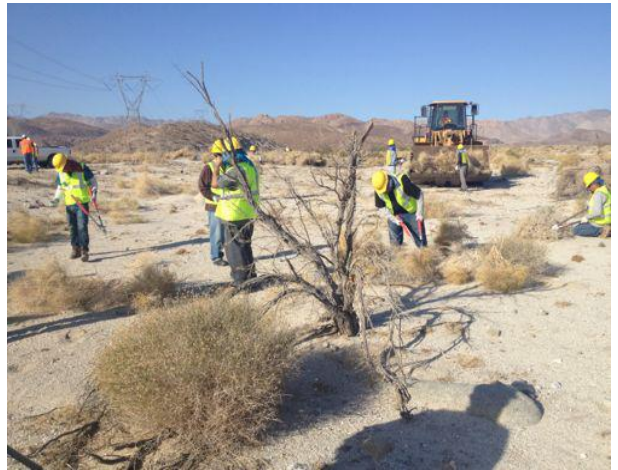
**Photo 4:** Hand crews clear vegetation within the approved work limits at the 30-acre substation/switchyard.

*30-acre Substation/Switchyard:* Crews completed hand clearing removal of vegetation located within the approved work limits associated with the 30-acre Substation/Switchyard.

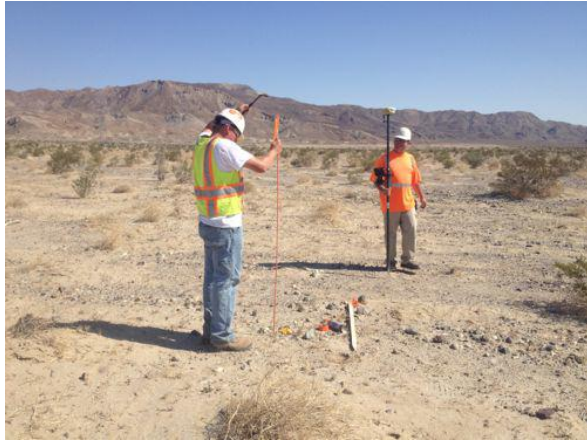
**Photo 5:** Surveyors placing stakes at the 30-acre substation/switchyard to identify the approved work limits.

*Limits of Work* – Environmental compliance monitors expressed concern that the approved project limits and access roads were not clearly delineated. The Project Applicant construction

contractor responded to concerns raised by the environmental compliance monitors by agreeing to place additional survey stakes where a direct line of site between stakes was not visible and by ordering signs that would identify approved access routes.

Environmental compliance monitors reported incidences where pick-up trucks were observed beyond the approved project limits. The Project Applicant construction contractor responded to concerns raised by the environmental compliance monitors by agreeing to place additional survey stakes where a direct line of site between stakes was not visible and by ordering signs that would identify approved access routes. Crews operating the drill rigs were also observed to not be carrying spill kits in accordance with the project requirements. It was requested that all drill rigs operating along the right-of-way be equipped with spill kits in accordance with the project requirements.

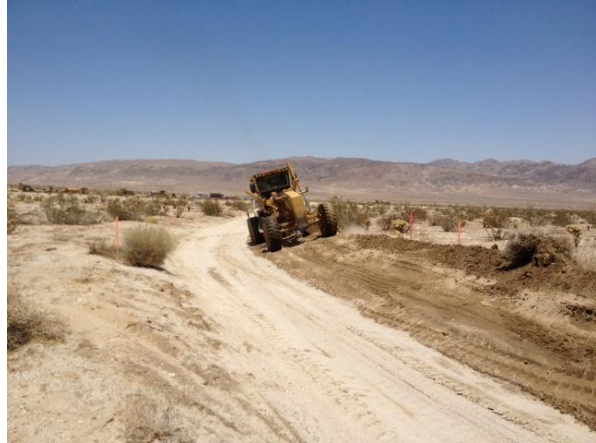
**Photo 6:** A road grader is utilized to construct an access road from the laydown yard located adjacent to County Route S2 and the 30-acre substation/switchyard.

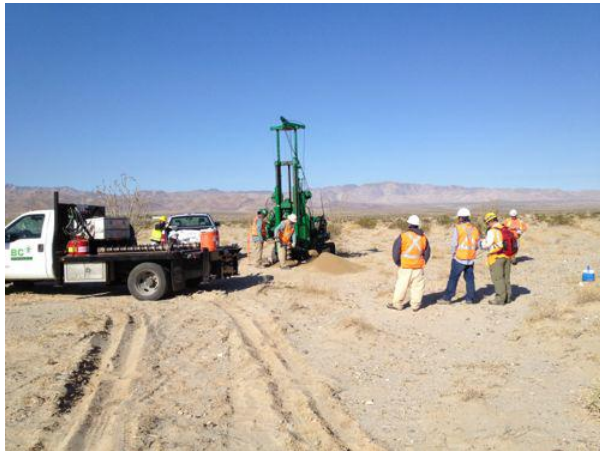
**Photo 7:** A geotechnical crew completes geotechnical testing at a future location for a wind turbine foundation.

*Geotechnical Testing:* Crews utilized approved access roads to complete geotechnical testing at turbine pad sites located throughout the project site. Geotechnical testing was completed at approximately six to seven turbine pad site foundations per day.

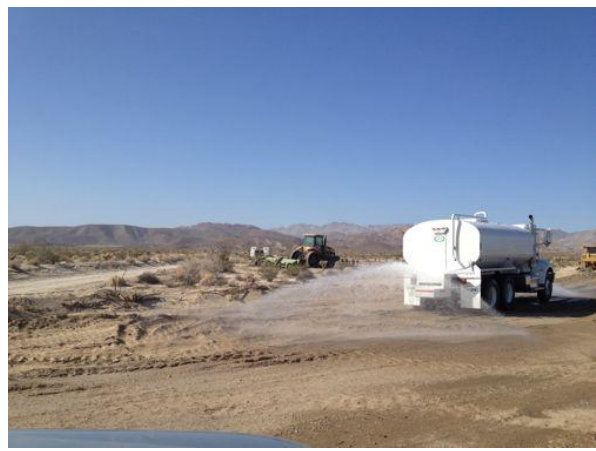
**Photo 8:** A water truck is utilized at the laydown yard for compaction and dust suppression.

*Dust Emissions* – Excessive dust emissions were observed by environmental compliance monitors during ground disturbance activities associated with establishing the 12-acre temporary laydown area. The Project Applicant's construction contractor responded to concerns raised by the environmental compliance monitors by increasing the number of water trucks and associated watering activities during ground disturbance activities.

Environmental compliance monitors reported dust issues associated with construction activities occurring at the temporary laydown yard. The Project Applicant's construction contractor responded to concerns associated with dust by mobilizing additional water trucks to the project site for dust suppression. Potential future compliance issues associated with dust will continue to be closely monitored.
