BLM Authorized Officer Weekly Report

Project: Ocotillo Wind Energy Facility Project

Weekly Project Update

Reporting Period: 6.11.12 through 6.17.12

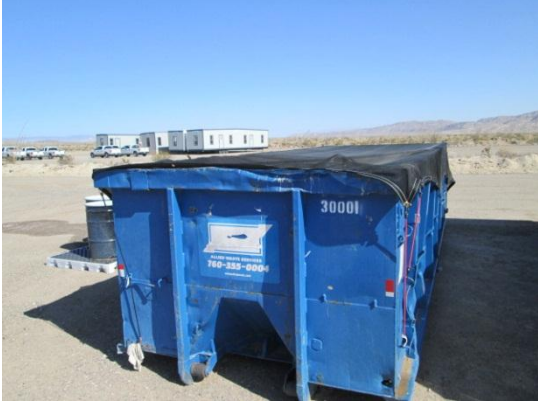
Photo 1: Hauling containers are covered with a tarp in accordance with the Raven Control Plan (MM-Wild-1j).

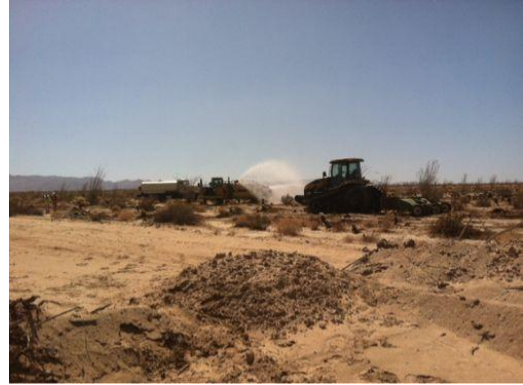
An ECM observed slight dust emissions at the laydown yard during grading activities on 6.14.12. The dust emissions were observed to last for approximately 15 seconds at two intervals. The ECM reported the dust emissions to the lead environmental monitor and additional water was applied during grading activities within five minutes of the dust emissions being observed. With the exception of the instance noted above, the construction contractor has been observed actively watering down construction areas during ground disturbance activities in accordance with MM-AIR-1 (see photos 2, 3 and 4).

Photo 2: A water truck is utilized for dust suppression during flailing activities at the laydown yard.

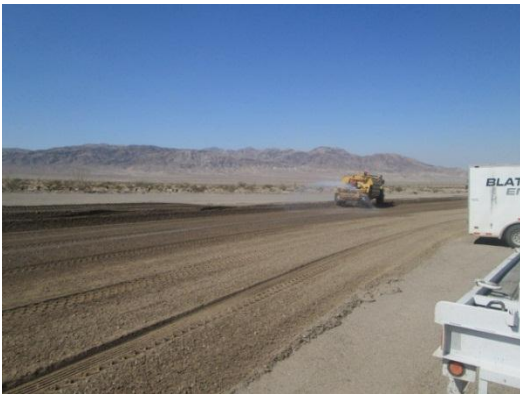
Photo 3: A water truck is utilized during grading activities associated with establishing the laydown yard.

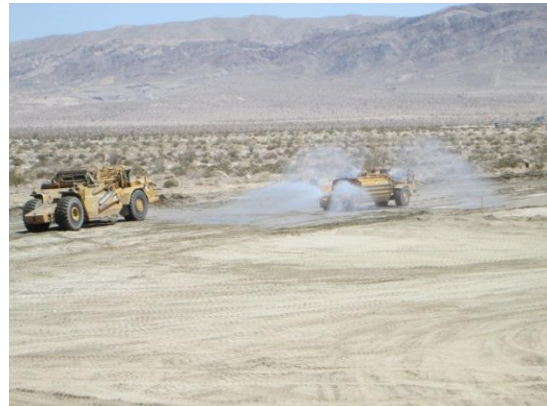
Photo 4: A water truck being utilized for compaction and dust suppression purposes at the substation/switchyard.

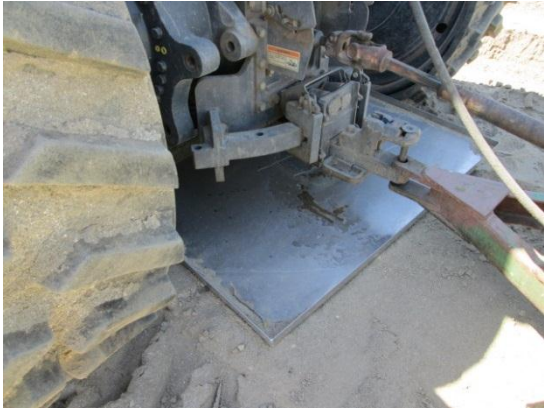
Spill clean-up kits are being maintained and utilized by construction crews in accordance with the SWPPP (MM-Water-1). Drip-pans are being placed beneath construction equipment being stored onsite overnight to ensure equipment does not leak directly onto the ground surface (see photo 5).

Photo 5: Drip-pans are being placed beneath equipment being stored overnight to ensure equipment does not leak directly onto the ground surface.

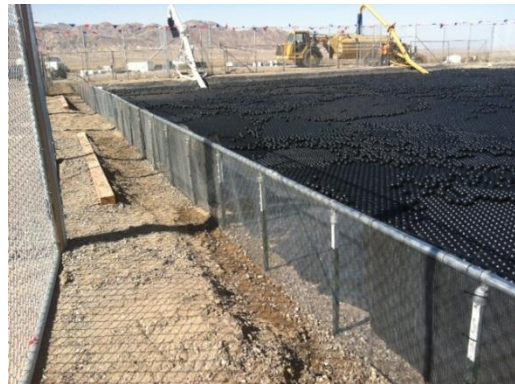
Armor Balls Movement in High Winds: An ECM observed portions of the water surface at the temporary water storage pond being exposed during high wind events. The ability for the armor balls to be effective in high wind events was communicated to the construction contractor on 6.11.12. The construction contractor identified the issue/concern associated with armor ball movement in the high winds will be remedied by placing a tarp or similar material along the southwest portion of the exclusionary fence, which will reduce the wind strength from disturbing the armor balls. The issue/concern associated with movement of the armor balls in high winds will be resolved by 6.20.12 when the material is put in place to reduce the strength of the wind.

An ECM observed portions of the water surface at the temporary water storage pond being exposed during high wind events (see photo 6). The ability for the armor balls to be effective in high wind events was communicated to the construction contractor on 6.11.12. The armor balls did not show any signs of movement and were adequately covering the water surface during non-high wind events. The construction contractor identified the issue/concern associated with armor ball movement in the high winds will be remedied by placing a tarp or similar material along the southwest portion of the exclusionary fence, which will reduce the wind strength from disturbing the armor balls. The issue/concern associated with movement of the armor

Photo 6: Armor balls have been placed along the water surface at the temporary water pond in accordance with Section 4.2 of the Raven Control Plan (MM-Wild-1j).

balls in high winds will be resolved by 6.20.12 when the material is put in place to reduce the strength of the wind.

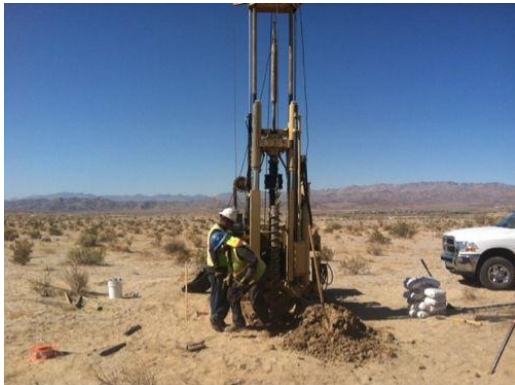
Geotechnical testing activities were observed throughout the week being completed within the approved work limits and both an archeological and biological monitor approved by the BLM were present during the geotechnical testing activities (see photo 7). The biological and archeological monitors were observed guiding the geotechnical rigs to the testing locations along approved access roads and observing for archeological and biological resources to minimize disturbances to resources that may be present.

Photo 7: A drill rig completing geotechnical activities within the approved work limits.

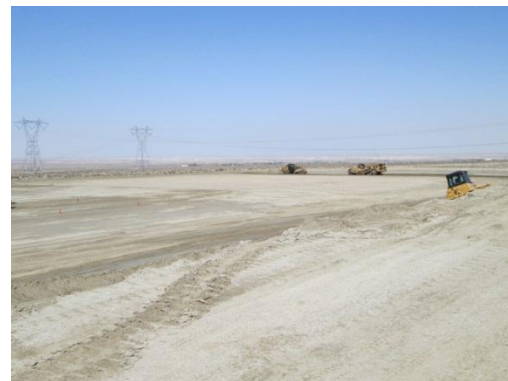
Grading activities occurring at the 30-acre substation/switchyard were observed being completed within the approved work limits (see photo 8). Dust emissions were being monitored on a regular basis and no issues/concerns were reported throughout the week.

Photo 8: Crews completing grading activities at the substation/switchyard to obtain the final grade for the substation/switchyard pad site.
