BLM Authorized Officer Weekly Report

Project: Ocotillo Wind Energy Facility Project

Weekly Project Update

Reporting Period: 6.18.12 through 6.24.12

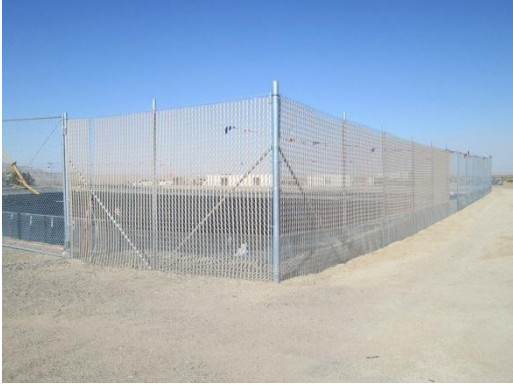
An ECM observed portions of the water surface at the temporary water storage pond being exposed during high wind events. The ability for the armor balls to be effective in high wind events was communicated to the construction contractor on 6.11.12 through 6.19.12. The construction contractor remedied the issue/concern by placing slats along the southwest portion of the exclusionary fence, which will reduce the wind strength from disturbing the armor balls. The issue/concern associated with movement of the armor balls in high winds was resolved on 6.20.12 when the material was put in place to reduce the strength of the wind (see photo 1).

Photo 1: Fencing slats are placed along the southwestern limits of the temporary water pond to reduce the wind effects of potential armor ball movement within the temporary water pond.

contractor on 6.11.12 through 6.19.12. The construction contractor remedied the issue/concern by placing slats along the southwest portion of the exclusionary fence, which will reduce the wind strength from disturbing the armor balls. The issue/concern associated with movement of the armor balls in high winds was resolved on 6.20.12 when the material was put in place to reduce the strength of the wind.

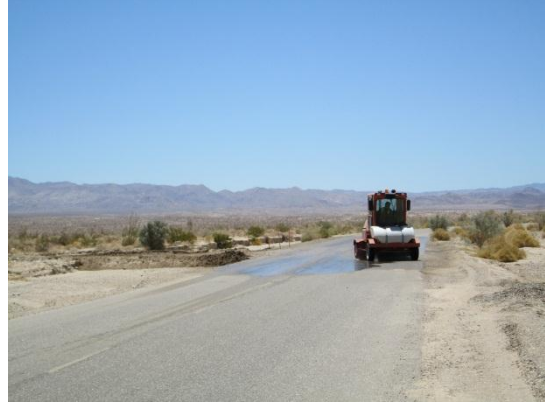
An ECM observed track-out along County Road S2 located immediately adjacent to the main point of ingress/egress to the project site on 6.19.12. The observation was communicated to

the lead environmental monitor at 7:30 AM and crews were observed sweeping the trac-out along County Road S2 at 2:00 PM (see photo 2).

Photo 2: A mechanical sweeper is utilized to clean track-out along paved roadways that intersect with access roads for wind turbines.

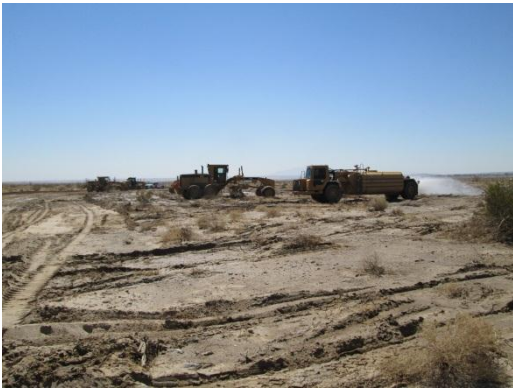
An ECM on 6.19.12 observed dust emissions along an inactive access to WT 147 that were intermittent for a duration of approximately 10 to 20 seconds with the varying wind speed and direction. The dust emissions were reported to the Imperial County Air Pollution Control District (APCD) by members of the general public. A Notice of Violation was issued to the construction contractor by the APCD for fugitive dust emission violations. Corrective actions completed by the construction contractor included applying water and an Envirotac Rhino Snot application to suppress dust emissions. With the exception of the instance noted above, the construction contractor has been observed actively watering down construction areas during ground disturbance activities in accordance with MM-AIR-1 (see photos 3 and 4).

Photo 3: A water truck is utilized for dust suppression and compaction purposes associated with establishing the foundation for a wind turbine pad site.

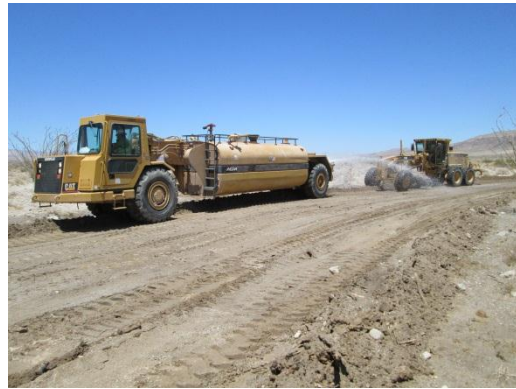
Photo 4: A water truck is utilized during grading activities associated with establishing the access road between WT 131 and WT 176.

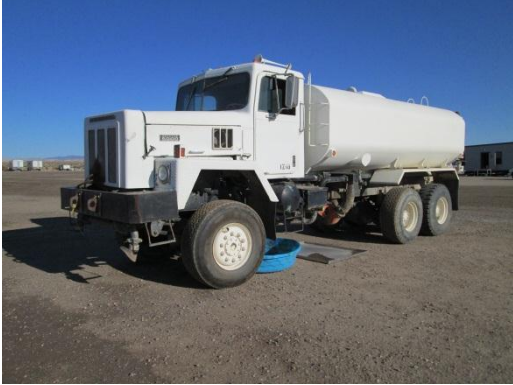
Spill clean-up kits are being maintained and utilized by construction crews in accordance with the SWPPP (MM-Water-1). Drip-pans are being placed beneath construction equipment being stored onsite overnight to ensure equipment does not leak directly onto the ground surface (see photo 5).

Photo 5: Crews place containment bins beneath construction equipment while not in use to prevent leaking equipment from leaking directly onto exposed soils.

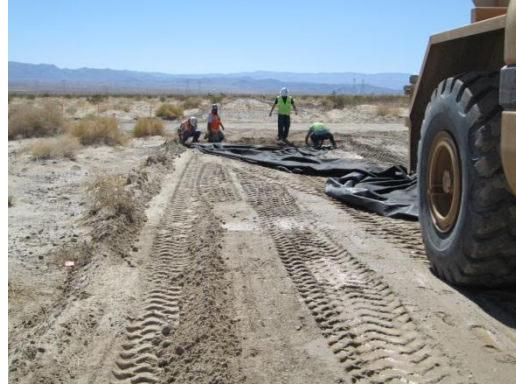
Stabilized construction entrances are being established and maintained at locations where project access roads intersect paved access roads (see photo 6). The stabilized construction entrances consist of rock aprons and rattle plates to minimize trac-out from construction equipment along paved access roads.

Photo 6: A crew constructs a stabilized construction entrance at wind turbine string 152 through 175.

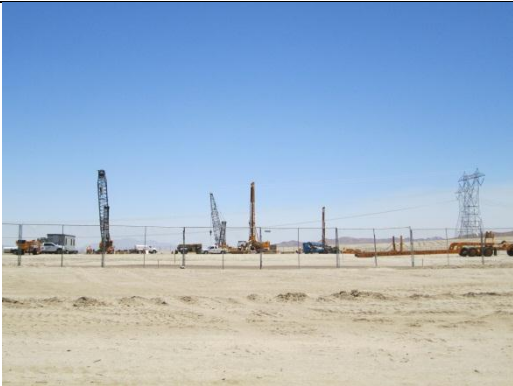
Construction activities occurring at the 30-acre substation/switchyard were observed being completed within the approved work limits (see photo 7). Dust emissions were being monitored on a regular basis and no issues/concerns were reported throughout the week.

Photo 7: Crews initiated Phase II of the substation/switchyard construction by mobilizing construction equipment to the graded pad site.

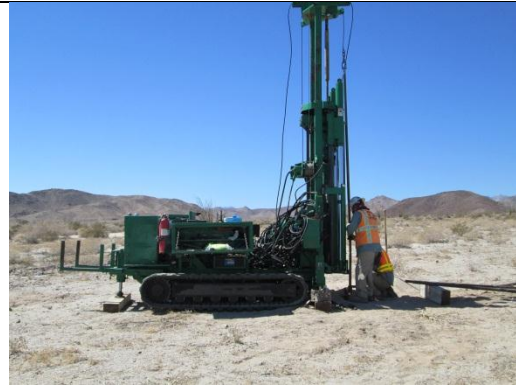
Geotechnical testing activities were observed throughout the week being completed within the approved work limits and both an archeological and biological monitor approved by the BLM were present during the geotechnical testing activities (see photo 8). The biological and archeological monitors were observed guiding the geotechnical rigs to the testing locations along approved access roads and observing for archeological and biological resources to minimize disturbances to resources that may be present.

Photo 8: A drill rig completing geotechnical activities within the approved work limits.
