BLM Authorized Officer Weekly Report

Project: Ocotillo Wind Energy Facility Project

Weekly Project Update

Reporting Period: 7.2.12 through 7.8.12

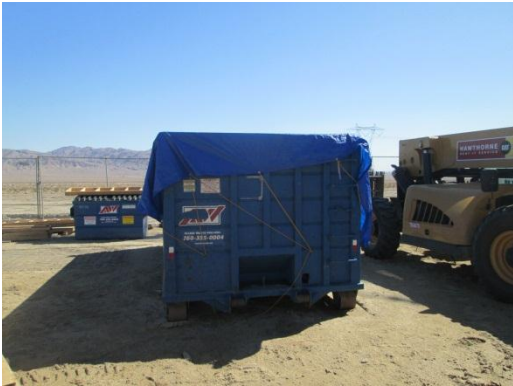
Photo 1: Covers are placed over trash bins in accordance with Section 4.1 of the Raven Control Plan (MM-Wild-1j).

In accordance with Section 4.1 of the Raven Control Plan (MM-Wild-1j), all trash on site must be kept in covered trash receptacles with lids that can be securely fastened. An ECM identified a trash bin located within the SDG&E substation yard that had not been covered on 7.3.12. The issue/concern was reported to the foreman onsite at the time of the observation and a cover was observed in place on 7.5.12 (see photo 1).

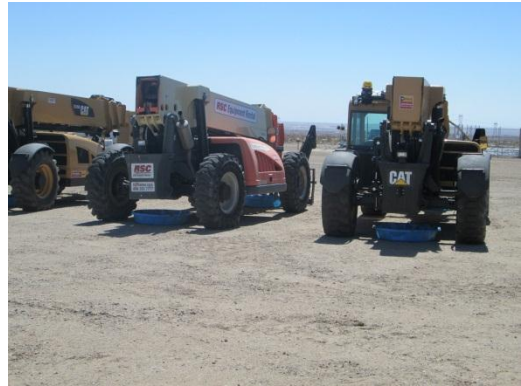
Photo 2: Drip-pans are placed beneath construction equipment staged onsite to ensure equipment does not leak directly onto the ground surface.

Drip-pans are being placed beneath construction equipment being stored onsite overnight to ensure equipment does not leak directly onto the ground surface (see photo 2).

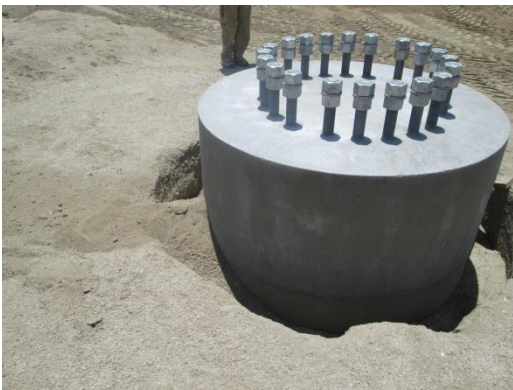
Photo 3: Wildlife escape ramps are constructed at foundations within the substation/switchyard in accordance with MM-Wild-1b.

In accordance with MM-Wild-1b, if potential wildlife pitfalls will not be immediately backfilled at the end of the day, the Biological Monitor will ensure that the construction crew slopes the ends of the excavation (3:1 slope) to provide wildlife escape ramps or will ensure that the construction crew completely and securely covers the excavation to prevent wildlife entry. Wildlife escape ramps were observed being constructed at foundations for the substation components in accordance with MM-Wild-1b (see photo 3). Covers were also observed being placed over areas that had been excavated in accordance with MM-Wild-1b (see photo 4).

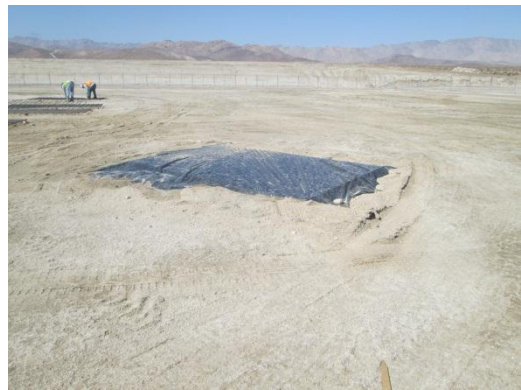
Photo 4: Covers are placed over areas excavated within the substation/switchyard in accordance with MM-Wild-1b.

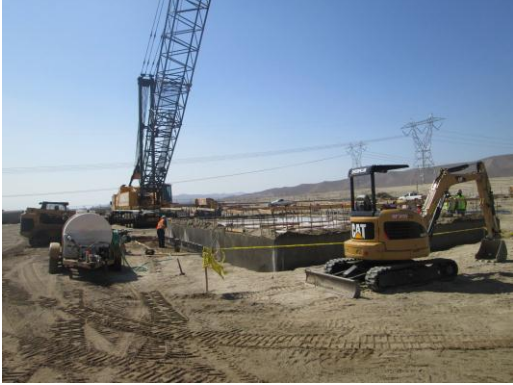
Photo 5: Crews construct foundations that will be utilized to erect above grade components associated within the SDG&E substation.

Construction activities occurring at the 30-acre substation/switchyard were observed being completed within the approved work limits (see photo 5 and 6). Dust emissions were monitored on a regular basis and no issues/concerns were reported throughout the week.

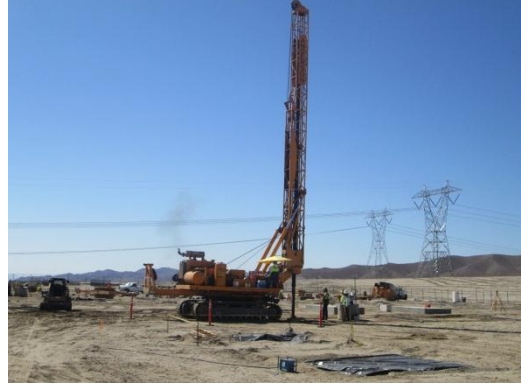
Photo 6: A drill rig is utilized to construct foundations for the SDG&E substation.

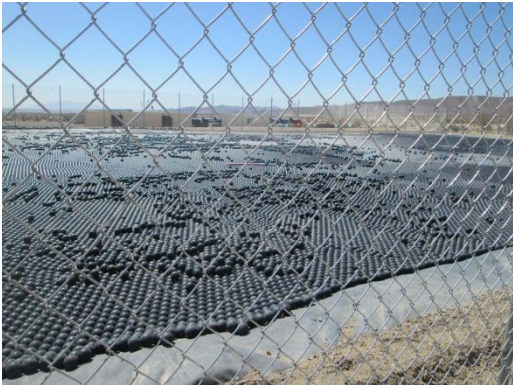
Photo 7: Armor balls have been placed on the surface of the temporary water pond in accordance with the Raven Control Plan (MM-Wild-1j).

In accordance with Section 4.2 of the Raven Control Plan, in order to prevent ravens and other wildlife from accessing the water storage pond constructed onsite, armor balls will be used to completely cover the surface of the water. Armor balls have been placed on the surface of the temporary water pond in accordance with the Raven Control Plan (see photo 7).

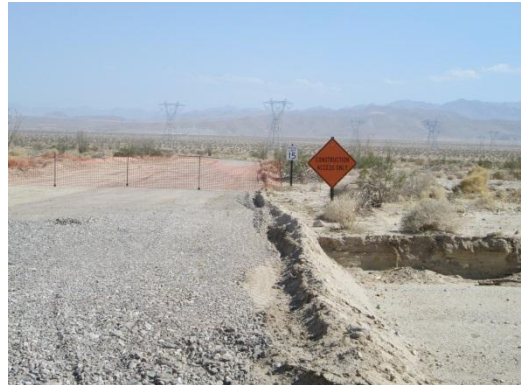
Photo 8: Signage has been placed at the point of ingress/egress to turbine string roads that intersect with public roads to notify motorists and the public that construction access is only permitted along turbine string roads for public safety purposes.

Signage has been placed at the point of ingress/egress to turbine string roads intersecting with public roads in order to notify motorists and the public that construction access is only permitted along turbine string roads for public safety purposes (see photo 8)
