BLM Authorized Officer Weekly Report

Project: Ocotillo Wind Energy Facility Project

Weekly Project Update

Reporting Period: 7.16.12 through 7.22.12

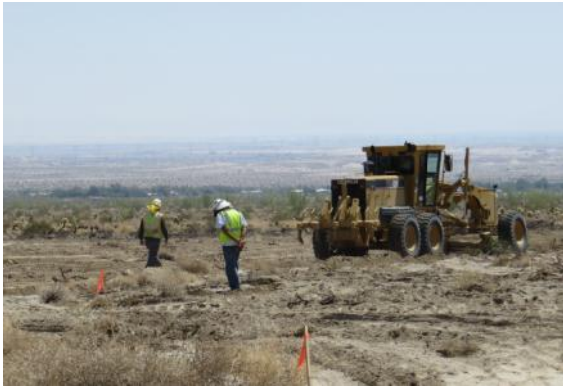
The Project Applicant has contracted with a biological and archeological consulting firm approved by the BLM to complete day-to-day monitoring of the construction activities in accordance with the ECCMP (see photo 1). Biological and archeological monitors were observed completing ongoing monitoring in accordance with the project requirements.

Photo 1: Archeological monitors complete monitoring during initial ground disturbance activity associated with establishing a wind turbine pad site.

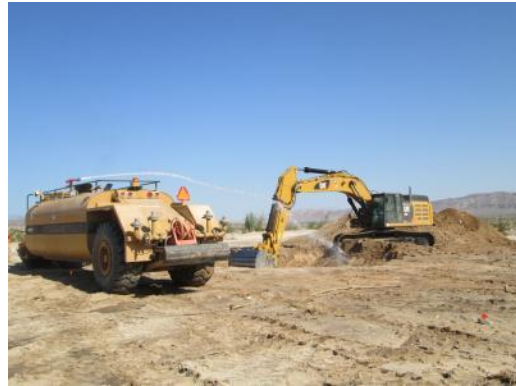
With the exception of the observation noted below, dust emissions were not observed to be an issue/concern throughout the daily construction activities. Crews were observed applying water during ground disturbance activities (see photo 2).

Photo 2: A water truck applies water during grading activities to minimize dust emissions in accordance with the Dust Control Plan.

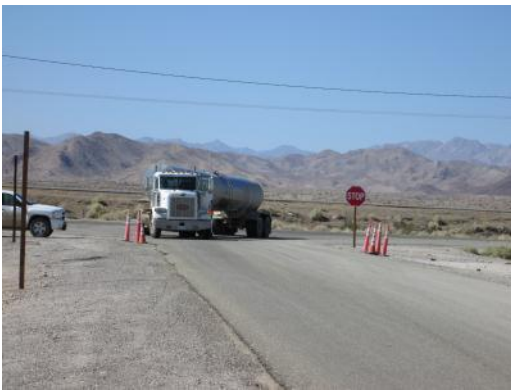
Dust Suppression: An ECM observed dust emissions along the Old Mining Road on 7.16.12. The dust emissions were observed when motorists kicked-up sediment along Old Mining Road. The sediment was present on the roadway as a result of natural sediment wash from the storm event on 7.13.12 (see Weekly Report #9). The construction contractor was contacted regarding the dust emissions. Upon the notification being provided water trucks were observed watering down Old Mining Road. In addition, a check-point was established at the intersection of Old Mining Road/Evan Hewes Highway to remind truck operators to reduce speeds while driving along the roadway. The application of water and reducing speeds proved to be effective in minimizing dust emissions.

An ECM observed dust emissions along the Old Mining Road on 7.16.12. The dust emissions were observed when motorists kicked-up sediment along Old Mining Road. The sediment was present on the roadway as a result of natural sediment wash from the storm event on 7.13.12 (see Weekly Report #9). The construction contractor was contacted regarding the dust emissions. Upon the notification being provided water trucks were observed watering down Old Mining Road. The application of water and reducing speeds proved to be effective in minimizing dust emissions. In addition, a check-point was established at the intersection of Old Mining Road/Evan Hewes Highway to remind truck operators to reduce speeds while driving along the roadway (see photo 3).

Photo 3: A check-point was established at the intersection of Old Mining Road/Evan Hewes Highway to notify truck operators of reduced speeds required along Old Mining Highway to minimize dust emissions.

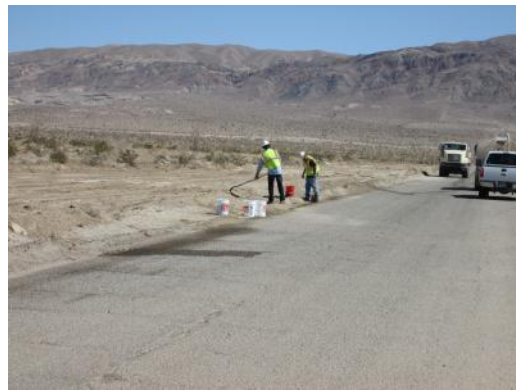
Crews were observed using spill kits and cleaning any spills and/or soil stains from leaking equipment throughout the day to day construction activities (see photo 4).

Photo 4: A crew cleans a hydraulic leak with a spill kit in accordance with the project requirements.

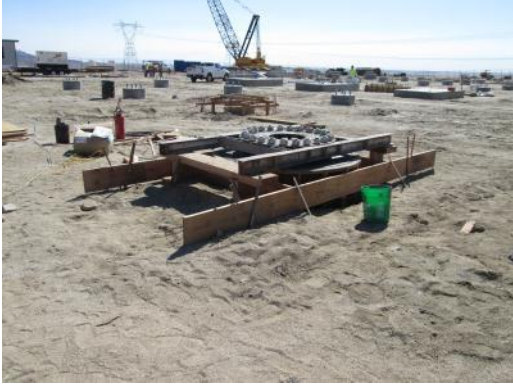
Construction activities occurring at the 30-acre substation/switchyard were observed being completed within the approved work limits. Crews were observed constructing foundations that will be utilized to erect above-grade substation components (see photo 5). Dust emissions were monitored on a regular basis and no issues/concerns were reported by the compliance monitors throughout the week.

Photo 5: A foundation is constructed within the SDG&E substation that will be utilized to transfer energy generated from the wind turbines to the Sunrise Powerlink located along the eastern limits of the substation.

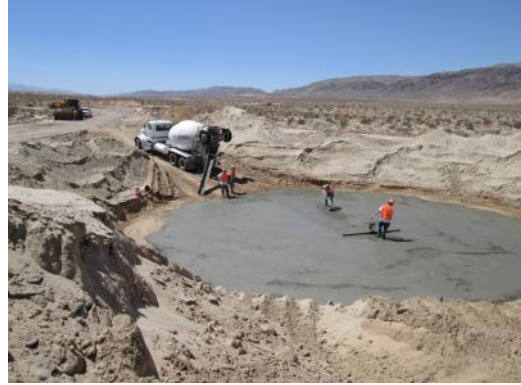
Crews were observed placing base pours at the wind turbine foundations and using rebar to construct turbine pad foundations (see Photos 6 and 7). Crews completing these activities were observed working within the approved work limits. Crews were also observed constructing wind turbine access roads, which consisted of placing a gravel road base along access roads (see photo 8).

Photo 6: Crews place a base pour at a wind turbine foundation.

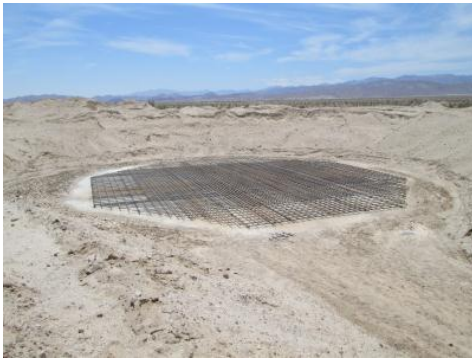
Photo 7: A concrete foundation with steel rebar is constructed at the wind turbine pad base that will be utilized for the construction of a wind turbine.

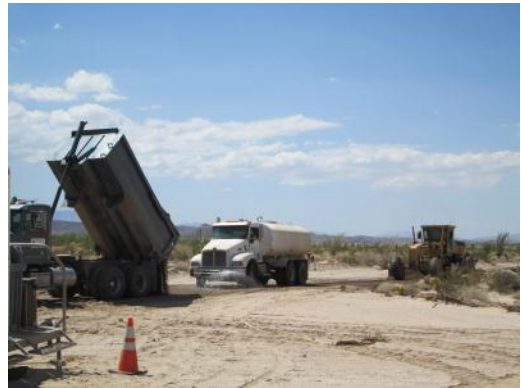
Photo 8: Gravel road base is placed along turbine access roads. A water truck is utilized to suppress dust during placement of the gravel road base
