## **BLM Authorized Officer Weekly Report**

**Project:** Ocotillo Wind Energy Facility Project

### **Weekly Project Update**

**Reporting Period:** 7.23.12 through 7.29.12

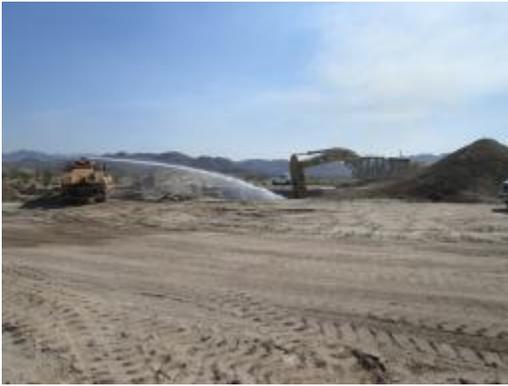
**Photo 1:** A water truck is utilized during excavation activities to minimize dust emissions.

An ECM observed dust emissions for approximately five minutes while crews were completing grading activities at a wind turbine pad site on 7.23.12. The foreman and lead biological monitor were informed of the dust being generated. Upon notification being provided the construction activities were ceased for the day. With the exception of the above mentioned issue/concern, all construction activities were observed to be in compliance with the Dust Control Plan (MM-AQ-1). Crews were observed watering down areas of active construction on a regular basis (see photo 1).

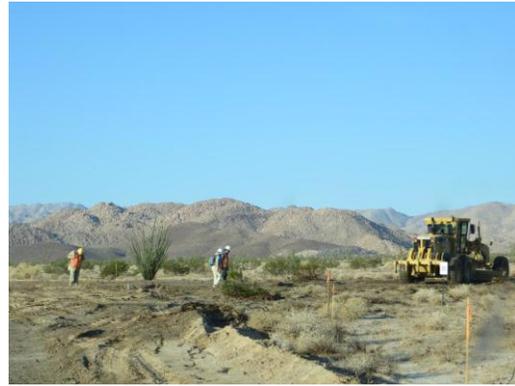
**Photo 2:** Archeological and Native American monitors complete monitoring of initial ground disturbance at a wind turbine foundation.

The Project Applicant has contracted with a biological and archeological consulting firm approved by the BLM to complete day-to-day monitoring of the construction activities in accordance with the ECCMP (see photo 2). Biological and archeological monitors were observed completing ongoing monitoring in accordance with the project requirements.

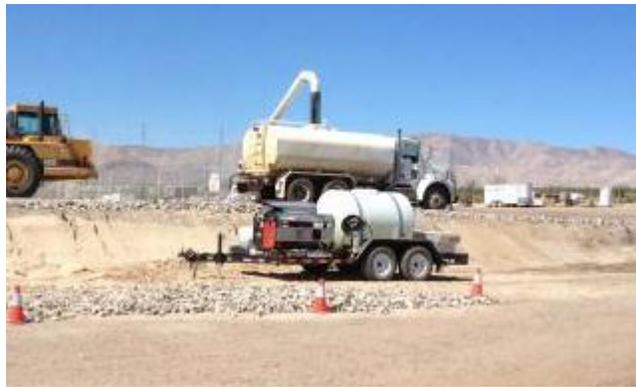
**Photo 3:** In accordance with the Integrated Weed Management Plan (MM-Veg-1d), a wheel wash station is located onsite to ensure vehicles and/or equipment that leave the site and are used on other sites are washed when leaving the site and prior to re-entering the site.

In accordance with the Integrated Weed Management Plan (MM-Veg-1d), a wheel wash station is located onsite to ensure vehicles and/or equipment that leave the site and are used on other sites are washed when leaving the site and prior to re-entering the site (see photo 3).

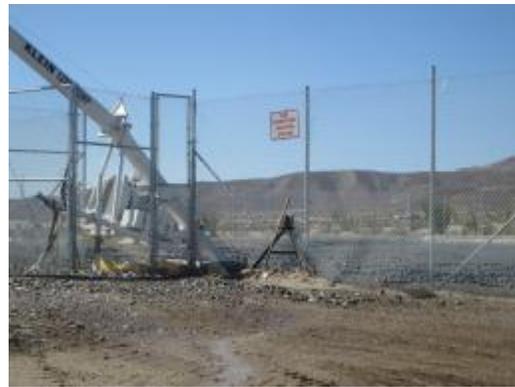
**Photo 4:** In accordance with Construction Fire Safety Plan (MM-Fire-1), a water drafting station has been established to provide a Fire Authority-approved fire truck access draft station at the temporary water pond.

In accordance with Construction Fire Safety Plan (MM-Fire-1), a water drafting station has been established to provide a Fire Authority-approved fire truck access draft station at the temporary water pond (see photo 4).

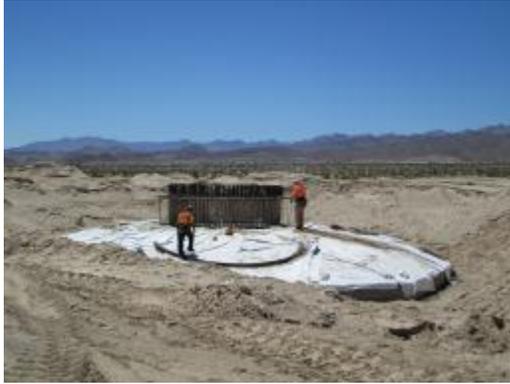
**Photo 5:** A crew completes construction activities at a wind turbine foundation.

In accordance with the SWPPP (MM-Water-9), concrete waste shall be disposed of properly. Crews were observed completed construction activities associated with wind turbine concrete pours throughout the reporting period (see photo 5). An ECM observed concrete waste associated with wind turbine foundation construction activities along the right-of-way and not being disposed of properly per the requirements of MM-Water-9 on 7.24.12 and 7.28.12. The contractor was aware of the issue/concern and notified the ECM the concrete waste would be cleaned-up in accordance with MM-Water-9. The ECM observed crews cleaning-up the concrete waste within the right-of-way prior to completing the daily construction activities.

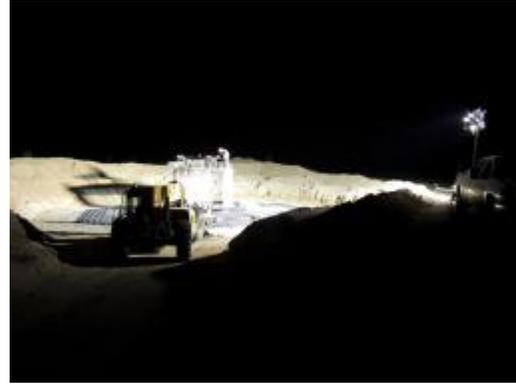
**Photo 6:** Crews complete nighttime work at wind turbine foundations. Lighting is pointed downward in accordance with the construction lighting mitigation plan (MM-VR-2).

As stated in Section 2.1.3 of the OWEF Plan of Development and Section 2.1.3.2 of the EIS, to meet the project schedule it may be necessary to work early morning, evenings, or even nights and/or Sundays during the foundation concrete pours and other tasks, to take advantage of the cooler times of the day and during the turbine erection period to take advantage of the times the wind speed is below the maximum safe working conditions. Construction activities occurring during this reporting period consisted of nighttime work in accordance with the activities disclosed in the Plan of Development and EIS (see photo 6).

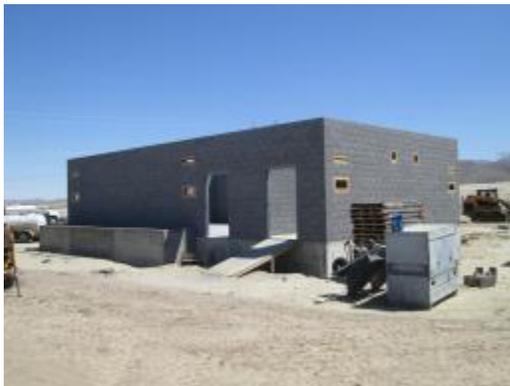
**Photo 7:** Construction of the control house at the onsite substation.

Construction activities occurring at the 30-acre substation/switchyard were observed being completed within the approved work limits. Crews were observed constructing the control house at the substation (see photo 7). Crews were also observed constructing above-grade components associated with foundations for substation facilities (see photo 8). Dust emissions were monitored on a regular basis and no issues/concerns were reported throughout the week.

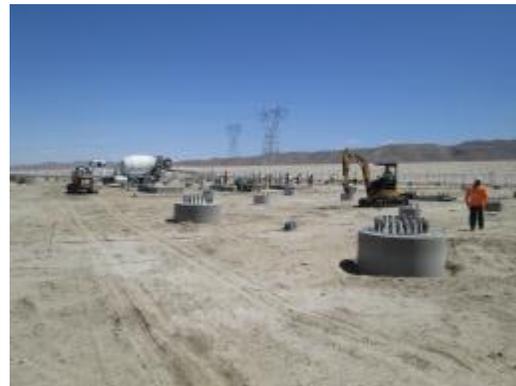
**Photo 8:** Construction crews complete foundations at the onsite substation that will be utilized for construction of substation components.
