BLM Authorized Officer Weekly Report

Project: Ocotillo Wind Energy Facility Project

Weekly Project Update

Reporting Period: 7.30.12 through 8.5.12

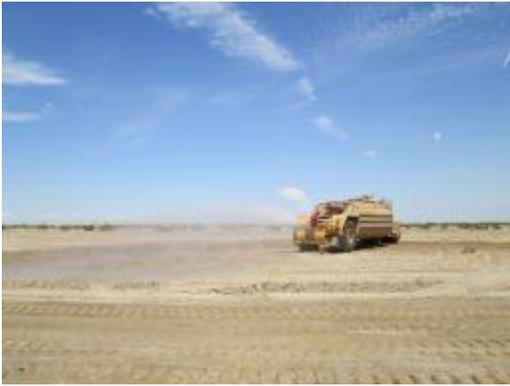
Construction activities were observed being completed in accordance with the Dust Control Plan (MM-AIR-1) throughout the reporting period. Water wagons and water trucks were routinely observed watering down areas prior to clearing and grading (see photo 1) and during active construction activities. Crews were also observed utilizing rattle plates and rock aprons placed along the entrances to paved roads to minimize trac-out.

Photo 1: A water wagon is utilized to pre-water a wind turbine foundation pad prior to excavation activities to minimize dust emissions in accordance with the Dust Control Plan (MM-AIR-1).

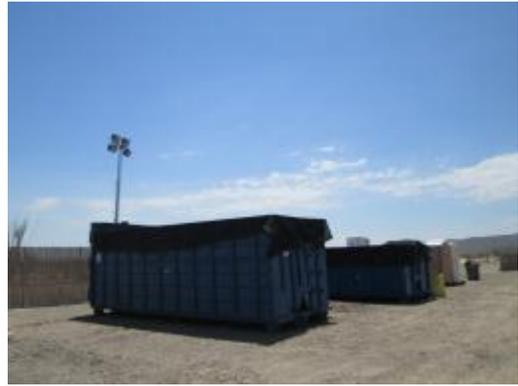
Trash bins were observed being covered in accordance with the Raven Control Plan (MM-Wild-1j), which requires all trash on site to be kept in covered trash receptacles (see photo 2). Issue/concerns regarding implementation of MM-Wild-1j are also identified above in the section titled "Issues/Concerns with Applicable Conditions of Certification".

Photo 2: Trash bins are covered at the laydown yard in accordance with the Raven Control Plan (MM-Wild-1j).

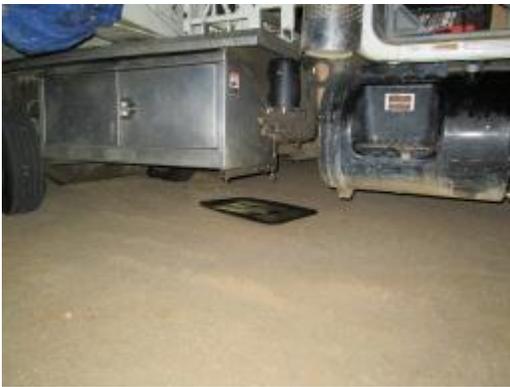
Drip pans have been observed beneath construction equipment staged along the ROW to minimize the potential for oils to stain soils (see photo 3). ECM's observed hazardous materials onsite being placed in proper containment as specified in the MM-Water-9.

Photo 3: Drip pans are placed beneath construction equipment to minimize the potential for oils to stain soils along the ROW.

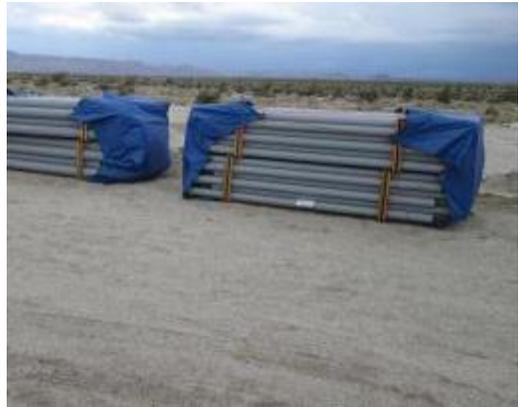
In accordance with MM-Wild-1m, construction piping or any other construction material with a diameter greater than three inches is to be covered if the piping or materials are to be stored in staging areas or temporary impact areas for more than three days. ECM's observed covers being placed over construction piping staged at the SDG&E substation in accordance with MM-Wild-1m.

Photo 4: In accordance with MM-Wild-1m, construction piping is covered at the substation.

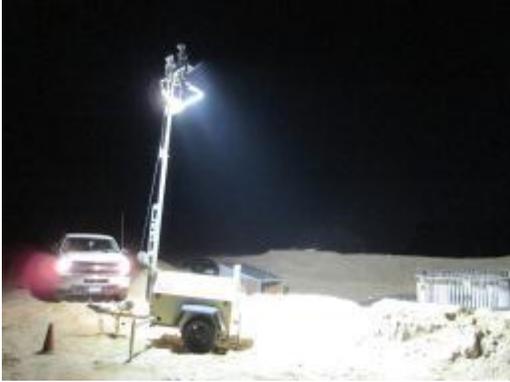
As stated in Section 2.1.3 of the OWEF Plan of Development and Section 2.1.3.2 of the EIS, to meet the project schedule it may be necessary to work early morning, evenings, or even nights and/or Sundays during the foundation concrete pours and other tasks, to take advantage of the cooler times of the day and during the turbine erection period to take advantage of the times the wind speed is below the maximum safe working conditions. Construction activities occurring during this reporting period consisted of nighttime work in accordance with the activities disclosed in the Plan of Development and EIS (see photo 5). ECM's are onsite during all nighttime work to ensure the lighting being set-up on a daily basis meets the requirements established in MM-VR-2.

Photo 5: Lighting being utilized for nighttime construction work is pointed downwards in accordance with MM-VIS-2.

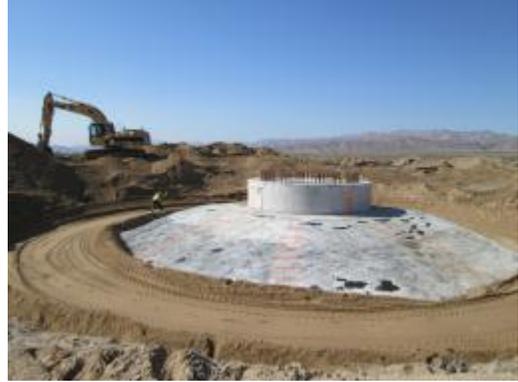
Construction crews were observed completing excavation activities, base pours, foundation and pedestal pours, and backfilling at wind turbine foundations located throughout the ROW (see photos 6 and 7). All work activity was observed being completed within the approved ROW limits.

Photo 6: Backfill is placed along the limits of a wind turbine foundation.

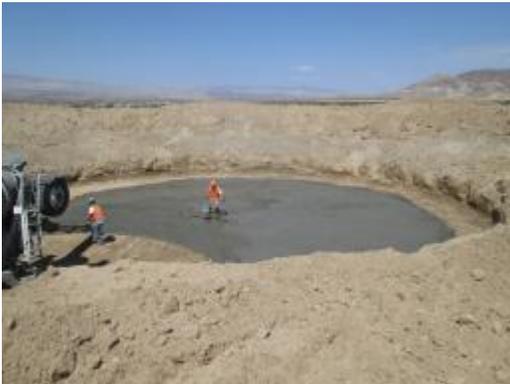
Photo 7: A base pour is completed at a wind turbine foundation.

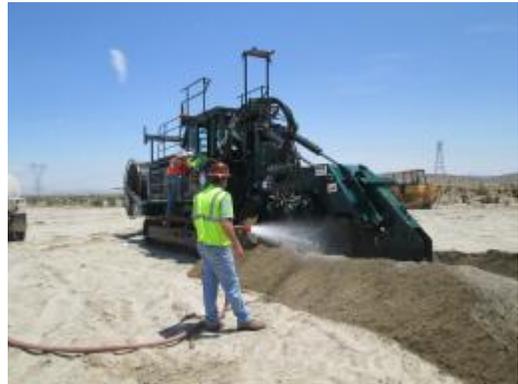
Construction crews have initiated work efforts associated with installation of the 34.5 kV underground collection lines that will transfer power generated at each wind turbine to the on-site substation (see photo 8). Crews were observed completing underground collection line installation within the approved work limits and water was being utilized during the construction activities to minimize fugitive dust emissions.

Photo 8: A track trencher is utilized to place the 34.5 kV collection lines underground within the approved work limits.
