## BLM Authorized Officer Weekly Report

**Project:** Ocotillo Wind Energy Facility Project

### Weekly Project Update

**Reporting Period:** 8.6.12 through 8.12.12

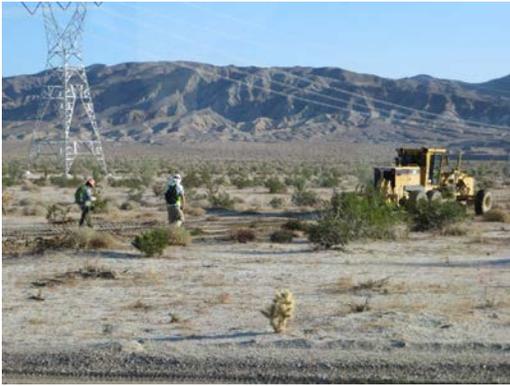
OE LLC has contracted with an archaeological consulting firm approved by the BLM to complete day-to-day monitoring of the construction activities in accordance with the ECCMP (see photo 1). Archaeological monitors were observed completing ongoing monitoring in accordance with the project requirements.

**Photo 1:** Archaeological monitors complete monitoring of the grading activities in accordance with the ECCMP.

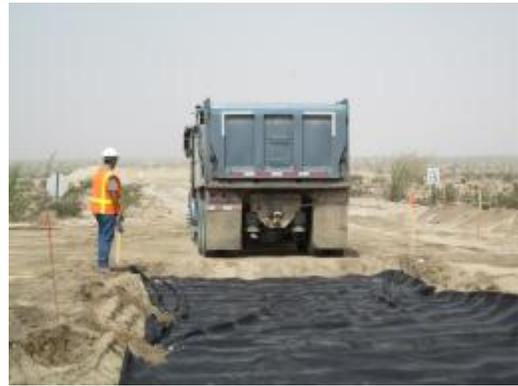
Construction activities were observed being completed in accordance with the Dust Control Plan (MM-AIR-1) throughout the reporting period. Stabilized construction entrances have been established at the entryway to each wind turbine string from paved roadways. Stabilized construction entrances include a rock apron that reduces potential trac-out along paved roadways (see photo 2). Water wagons and water trucks were routinely observed watering down areas of active excavation (see photo 3).

**Photo 2:** Stabilized construction entrances are established at the entryway to each wind turbine string from paved roadways. Stabilized construction entrances include a rock apron that reduces potential trac-out along paved roadways.

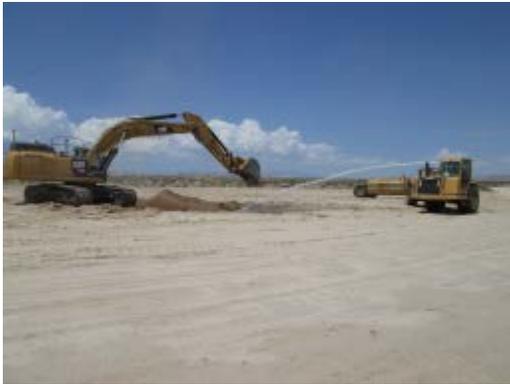
**Photo 3:** Water trucks are utilized during excavation activities to minimize dust emissions in accordance with the Dust Control Plan (MM-Air-1).

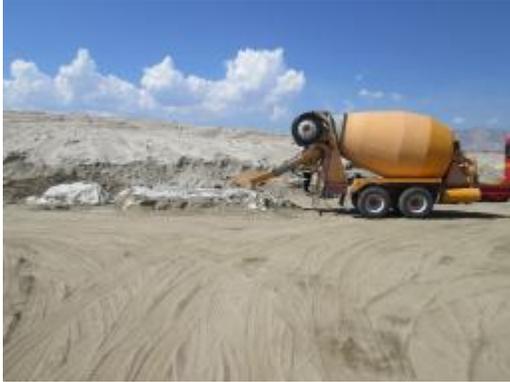
Construction crews completing concrete pouring activities at the substation are utilizing a cement washout station located in close proximity to the substation. The cement washout consists of spoil piles lined with plastic to provide proper containment of cement debris (see photo 5).

**Photo 5:** A concrete washout is utilized by cement truck operators to wash-out cement trucks along the ROW.

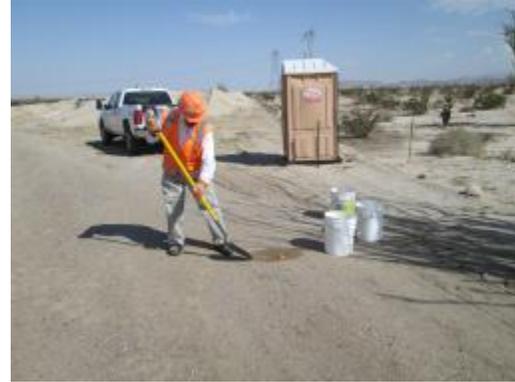
Crew members were observed removing stained soil along the ROW through use of a shovel and bucket to ensure Good Site Management practices are being implemented in accordance with Section 4.3.4 of the SWPPP (see photo 6). Drip pans have also been observed beneath construction equipment staged along the ROW to minimize the potential for oils to stain soils. ECM's observed hazardous materials onsite being placed in proper containment as specified in the MM-Water-9.

**Photo 6:** Crews remove stained soil along the ROW in accordance with the SWPPP (MM-Water-9).

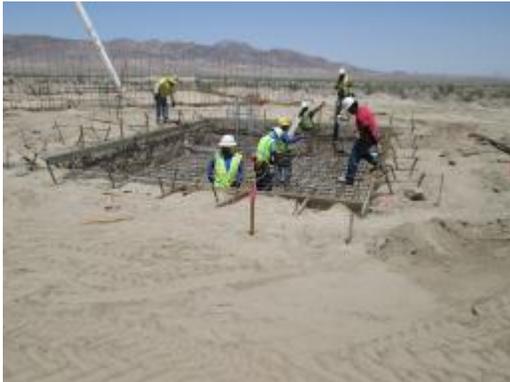
Construction crews during this reporting period were observed completing rebar assembly for concrete foundations at the Operations and Maintenance facility (see photo 7). All work activity was observed being completed within the approved ROW limits.

**Photo 7:** Foundations being constructed to support components for the Operation & Maintenance facility.

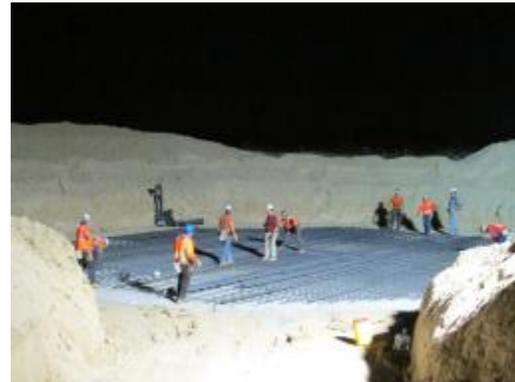
As stated in Section 2.1.3 of the OWEF Plan of Development and Section 2.1.3.2 of the EIS, to meet the project schedule it may be necessary to work early morning, evenings, or even nights and/or Sundays during the foundation concrete pours and other tasks, to take advantage of the cooler times of the day and during the turbine erection period to take advantage of the times the wind speed is below the maximum safe working conditions. Construction activities occurring during this reporting period consisted of nighttime work in accordance with the activities disclosed in the Plan of Development and EIS (see photo 8). ECM's are onsite during all nighttime work to ensure the lighting being set-up on a daily basis meets the requirements established in MM-VR-2.

**Photo 8:** A crew completes a bottom mat at a wind turbine foundation during the evening hours.
