BLM Authorized Officer Weekly Report

Project: Ocotillo Wind Energy Facility Project

Weekly Project Update

Reporting Period: 8.13.12 through 8.19.12

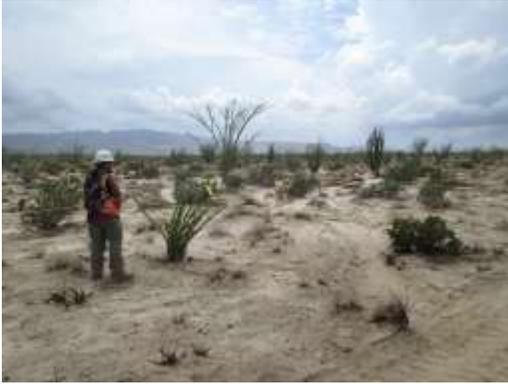
Photo 1: A lead biologist contracted under OE LLC and approved by BLM completes pre-construction nesting bird surveys in accordance with the Nesting Bird Mitigation and Monitoring Plan (MM-Wild-2b).

In accordance with MM Wild-2b and the Nesting Bird Mitigation and Monitoring Plan, a pre-vegetation clearing survey for avian nesting will be conducted prior no more than 7 days prior to vegetation clearing. If any active nest is located, the nest area will be flagged or otherwise marked for avoidance, and a buffer zone will be established. Lead biologists approved by the BLM were observed completing pre-construction nesting bird surveys in accordance with the Nesting Bird Mitigation and Monitoring Plan and MM-Wild-2b throughout the reporting period (see photo 1). Biological monitors were also observed being present in areas of initial ground disturbance along the ROW throughout the reporting period.

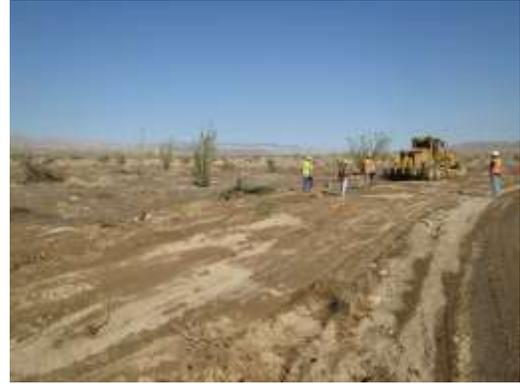
Photo 2: Archeological and biological monitors complete monitoring activities in accordance with the ECCMP during initial ground disturbance associated with establishing an access road to a wind turbine pad site.

OE LLC has contracted with an archeological consulting firm approved by the BLM to complete day-to-day monitoring of the construction activities in accordance with the ECCMP (see photo 2). Archeological monitors were observed completing ongoing monitoring in accordance with the project requirements and establishing ESA's prior to initiating ground disturbance. ECM's were onsite during all ground disturbance activities to ensure lead archeological monitors were present completing monitoring in accordance with the project requirements.

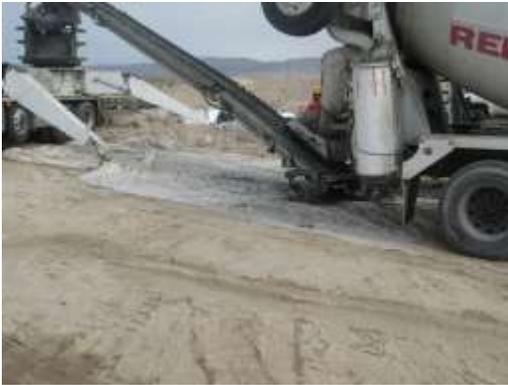
Photo 3: Plastic sheets are placed beneath concrete trucks and a conveyor belt to minimize the potential for concrete waste to be spilled onto the ROW during a wind turbine foundation pour.

Construction crews completing concrete pouring activities at the wind turbine foundations are utilizing plastic sheets placed beneath the concrete truck and conveyor belt in order to

minimize the potential for concrete spills along the ROW (see photo 3). By placing plastic sheets beneath the concrete trucks and conveyor belt has proved to be an effective method for minimizing the potential for concrete waste to be discharged along the ROW. Crews have also been observed regularly cleaning-up any concrete waste debris in accordance with the SWPPP (MM-Water-9).

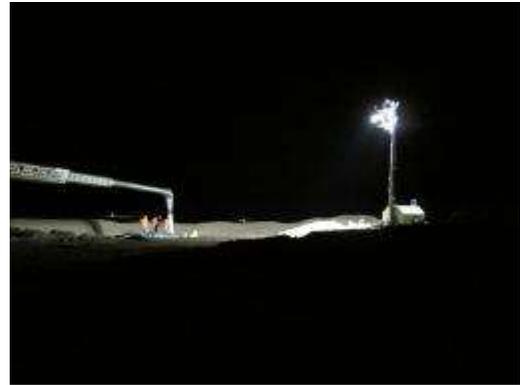
Photo 4: Night lights are oriented downwards during nighttime construction work associated with a concrete pour in accordance with MM-VIS-2.

Nighttime Lighting: An ECM observed lighting on 8.13.12, 8.14.12 and 8.15.12 that did not meet the intent of MM-VR-2 as the lighting was not fully directed downward per the requirements identified in MM-VR-2. Upon notification being provided to the construction contractor the lighting was re-directed downwards in accordance with the criteria established in MM-VR-2. ECM's are onsite during all nighttime work to ensure the lighting being set-up on a daily basis meets the requirements established in MM-VR-2.

As stated in Section 2.1.3 of the OWEF Plan of Development and Section 2.1.3.2 of the EIS, to meet the project schedule it may be necessary to work early morning, evenings, or even nights and/or Sundays during the foundation concrete pours and other tasks, to take advantage of the cooler times of the day and during the turbine erection period to take advantage of the times the wind speed is below the maximum safe working conditions. Construction activities occurring during this reporting period consisted of nighttime work in accordance with the activities disclosed in the Plan of Development and EIS. ECM's are onsite during all nighttime work to ensure the lighting being set-up on a daily basis meets the requirements established in MM-VR-2. ECM's are onsite to work with crews on setting up lights at each construction activity area (see photo 4). Lights have been pointed away from the town of Ocotillo to the greatest extent feasible considering worker safety..

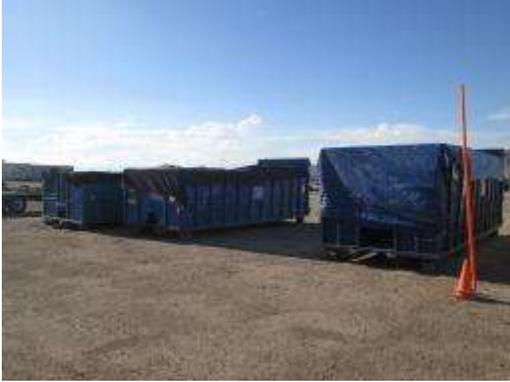
Photo 5: Covers are placed over waste bins in accordance with the Raven Control Plan requirements (MM-Wild-1j).

Trash Management: In accordance with Section 4.1 of the Raven Control Plan (MM-Wild-1j), all trash on site must be kept in covered trash receptacles. An ECM identified trash bins located within the temporary laydown yard that had not been covered on SDGE substation on 8.13.12 and 8.16.12, near wind turbine 112 on 8.14.12 and at the temporary laydown yard on 8.14.12.

ECM's and the lead biological monitors completed routine site observations to make sure trash receptacles are being covered in accordance with Section 4.1 of the Raven Control Plan (MM-Wild-1j). With the exception of the instances noted above in Section "Issues/Concerns with Applicable Conditions of Certification", trash receptacles were observed being covered along the ROW. Covers consist of tarps and plastic lids that are secured to the trash bins (see photo 5).

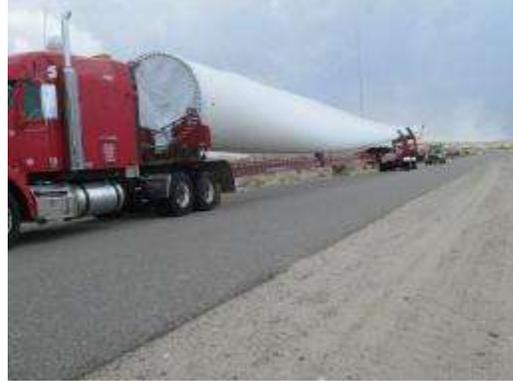
Photo 6: A wind turbine blade is delivered to the project site via Old Mining Road.

Transportation deliveries associated with hauling turbine components to the project site were initiated during this reporting period. Turbine components were delivered to the project site in accordance with the Construction Traffic Management Plan (POD-14 and POD-15). The turbine components were delivered via the I-8/Ocotillo Imperial Highway exit, and then proceeded east along W Evan Hewes Highway to a private road (Old Mining Road) (see photo 5). All deliveries were escorted by California Highway Patrol and per the requirements identified in the transportation permits issued by the State of California Department of Transportation.

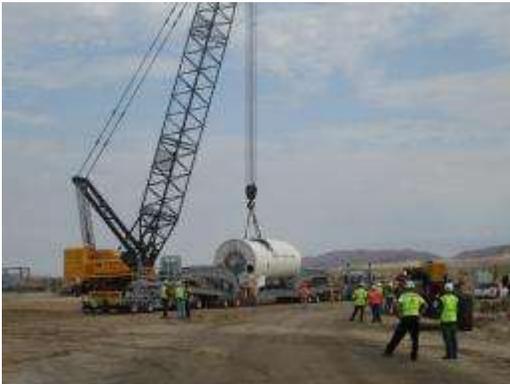
Photo 7: A crane is utilized to unload a nacelle from a haul truck to be staged along the ROW.

Cranes were utilized to unload the turbine components to be staged along the ROW within the approved work limits (see photo 6). Turbine assembly is scheduled to begin during next week's reporting period.

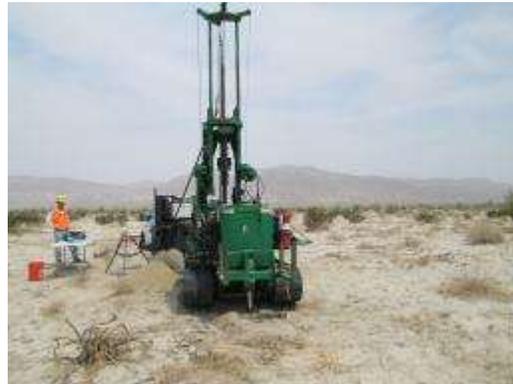
Photo 8: A crew completes geotechnical investigations at a wind turbine pad site in accordance with MM-Soils-1 and PHS-3.

Geotechnical activities were completed during this reporting period in accordance with MM-Soils-1 and PHS-3. Geotechnical testing is completed at all approved turbine locations to

confirm soil characteristics and final foundation designed. Following the required testing being completed for each turbine, a final geotechnical report is submitted to the County of Imperial, California's (County's) Building Department and the BLM. OE LLC is required to submit all documentation identified under PHS-3 and Soil-1 prior to obtaining building permits from the County's Building Department.
