BLM Authorized Officer Weekly Report

Project: Ocotillo Wind Energy Facility Project

Weekly Project Update

Reporting Period: 8.27.12 through 9.2.12

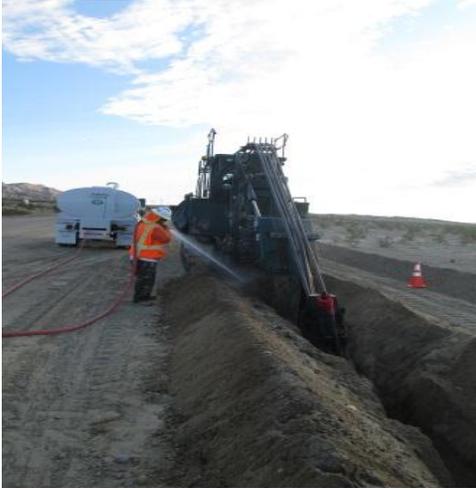
Photo 1: Construction crews utilize water to minimize dust emissions during trenching activities for installation of the 34.5 kV underground collection lines in accordance with the Dust Control Plan (MM-Air-1).

Construction activities were observed being completed in accordance with the Dust Control Plan (MM-AIR-1) throughout the reporting period. Water wagons and water trucks were routinely observed watering down areas of active grading, trenching, and excavation to ensure dust emissions were minimized during construction in accordance with the dust control plan (see photo 1). Stabilized construction entrances have been established and maintained at locations where project access roads intersect paved access roads. The stabilized construction entrances consist of rock aprons to minimize track-out from construction equipment along paved access roads and to prevent fugitive dust in accordance with MM-Air-1 (see photo 2).

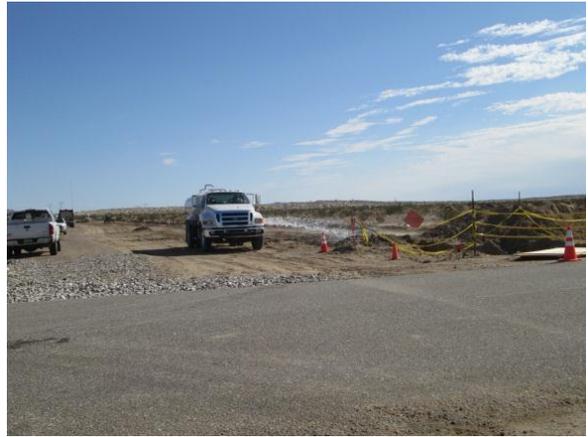
Photo 2: Stabilized construction entrances are placed at locations where project access roads intersect paved access roads in accordance with the Dust Control Plan (MM-Air-1).

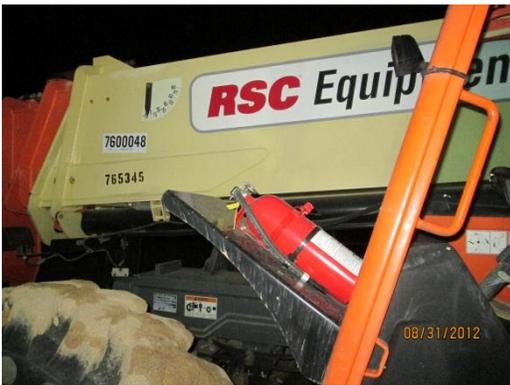
Photo 3: Fire extinguishers are placed within construction equipment in accordance with the Construction Fire Safety Plan.

In accordance with the Construction Fire Safety Plan, all vehicles and equipment with an internal combustion engine must be equipped with a fire extinguisher to help prevent and contain fires within the project area. ECM's observed and documented construction equipment with fire extinguishers in compliance with the Construction Fire Safety Plan (see photo 3).

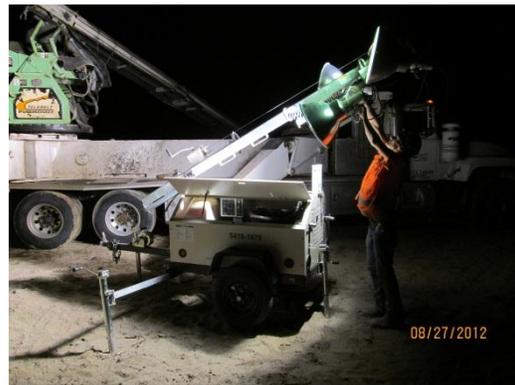
Photo 4: A construction worker orients lights downwards during nighttime construction activity in accordance with MM-VIS-2.

Nighttime Lighting: An ECM observed lighting on 8.27.12 and 8.29.12, that did not meet the intent of MMR-VR-2 as the lighting was not fully directed downward per the requirements identified in MM-VR-2. In addition, ECM's observed lights being turned on in excess of one hour prior to work activities commencing. Upon notification being provided to the construction contractor, the lighting was re-directed downwards and turned off when the area was unoccupied in accordance with the criteria established in MM-VR-2.

As stated in Section 2.1.3 of the OWEF Plan of Development and Section 2.1.3.2 of the EIS, to meet the project schedule it may be necessary to work early morning, evenings, or even nights and/or Sundays during the foundation concrete pours and other tasks, to take advantage of the cooler times of the day and during the turbine erection period to take advantage of the times the wind speed is below the maximum safe working conditions. Construction activities occurring during this reporting period consisted of nighttime work in accordance with the activities disclosed in the Plan of Development and EIS. ECM's are on site during all nighttime work to ensure the lighting being set-up on a daily basis meets the requirements established in MM-VR-2. ECM's are on site to work with crews on setting up lights at each construction activity area. Lights have been pointed away from the town of Ocotillo to the greatest extent feasible; however in order to ensure worker safety, instances have required lights to be pointed in the direction of the town of Ocotillo. ECM's observed construction crew members orienting lights downwards and away from the town of Ocotillo during this reporting period in accordance with MM-VIS-2 (see photo 4).

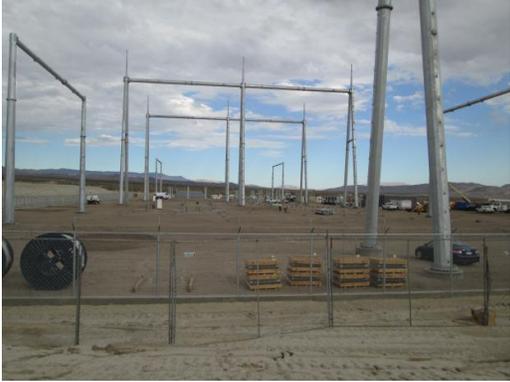
Photo 5: A-Frame steel structures are erected at the substation/switchyard.

Construction continued at the Substation/Switchyard and O&M Facility during this construction period. At the Substation/Switchyard, construction crews were observed erecting structural steel and continuing with the underground conduit work (see photo 5). Construction crews were observed creating a pad site for the turning structures that will be used to deliver power generated from the wind turbines via the Substation/Switchyard to the Sunrise Powerlink (see photo 6). At the O&M facility, construction crews were continuing to work on the masonry block installation, structural steel installation, and foundation pours (see photo 7). Work activities were observed to be completed within the approved project limits at both the Substation Switchyard and O&M Facility.

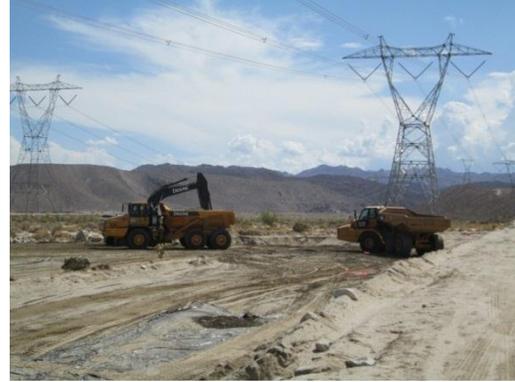
Photo 6: Construction crews were observed creating a pad site for the turning structures that will be used to deliver power generated from the wind turbines via the Substation/Switchyard to the Sunrise Powerlink

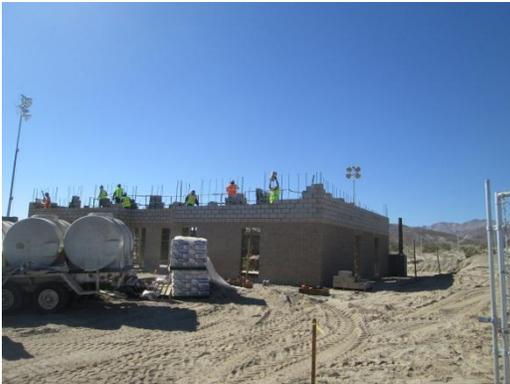
Photo 7: Crews complete construction activities associated with building the walls of the O&M facility.

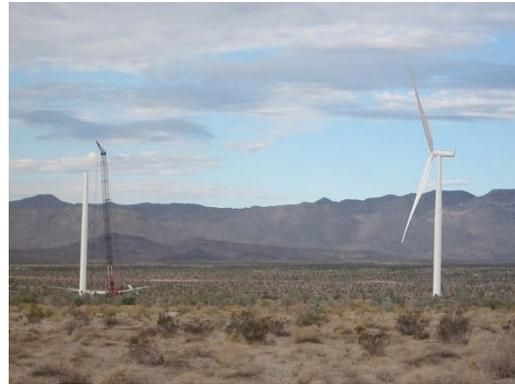
Photo 8: Wind turbines are erected on site via use of a large crane.

Cranes were utilized to unload the turbine components to be staged along the ROW within the approved work limits. Turbine assembly continued during this reporting via the use of cranes and five turbines have been erected to date (see photo 8).
