## BLM Authorized Officer Weekly Report

**Project:** Ocotillo Wind Energy Facility Project

### Weekly Project Update

**Reporting Period:** 9.3.12 through 9.9.12

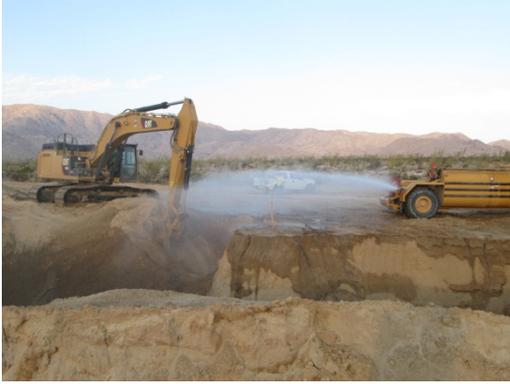
**Photo 1:** A water truck is used to suppress fugitive dust emissions during excavation activities at a wind turbine pad site in accordance with (MM-Air-1)

Construction activities were observed being completed in accordance with the Dust Control Plan (MM-AIR-1) throughout the reporting period. Water wagons and water trucks were routinely observed watering down areas of active grading, trenching, and excavation to ensure dust emissions were minimized during construction in accordance with the dust control plan (see photo 1). Soil stabilizers were placed on unpaved access roads to prevent fugitive dust in accordance with MM-Air-1 (see photo 2). In addition, speed limit signage has been placed along access roads to notify motorists of the speed limit. The speed limit signs have been placed on-site in accordance with MM-Air-3 (see photo 3).

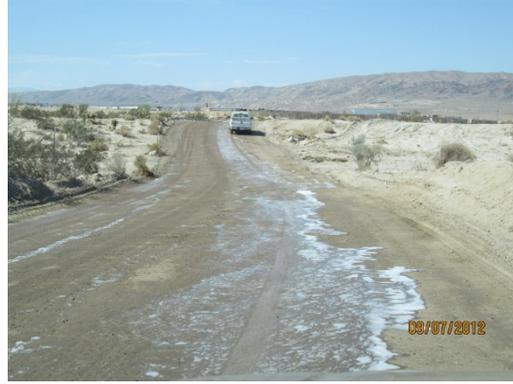
**Photo 2:** Soil stabilizers are applied to access roads to minimize fugitive dust emissions in accordance with MM-Air-1.

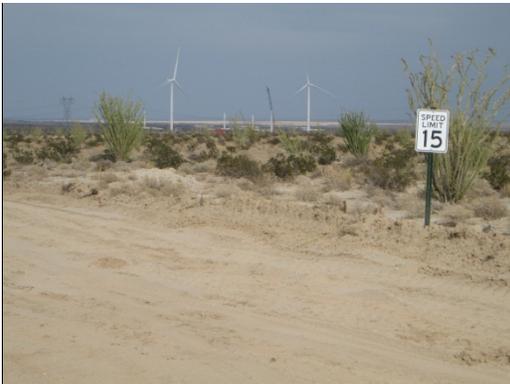
**Photo 3:** Speed limit signs are posted along access roads in accordance with MM-Air-3.

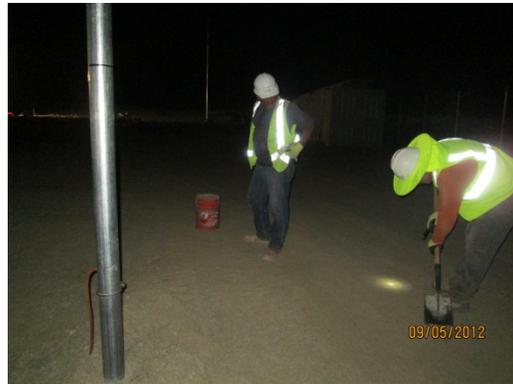
On 9.5.12, 9.6.12, and 9.8.12 ECM's observed small diesel spills at the Substation/Switchyard and at wind turbine pad sites. In each of these cases, the leaking equipment was identified and the diesel spills were cleaned-up in accordance with the project requirements (see photo 4).

**Photo 4:** Construction crews clean a diesel leak near the 30-acre Substation/Switchyard using a spill kit in accordance with MM-Water-10.

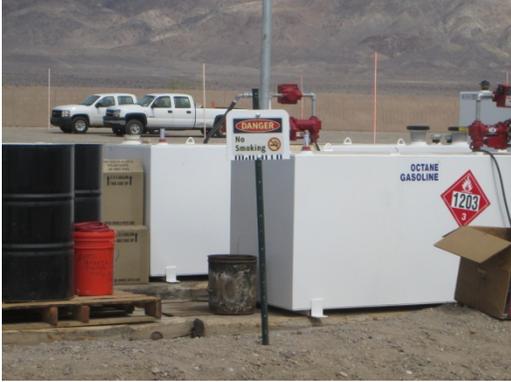
**Photo 5:** A “no smoking” sign is placed adjacent to the storage/refueling area at the Laydown Yard in accordance with the Construction Fire Safety Plan (MM-Fire-1).

In accordance with the Construction Fire Safety Plan (MM-Fire-1), ECM's observed "no smoking" signs erected adjacent to the storage/refueling area at the Laydown Yard (see photo 5).

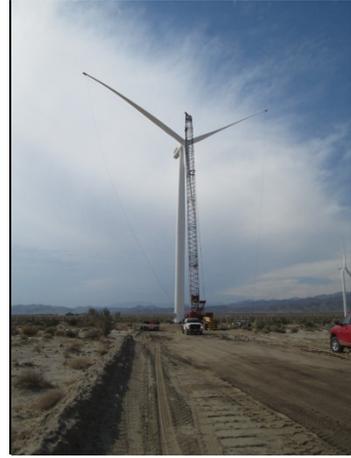
**Photo 6:** A crane is utilized to lift a rotor into place for assembly to the nacelle.

Cranes were utilized to unload the turbine components to be staged along the ROW within the approved work limits. Turbine assembly continued during this reporting period and eight turbines have been erected to date (see photo 6).

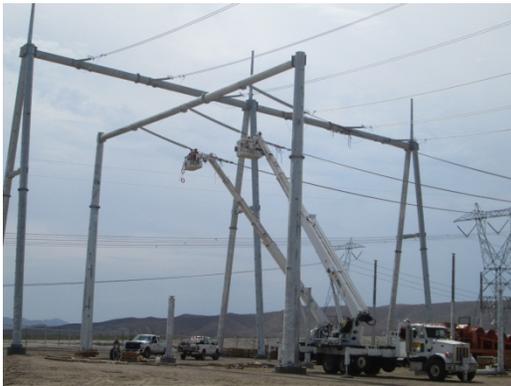
**Photo 7:** Crews complete construction of the A-Frame steel structures at the 30-acre Substation/Switchyard

Construction continued at the Substation/Switchyard and O&M Facility during this construction period. At the Substation/Switchyard, construction crews were observed erecting steel and continuing with the underground conduit work (see photo 7). At the O&M facility, construction crews were continuing to work on the masonry block installation, structural steel installation, foundation pours, and installation of the roof (see photo 8). Work activities were observed to be completed within the approved project limits at both the Substation/Switchyard and O&M Facility.

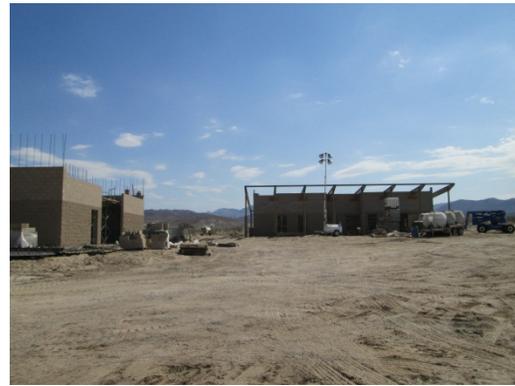
**Photo 8:** Construction continues at the O&M building with the installation of masonry block and roofing material.
