BLM Authorized Officer Weekly Report

Project: Ocotillo Wind Energy Facility Project

Weekly Project Update

Reporting Period: 9.10.12 through 9.16.12

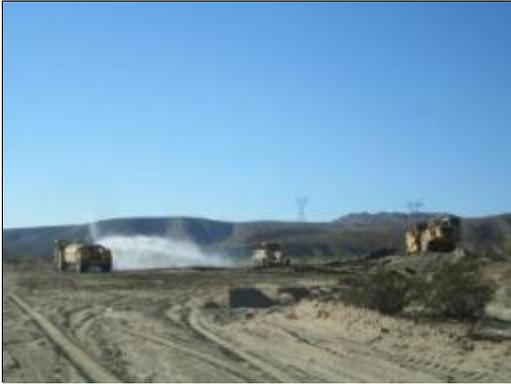
Water wagons and water trucks were routinely observed watering down areas of active grading, trenching, and excavation to ensure dust emissions were minimized during construction in accordance with the dust control plan (see photo 1). In addition, construction crews were reminded by the foreman of the posted speed limit on project access roads during weekly construction meetings and during completion of the mandatory Worker Environmental Awareness Program (WEAP) safety training.

Photo 1: Construction crews utilize water to minimize dust emissions during backfilling activities in accordance with the Dust Control Plan (MM-Air-1).

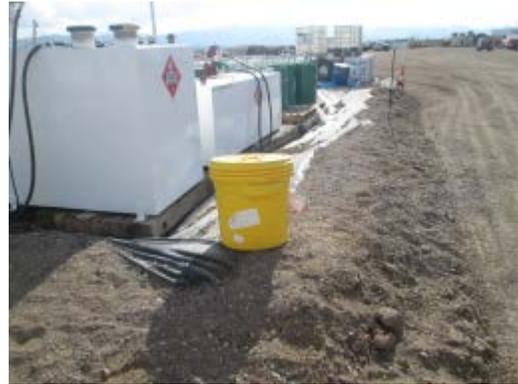
A fuel farm has been established at the Laydown Yard to provide fuel to construction equipment onsite. Per Section F of the Construction Fire Safety Plan (MM-Fire-1), each tank is required to be grounded, secondary containment is to be put in place to accommodate the capacity of the largest tank, at least four fire extinguishers are to be onsite, no smoking signs are to be posted, NFPA/DOT placards designating the hazardous product shall be posted and no portable electrical generators shall be operated within the storage area. ECM's verified the above mentioned items are being implemented at the onsite fuel farm (see photo 2).

Photo 2: A fuel farm has been established at the temporary Laydown Yard and was verified by ECM's to be set-up in accordance with the Construction Fire Safety Plan (MM-Fire-1).

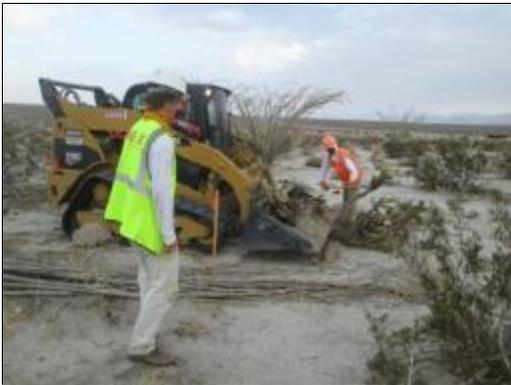
On 9.10.12 an ECM observed a biological monitor directing the relocation of a Wolf's Cholla Scrub (*Cylindropuntia wolfii*) in accordance with the Habitat Revegetation Plan (MM-Veg-2b) (see photo 3).

Photo 3: A biological monitor observes the relocation of a Wolf's Cholla Scrub in accordance with the Habitat Revegetation Plan (MM-Veg-2b).

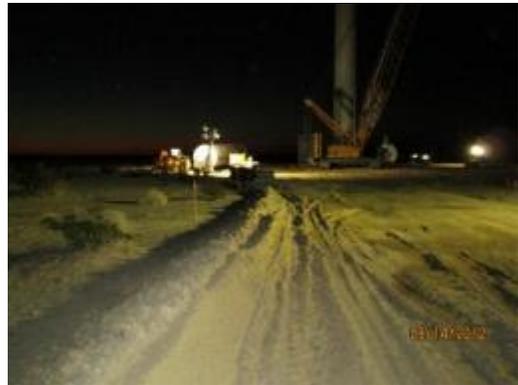
In accordance with MM-Wild-1d, the boundaries of all areas to be disturbed are delineated with stakes and flagging prior to construction activities. ECM's observed OE LLC working with land surveyors and the biological monitor to ensure all work areas are clearly delineated prior

to ground disturbance (see photo 4). The limits of work are monitored by a biological monitor during all ground disturbance activities to ensure construction activities remain within the approved work limits and that the work limits are properly delineated. With the exception of the instance noted above in Section “Issues/Concerns with Applicable Conditions of Certification”, all construction activities remained within the approved work limits during this reporting period. In accordance with MM-Wild-1t, a biological consultant is to be approved by the BLM, USFWS, and CDFG to serve as the Bighorn Sheep Monitor during construction activities within USFWS Essential Habitat. BLM, USFWS and CDFG approved a biological consultant to perform the roles and responsibilities outlined in MM-Wild-1t and the Bighorn Sheep Mitigation and Monitoring Plan. ECM’s have observed the biological consultant performing monitoring duties in accordance with MM-Wild-1t and the Bighorn Sheep Mitigation and Monitoring Plan when crews are working within USFWS Essential Habitat.

Photo 4: Survey stakes are placed at the approved project work limits in accordance with MM-Wild-1d to ensure all construction activities remain within the approved work limits.

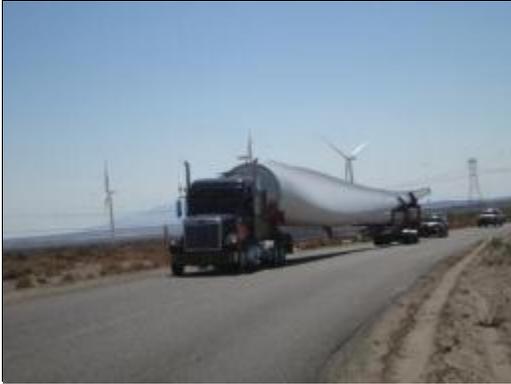
Transportation deliveries associated with hauling turbine components to the project site continued during this reporting period. Turbine components were delivered to the project site in accordance with the Construction Management Plan. The turbine components were delivered via the I-8/Ocotillo Imperial Highway exit, and then proceeded east along W Evan Hewes Highway to a private road (Old Mining Road) (see photo 5). All deliveries were escorted by California Highway Patrol.

Photo 5: A wind turbine blade is delivered to the project site via Old Mining Road in accordance with the Traffic Management Plan.

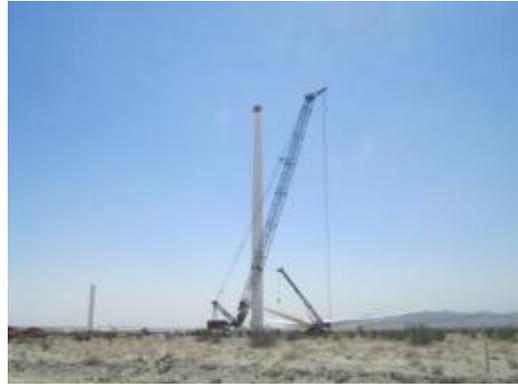
Cranes were utilized to unload the turbine components to be staged along the ROW within the approved work limits. Turbine assembly continued during this reporting period and 16 turbines have been erected to date (see photo 6).

Photo 6: A crane is utilized to lift a rotor into place for assembly to the nacelle.

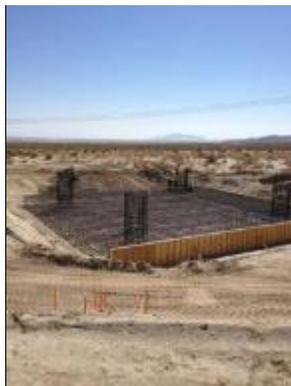
Construction continued at the Substation/Switchyard and O&M Facility during this construction period. At the Substation/Switchyard, construction crews were observed erecting steel, continuing with the underground conduit work, and rebar construction for electrical tie-ins. Construction activities associated with establishing the foundation for the turning structures that will be utilized to tie-in the onsite Substation/Switchyard with the Sunrise Powerlink were observed being completed within the approved work limits (see photo 7). At the O&M facility, construction crews were continuing to work on the masonry block installation, structural steel installation, foundation pours, and installation of the roof (see photo 8). During the completion of specific work efforts or periods of inactivity, the gates to the O&M facility, Substation Switchyard, and Laydown Yard are closed, all trash is placed within covered bins, and all hazardous materials are properly stored.

Photo 7: Crews continue rebar construction for a turning structure that will be utilized to tie-in energy generated onsite to the Sunrise Powerlink.

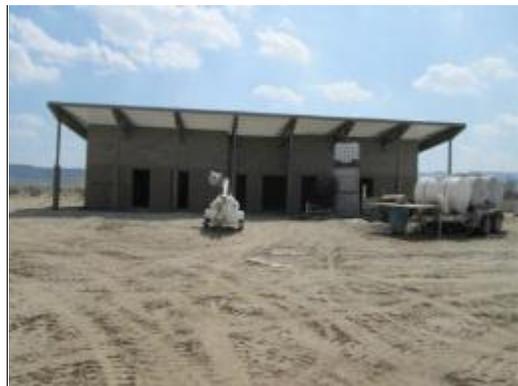
Photo 8: Construction continues at the O&M building with the installation of masonry block and roofing material.
