BLM Authorized Officer Weekly Report

Project: Ocotillo Wind Energy Facility Project

Weekly Project Update

Reporting Period: 9.17.12 through 9.23.12

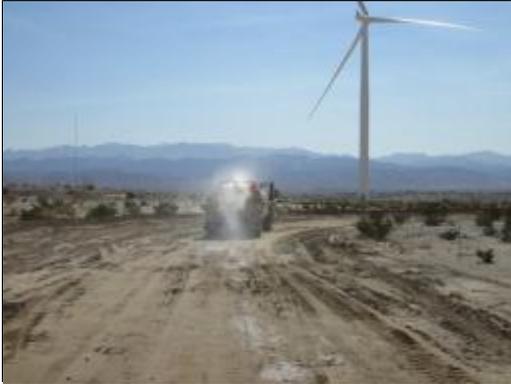
Photo 1: Construction crews utilize water to minimize dust emissions in accordance with the Dust Control Plan (MM-Air-1).

Water wagons and water trucks were routinely observed watering down areas of active grading, trenching, and excavation to ensure dust emissions were minimized during construction activities in accordance with the dust control plan (see photo 1). In addition a soil binding agent is being utilized along access roads and stockpiles to minimize dust emissions in areas that have been disturbed as a result of construction activities.

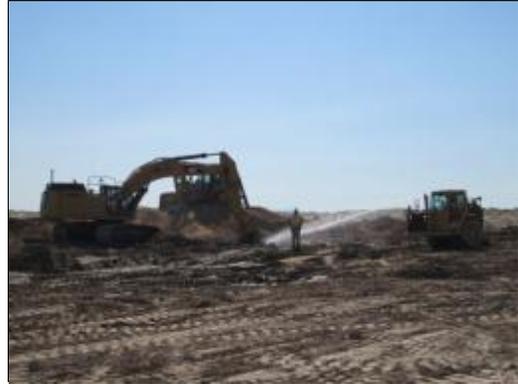
Photo 2: A paleontological monitor observes excavation activities occurring in sensitive fossil bearing formations in accordance with MM-Paleo-1.

In accordance with the Paleontological Monitoring and Treatment Plan (MM-Paleo-1), a paleontological monitor permitted by BLM is to be present when excavation activities occur within sensitive fossil bearing formations. ECM's observed a paleontological monitor completing monitoring duties as defined in the Paleontological Monitoring and Treatment Plan when crews were excavating foundations within sensitive fossil bearing formations (see photo 2).

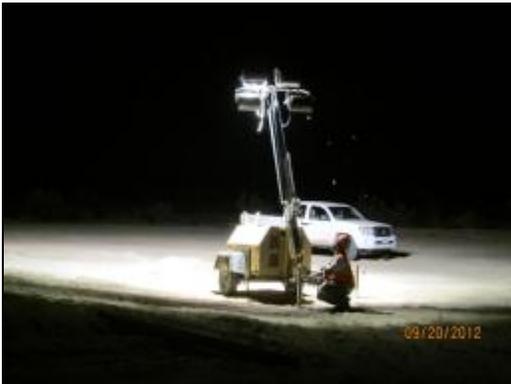
Photo 3: A construction worker orients lights downwards during nighttime construction activity in accordance with MM-VIS-2.

Construction activities occurring during this reporting period consisted of nighttime work in accordance with the activities disclosed in the Plan of Development and EIS. ECM's are onsite during all nighttime work to ensure the lighting being set-up on a daily basis meets the requirements established in MM-VR-2. ECM's are onsite to work with crews on setting up lights at each construction activity area. An ECM observed lighting on 9.17.11 and 9.19.12 that did not meet the intent of MM-VR-2 as the lighting was not fully directed downwards per the requirements identified in MM-VR-2. Upon notification being provided to the construction contractor, the lighting was redirected downwards in accordance with the criteria established in MM-VR-2 (see photo 3). On 9.17.12 and 9.19.12 an ECM observed lighting that was left on in excess of thirty minutes at an unoccupied turbine pad. In each case, the ECM notified the construction contractor and the lighting was immediately turned off.

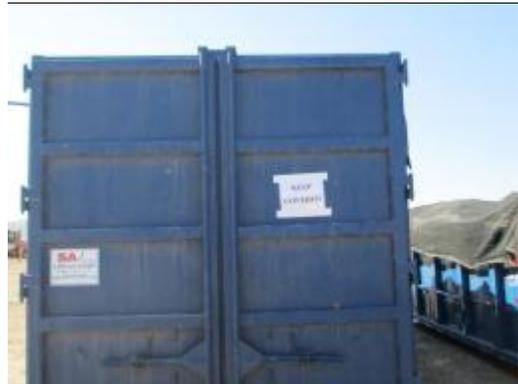
Photo 4: A "Keep Covered" sign is affixed to all trash receptacles to remind construction crews to securely cover trash receptacles at all times in accordance with MM-Wild-1j.

In accordance with Section 4.1 of the Raven Control Plan (MM-Wild-1j), all trash onsite must be kept in covered trash receptacles. On 9.17.12 an ECM observed an uncovered trash bin at

the 30-acre Substation/Switchyard. ECM's and the lead biological monitors completed routine site observations to make sure trash receptacles are being covered. With the exception of the instances noted above, trash receptacles were observed being covered along the ROW. Covers consist of tarps and plastic lids that are secured to the trash bins. "Keep Covered" signage has also been affixed to all trash receptacles to remind construction crews to securely cover trash receptacles at all times (see photo 4).

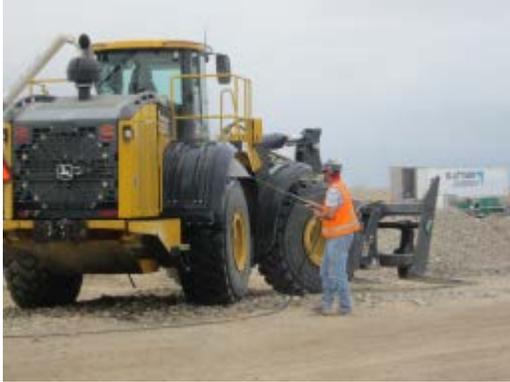
Photo 5: Construction crews wash wheel wells and tires on heavy construction equipment in accordance with the Integrated Weed Management Plan (MM-Veg-1d).

The lead biological monitor was observed conducting regular vehicle inspections at the Laydown Yard to ensure that all vehicles have been washed prior to entering the project site in accordance with the Integrated Weed Management Plan (IWMP) MM-Veg-1d. In the event a vehicle had not been washed a "wash ticket" is issued and the operator of the equipment is required to washout the wheel wells and tires at the wash station located at the laydown yard (see photo 5).

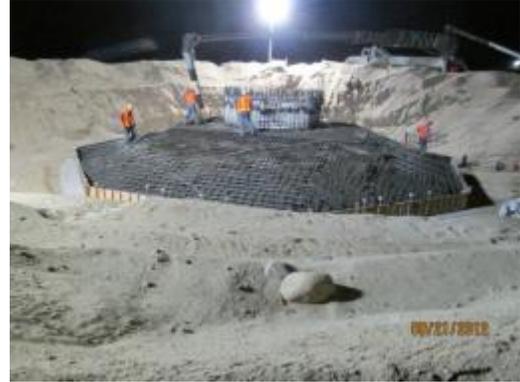
Photo 6: A concrete base pour is completed at a wind turbine foundation during the evening hours.

Construction crews were observed throughout the reporting period completing turbine base concrete pours (see photo 6). Sixty five wind turbine base pours have been completed to date.

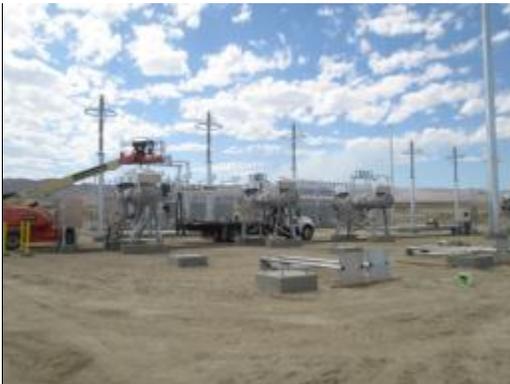
Photo 7: Construction crews continue construction at the 30-acre Substation/Switchyard.

Construction continued at the Substation/Switchyard and O&M Facility during this construction period. At the Substation/Switchyard, construction crews were observed erecting steel, continuing with the underground conduit work, and rebar construction for electrical tie-ins (see photo 7). Construction activities associated with establishing the foundation for the turning structures that will be utilized to tie-in the onsite Substation/Switchyard with the Sunrise Powerlink were observed being completed within the approved work limits. At the O&M facility, construction crews were continuing to work on the masonry block installation, structural steel installation, foundation pours, and installation of the roof. Trenching activities were also observed adjacent to the O&M facility (see photo 8). During the completion of specific work efforts or periods of inactivity, the gates to the O&M facility, Substation Switchyard, and Laydown are closed, all trash is placed within covered bins, and all hazardous materials are properly stored.

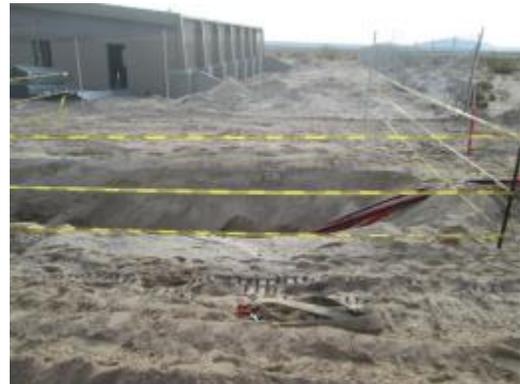
Photo 8: Trenching activities associated with installation of the 34.5 kV underground collection lines continue along Dos Cabezas Road adjacent to the O&M facility.
