BLM Authorized Officer Weekly Report

Project: Ocotillo Wind Energy Facility Project

Weekly Project Update

Reporting Period: 9.24.12 through 9.30.12

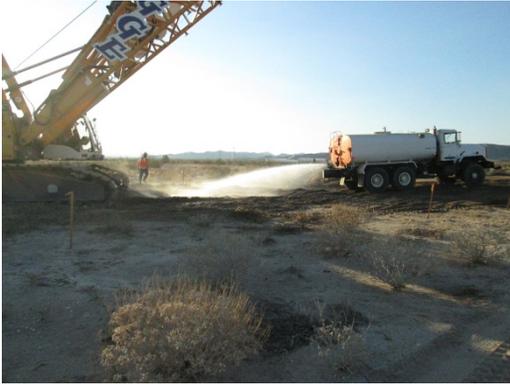
Photo 1: Construction crews utilize water to minimize dust emissions during a crane walk in accordance with the Dust Control Plan (MM-Air-1).

Water wagons and water trucks were routinely observed watering down areas of active grading, trenching, and excavation to ensure dust emissions were minimized during construction activities in accordance with the dust control plan (MM-Air-1) (see photo 1). In addition a soil binding agent is being utilized along access roads and stockpiles to stabilize topsoil, minimize dust emissions, and minimize erosion in areas that have been disturbed as a result of construction activities (see photo 2).

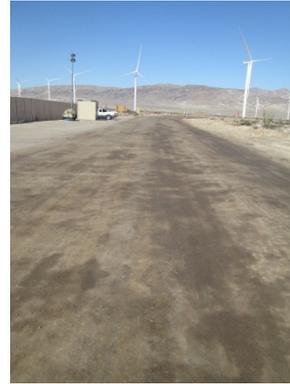
Photo 2: A soil binding agent is placed along access roads to minimize dust emissions in accordance with the Dust Control Plan (MM-Air-1).

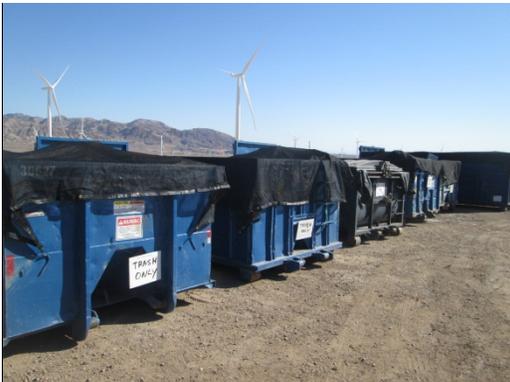
Photo 3: Trash receptacles are covered and labeled in accordance with the Raven Control Plan (MM-Wild-1j) and Construction Waste Management Plan (MM-PHS-9).

ECM's and the lead biological monitors completed routine site observations to ensure trash receptacles are being covered in accordance with Section 4.1 of the Raven Control Plan (MM-Wild-1j). With the exception of the instances noted above in Section "Issues/Concerns with Applicable Conditions of Certification", trash receptacles were observed being covered along the ROW. Covers consist of tarps and plastic lids that are secured to the trash bins (see photo 3). In accordance with the Construction Waste Management Plan (MM-PHS-9) ECM's observed all trash being removed from the project site on a regular basis and as previously discussed, all trash receptacles covered.

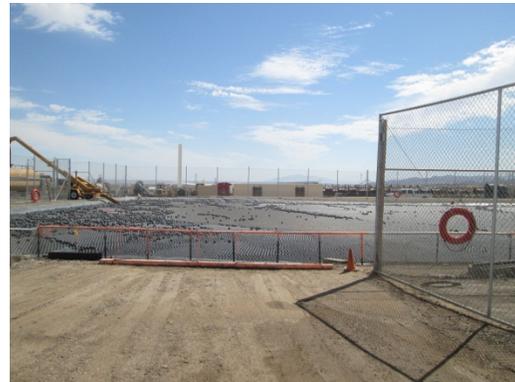
Photo 4: The exclusionary fence placed along the limits of the temporary water pond is being maintained and routinely inspected for tears or gaps by the environmental monitors.

In accordance with MM-Wild-1d, the boundaries of all areas to be disturbed are delineated with stakes and flagging prior to construction activities. ECM's observed OE LLC working with land surveyors and the biological monitor to ensure all work areas are clearly delineated prior to ground disturbance. The limits of work are monitored by a biological monitor during all ground disturbance activities to ensure construction activities remain within the approved work limits and that the limits are properly delineated. ECM's also observed the exclusionary fence surrounding the temporary water pond being maintained (see photo 4).

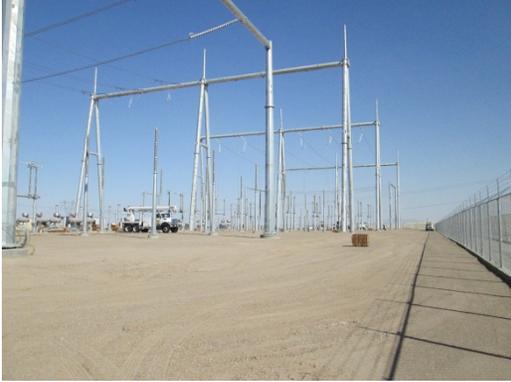
Photo 5: Construction crews continue construction at the 30-acre Substation/Switchyard.

Construction continued at the Substation/Switchyard and O&M Facility during this construction period. At the Substation/Switchyard, construction crews were observed erecting steel, continuing with the underground conduit work, and rebar construction for electrical tie-ins (see photo 5). Construction activities associated with establishing the foundation for the turning structures that will be utilized to tie-in the onsite Substation/Switchyard with the Sunrise Powerlink were observed being completed within the approved work limits (see photo 6). At the O&M facility, construction crews were continuing to work on the masonry block installation, structural steel installation, and installation of the roof (see photo 7). Wind turbine erection continued during the reporting period with a total of 26 wind turbines erected to date (see photo 8). During the completion of specific work efforts or periods of inactivity, the gates to the O&M facility, Substation Switchyard, and Laydown Yard are closed, all trash is placed within covered bins, and all hazardous materials are properly stored.

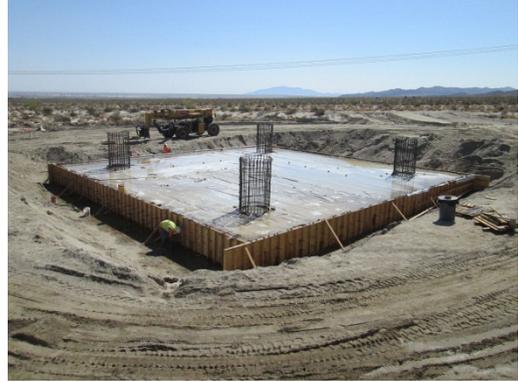
Photo 6: A concrete base pour is completed for a turning structure associated with the tie-in to the Sunrise Powerlink.

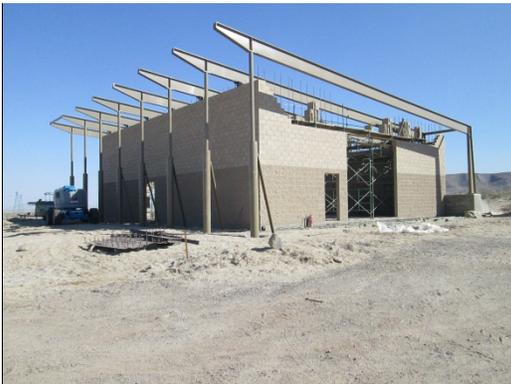
Photo 7: Construction continues at the O&M facility as crews complete the installation of roofing materials.

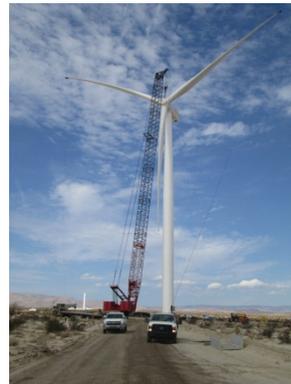
Photo 8: Crews utilize a large crane to install a rotor to the nacelle via use of safety tag lines.
