# BLM Authorized Officer Weekly Report

**Project:** Ocotillo Wind Energy Facility Project

## Weekly Project Update

**Reporting Period:** 11.19.12 through 11.25.12

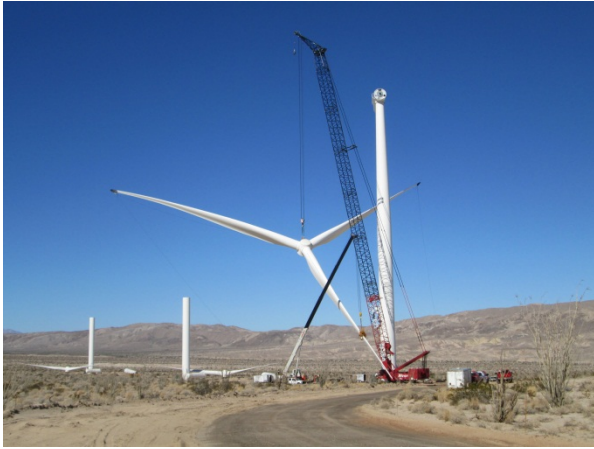
**Photo 1:** A large crane is utilized to assemble the rotor and blades to the nacelle at a wind turbine pad site. Ten turbines were erected this reporting period.

Construction activities conducted for this period were reduced due to the Thanksgiving holiday. Activities consisted of erecting wind turbines, rotors and blades (see photo 1), excavating and backfilling wind turbine foundations (see photo 2), access road improvements, electrical work at turbine sites (see photo 3), O&M Building improvements and testing equipment at the 30-acre Substation/Switchyard, and assembly of the lattice tower turn structures that will connect to the Southwest Power Link. Ten turbines were erected during this reporting period, totaling 79 turbines. To date approximately 108 wind turbine foundations have been excavated, and 97 wind turbine foundations concrete pours have been completed.

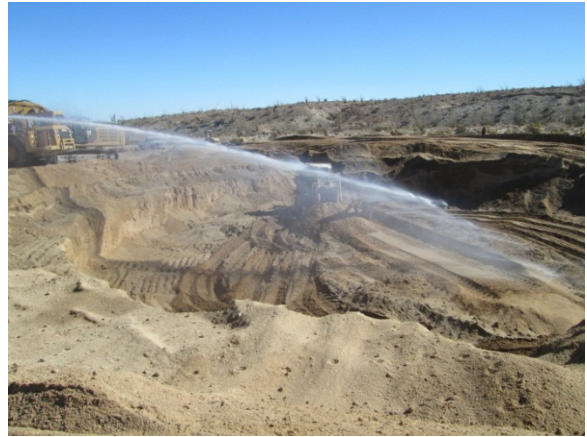
**Photo 2:** Turbine excavation activities are watered down to prevent fugitive dust in accordance with MM-Air 1.

Water pulls were observed pre-watering access roads and areas under active construction in order to minimize dust in accordance with the Dust Control Plan and MM Air-1 and watering excavation pits as shown in photo 2. Also in accordance with MM Air-1 and the SWPPP, ECMs noticed diligence with minimization and cleaning of track out along Highway S2 and Mine Road (see photos 7 and 8).

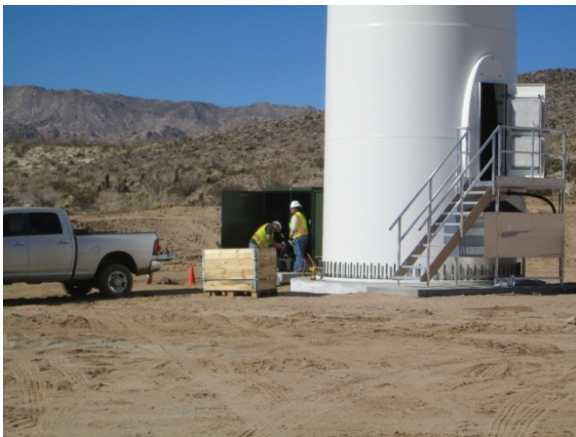
**Photo 3:** Electrical work associated with connecting wind turbines to the underground collector cable network continued during this reporting period.

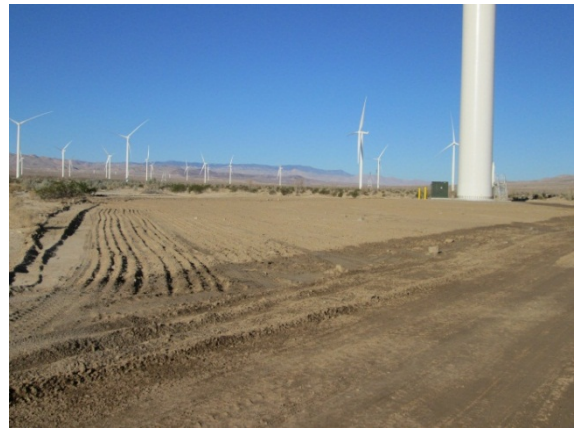
**Photo 4:** Topsoil staged onsite from initial ground disturbance is utilized to reclaim a wind turbine pad site in accordance with MM-Veg 2b.

ECMs observed compliance with MM Veg-2b and the associated Habitat Restoration/ Re-vegetation Plan (HRRP), as crews implemented appropriate salvage, storage and reclamation use of topsoil along access roads and turbine sites (see photo 4).

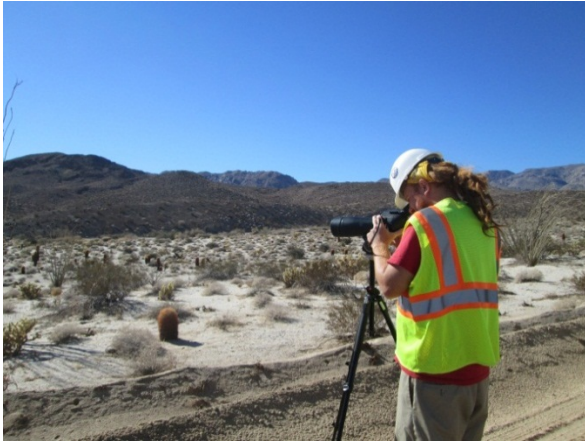
**Photo 5:** A designated biologist monitors PBS activity in accordance with MM Wild-1a and 1b.

OE LLC has also contracted with a biological consulting firm approved by the BLM to complete day-to-day monitoring of the construction activities in accordance with the ECCMP. ECMs observed biological monitoring activities associated with PBS and FTHL in accordance with MM Wild- 1a, 1b, and 1j (see photo 5 and 6).

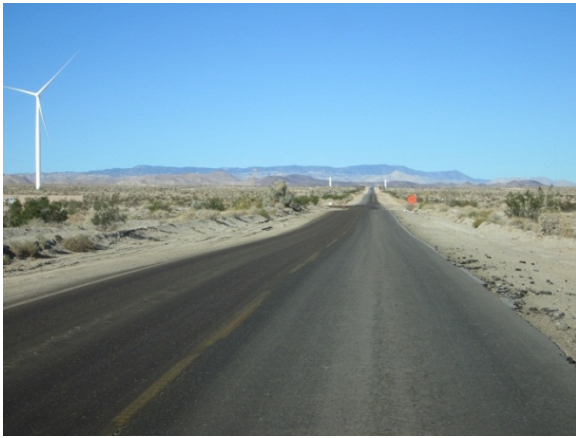
**Photo 7:** Highway S2 is swept and cleaned of track out in accordance with the SWPPP and MM Air-1

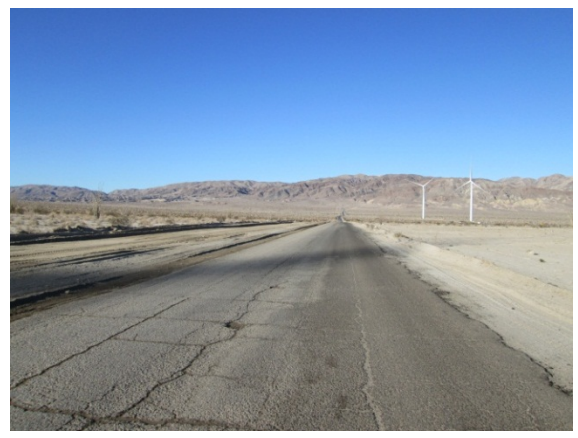
**Photo 8:** Old Mine Road is swept and cleaned of track out in accordance with the SWPPP and MM Air-1.
