BLM Authorized Officer Weekly Report

Project: Ocotillo Wind Energy Facility Project

Weekly Project Update

Reporting Period: 11.26.12 through 12.2.12

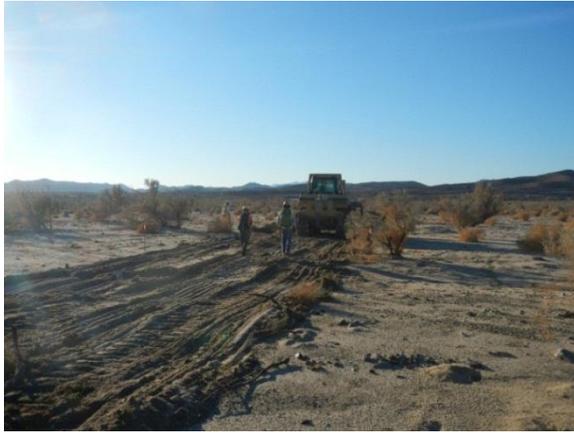
Photo 1: ECMs observed biological, cultural, and Native American monitors performing roles and responsibilities as outlined in the ECCMP during initial ground disturbance.

Construction activities consisted of turbine deliveries, erecting wind turbines, assembling rotors and blades, electrical work at turbine sites, improvement of access roads, trenching and installation of cables for the collection lines (see photo 1), O&M Building improvements (interior finishes, HVAC, septic tank installation) equipment testing at the 30-acre Substation/Switchyard and installation of the substation protective berm (see photo 2).

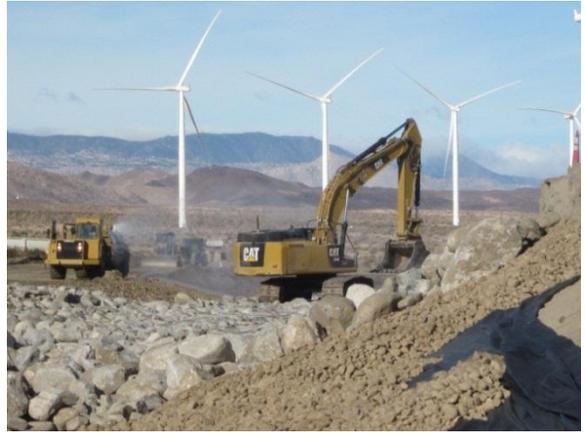
Photo 2: ECMS observed construction crews placing rip-rap around the substation for flood protection. Water wagons were being utilized to keep dust suppressed in accordance with MM Air-1.

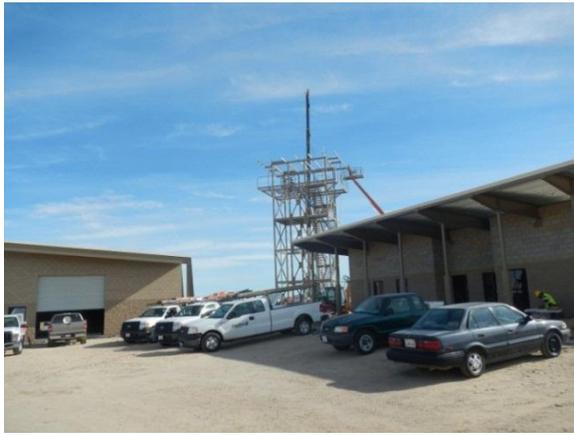
Photo 3: ECMs observed crews constructing the avian lookout tower as required per the ABPP. The lookout tower is adjacent to the O&M facility, which consists of "buff" colored masonry in order to minimize visual impacts in accordance with the Surface Treatment Plan.

ECMs observed multiple construction activities associated with the O&M facility, including implementation of best management practices identified in the Surface Treatment Plan (MM VR-3) and Screening Plan (MM VR-4). These plans were designed to minimize visual impacts associated with the industrial material used for these facilities through use of color schemes, steel coating, bird deterrent material, etc. and to aid in blending these components into the surrounding desert landscape. ECMs observed construction progress at the ABOCCC as required per the ABPP. The 50' ABOCCC will include a state of the art Merlin radar system onsite for the life of the project and is specifically tiered to collect data to potentially curtail turbines in order to minimize direct impacts to golden eagles. The system will also be used for data collection purposes for general avian and bat species (see photos 3 and 4).

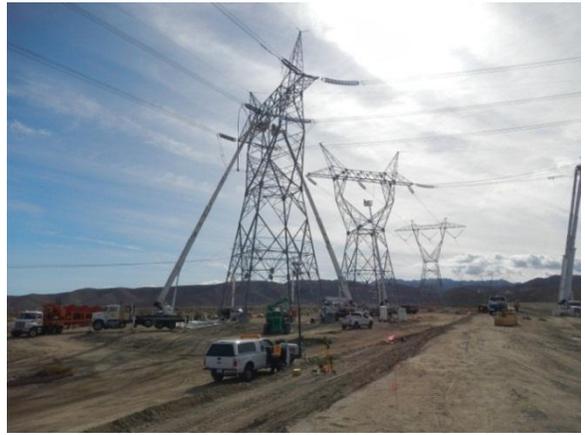
Photo 4: Crews were observed erecting steel lattice towers associated with the turning structures that will provide a connection from the onsite substation to the Sunrise Powerlink.

With 75 percent of the project's turbines erected and approximately 88 percent of initial ground disturbance complete, OE LLC is also focusing on site reclamation activities in accordance with the plan of development and proscribed mitigation measures (see photo 5). Additionally, ECMs observed progress with the Advanced Biological Observation Command and Control Center (ABOCCC) (see photo 3) at the O&M facility as identified in MM Wild-1p and the associated Avian and Bat Protection Plan (ABPP) (see discussion in the Compliance section below). Work also continued with the SDG&E turning structures to the onsite substation (see photo 4).

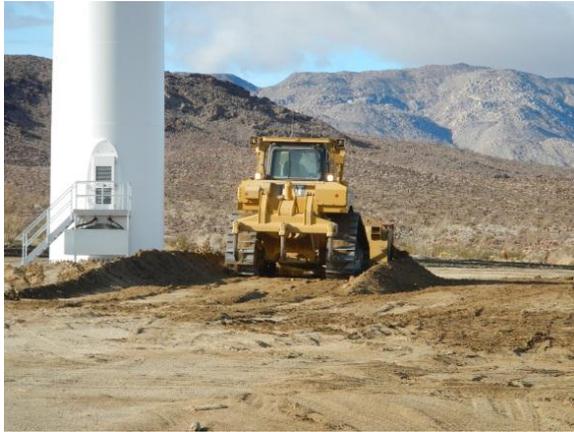
Photo 5: Topsoil staged onsite from initial ground disturbance is utilized to restore a wind turbine pad site in accordance with MM-Veg 2b.

ECMs observed activities related to site restoration this week, including re-vegetation activities at turbine pad sites in accordance with MM Veg-2b and the associated Habitat Restoration/Re-vegetation Plan (HRRP) (see photo 5). Re-vegetation activities included de-compacting and replacing topsoil in areas where construction activities are complete and where no further construction traffic is anticipated to occur at the turbine sites. Construction crews were made aware of active re-vegetation activities on the project site and were provided protocols for avoidance.

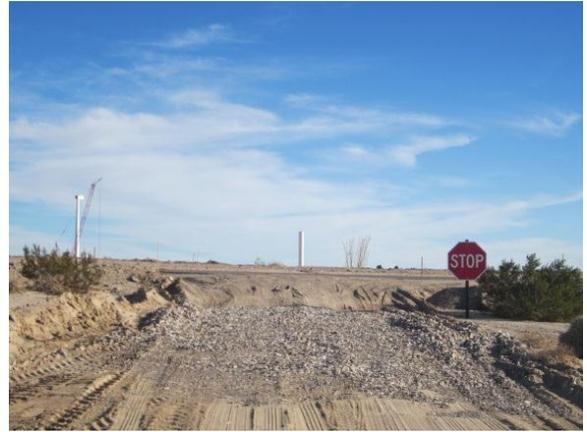
Photo 6: ECMs observed rock aprons being maintained to minimize trac-out along Old Mining Road in accordance with the SWPPP and MM Air-1.

Water pulls were observed pre-watering access roads and areas under active construction in order to minimize dust in accordance with the Dust Control Plan and MM Air-1 and watering excavation pits. Also in accordance with MM Air-1 and the SWPPP, ECMs noticed diligence with minimization and cleaning of track out along Highway S2 and Mine Road and observed preventative track-out measures such as stabilized construction entrances/ rock aprons in good condition (see photo 6).

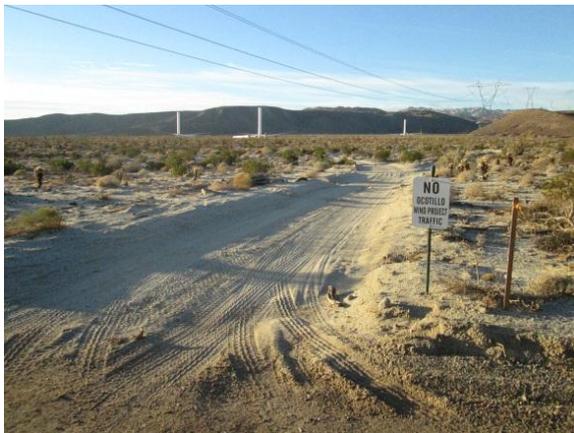
Photo 7: Signage has been posted where WECO routes intersect wind turbine access roads to notify construction workers where WECO route use is not permitted in accordance with the Access Control Plan (MM-CUL-11).

ECMs observed diligence with multiple signage requirements, including designation of access roads and avoidance areas for OWEF construction crews in order to control unauthorized access (see photo 7). Access control signage has been posted to driveway locations to new project roads off HWY S2 in accordance with MM CUL-11, and associated Access Control Plan.

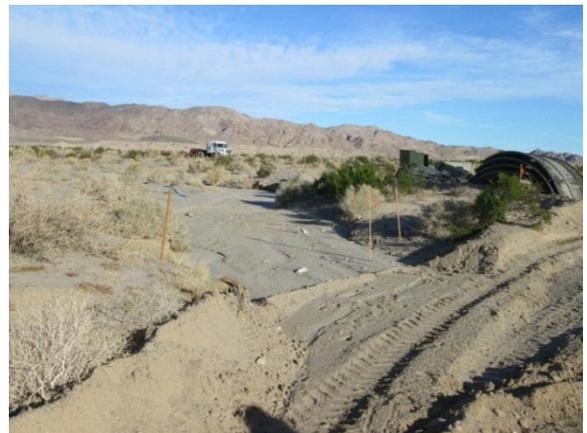
Photo 8: ECMs observed marking of jurisdictional waterways in accordance with the Streambed Alteration Agreement (MM WATER-1).

ECMs observed marking of jurisdictional waterways in accordance with MM WATER-1 and associated Streambed Alteration Agreement with CDFG (see photo 8). Flagging these areas identifies the limits of construction grading and the areas that may need additional surveys performed by the qualified biologist on site.
