BLM Authorized Officer Weekly Report

Project: Ocotillo Wind Energy Facility Project

Weekly Project Update

Reporting Period: 12.10.12 through 12.16.12

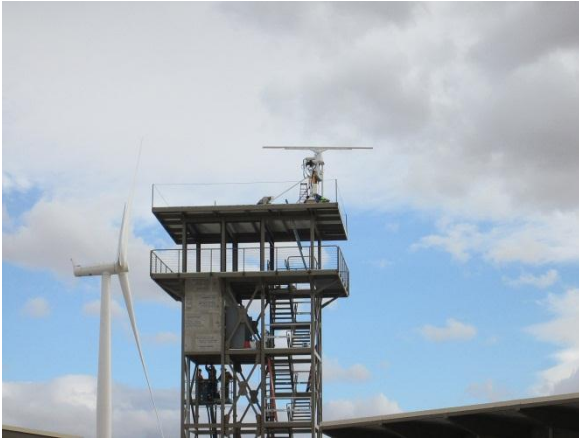
Photo 1: ECMs observed crews continuing construction activities at the ABOCC including installation of the avian radar system as identified in MM Wild-1p and the associated ABPP and ECP.

As discussed in the "Construction Activities" section of this report, Environmental Compliance Monitors observed construction progress at the Operations & Maintenance Facility (see photo 7) and the ABOCC. Construction activities included the installation of a sidewalk at the front of the Operations & Maintenance Facility and the installation of a state of the art Merlin radar

system onsite to collect data and potentially curtail turbines in order to minimize impacts to avian species.

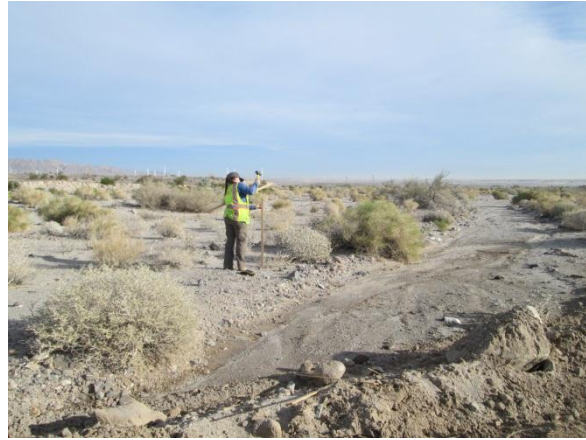
Photo 2: A biological monitor places stakes to delineate a jurisdictional waterway in accordance with Mitigation Measure Veg-3.

Ocotillo Express LLC has also contracted with a biological consulting firm approved by the Bureau of Land Management to complete day-to-day monitoring of the construction activities in accordance with the ECCMP. The biological consulting firm submitted the Burrowing Owl observation log (as required by MM-Wild-1n and 2a) to the ECM team. During this reporting period, the lead biological monitor was observed staking jurisdictional waterways in accordance with Mitigation Measure Veg-3 (see photo 2).

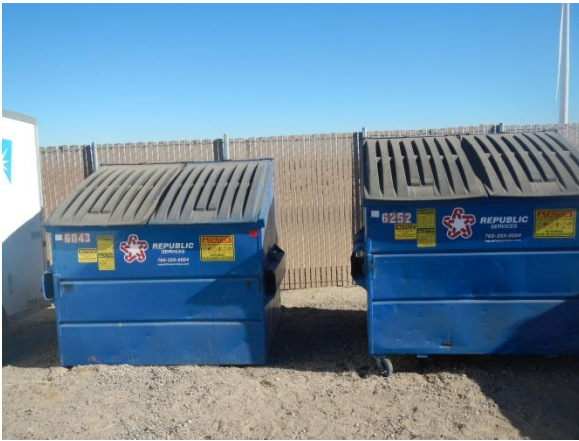
Photo 3: Trash bins are observed to be covered at the laydown yard in accordance with the Raven Control Plan (Mitigation Measure Wild-1j).

In accordance with Section 4.1 of the Raven Control Plan, all trash onsite must be kept in covered trash receptacles. ECMs observed litter debris from construction crews periodically throughout the reporting period. The observations were reported to the lead environmental monitor and the construction contractor has responded by reminding crews to maintain a clean work site and by designating individuals to pick-up debris at the completion of the work day. In accordance with the waste management procedures, ECMs also reported dumpsters that needed to be covered to the lead environmental monitor. The dumpsters were covered upon notification being provided to the lead environmental monitor (see photo 3).

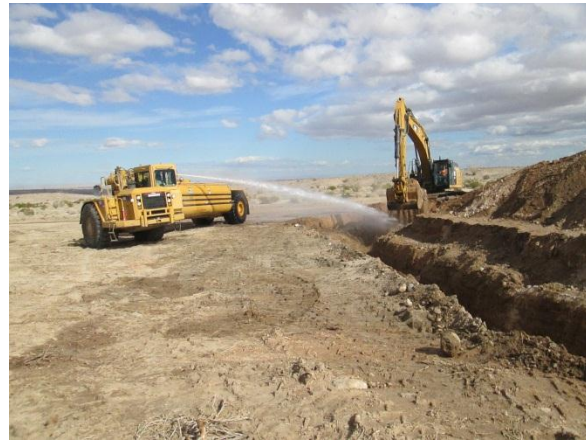
Photo 4: A water tender is observed suppressing fugitive dust during wind turbine foundation excavations in accordance with the Dust Control Plan (Mitigation Measure Air-1).

ECMs observed construction crews completing geotechnical trenching excavations at turbine pad sites located south of Interstate 8 this week. Water tenders were observed during the excavation activities to suppress fugitive dust in accordance with the Dust Control Plan (Mitigation Measure Air-1) (see photo 4).

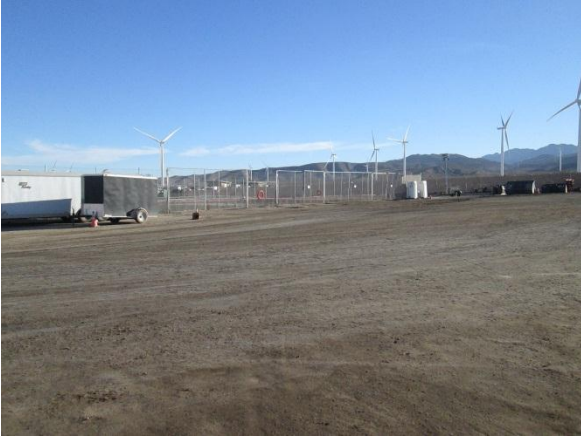
Photo 5: The gates to the temporary water pond in the Laydown Yard are closed during periods of minimal activity to prevent wildlife from entering.

In accordance with Mitigation Measure Wild-1b, at the end of each work day, the lead biologist is to inspect all potential wildlife pitfalls to ensure that the construction crew slopes the ends of the excavation to provide wildlife escape ramps or completely and securely covers the excavation to prevent wildlife entry. Environmental Monitors completed routine inspections to ensure all wildlife pitfalls include wildlife escape ramps and/or have been covered per Mitigation Measure Wild-1b. In addition, ECM's observed gates at the temporary water pond at the Laydown Yard being shut during periods of minimal activity (see photo 5).

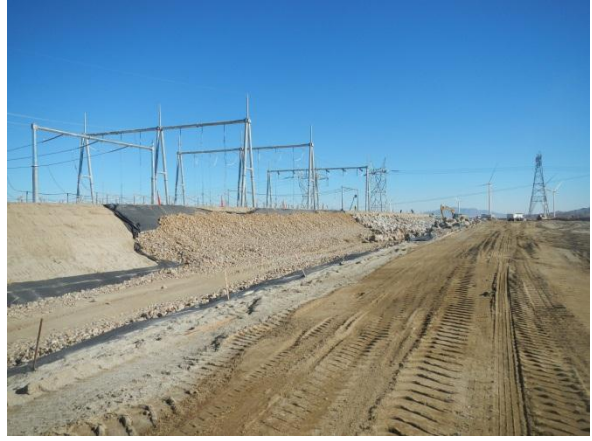
Photo 6: ECMs observed crews installing rip-rap around the substation switchyard for flood protection.

ECMs observed construction crews installing rip-rap around the 30-acre Substation/Switchyard for flood protection (see photo 6). The rip-rap is being installed for flood protection purposes in accordance with the building and grading permits approved by Imperial County.

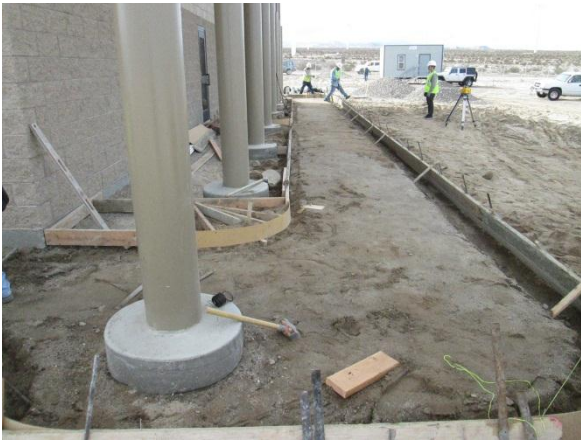
Photo 7: ECMs observed crews installing a sidewalk at the front of the O&M Facility.

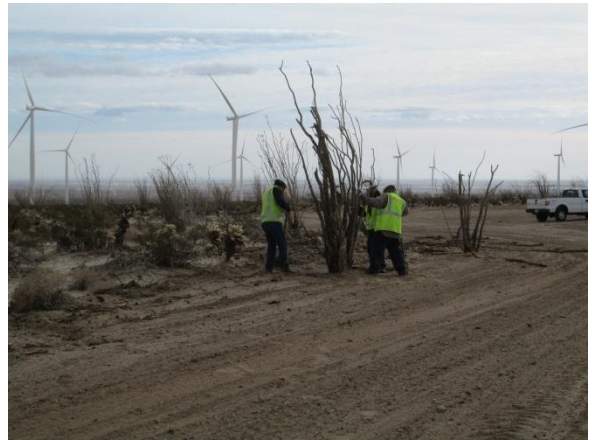
Photo 8: ECMs observed crews re-planting an Ocotillo in accordance with Mitigation Measure Veg-2b and the associated Habitat Restoration/Re-vegetation Plan.

Construction activities related to site restoration continued this week, including re-vegetation activities at turbine pad sites in accordance with Mitigation Measure Veg-2b and the associated Habitat Re-vegetation Plan (see photo 8). Re-vegetation activities included de-compacting and replacing topsoil in areas where construction activities are complete. Cultural and biological monitors were present during re-vegetation activities that required ground disturbance in accordance with the ECCMP.
