BLM Authorized Officer Weekly Report

Project: Ocotillo Wind Energy Facility Project

Weekly Project Update

Reporting Period: 12.24.12 through 12.30.12

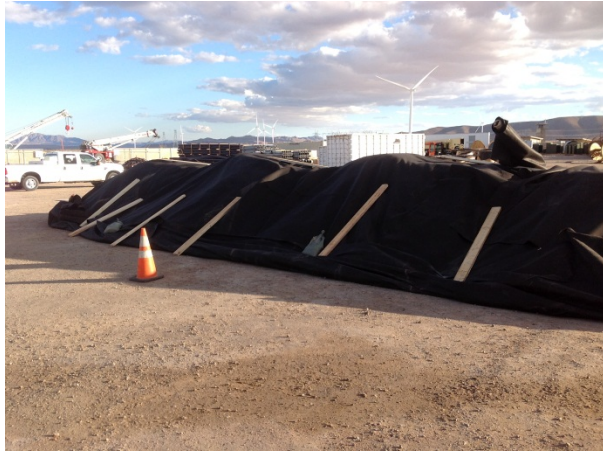
Hydraulic Fluid Leak (Mitigation Measure Water-10): On December 27, 2012 a hydraulic fluid leak was observed in the hub section (nacelle) of a wind turbine. The leak was isolated to a connection in the hydraulic system in the hub. There was a small amount of residual fluid in the blades (less than five gallons) that was released to the ground below. The stained soil was located within the disturbed area around the wind turbine and the majority was within 30 feet of the turbine tower base.

In accordance with the Spill Prevention, Control, and Countermeasure (SPCC) Plan, the spill that occurred was classified as a "minor". ECMs observed the turbine manufacturer repairing and

Photo 1: Soil removed from the nacelle where hydraulic fluid had been observed is contained prior to being removed offsite for proper disposal in accordance with the SPCC.

cleaning the hub section of the wind turbine along with construction crews cleaning and removing the stained soil in accordance with the SPCC (see photo 1). As a result of this spill, the ROW holder is completing inspections of the hydraulic system in the hub (nacelle) for all turbines to minimize the potential for any future hydraulic leaks.

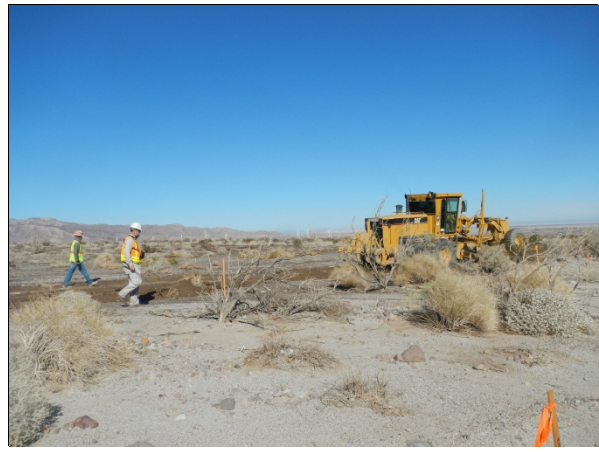
Photo 2: ECMs observed grading activities associated with the phase II substation. Both a biological and archeological monitor was present during initial ground disturbance in accordance with the ECCMP.

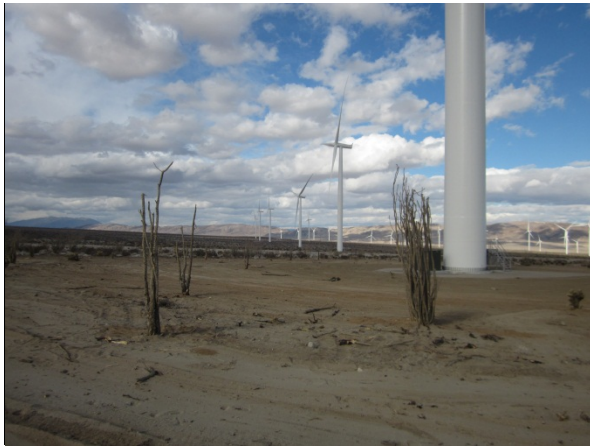
Photo 3: ECMs observed planting of vertical mulch in accordance with Mitigation Measure Veg-2b and the associated Habitat Re-vegetation Plan

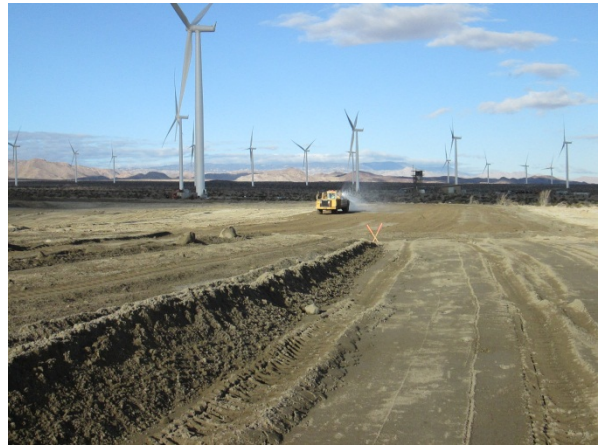
Construction activities continued during this reporting period associated with completing the berm installation around the SDG&E substation for flood control purposes. In addition, grading activities continued at phase II of the substation. ECMs observed water trucks suppressing potential fugitive dust associated with these activities in accordance with MM Air-1 and the affiliated Fugitive Dust Control Plan (see photo 4).

Photo 4: Water trucks apply water during grading activities in accordance with the Fugitive Dust Control Plan (MM Air-1).
