BLM Authorized Officer Weekly Report

Project: Ocotillo Wind Energy Facility Project

Weekly Project Update

Reporting Period: 2.25.13 through 3.3.13

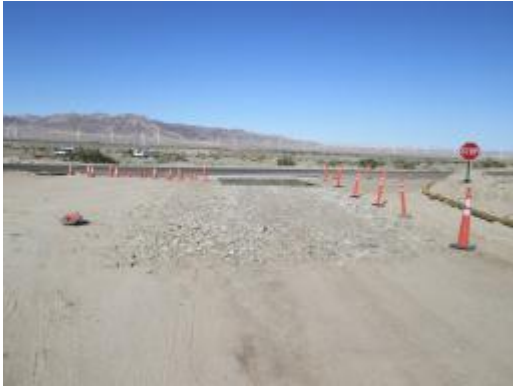
Photo 1: A stabilized construction entrance is maintained at a project entrance. The stabilized entrance consists of a rattle plate and rock apron in accordance with the Dust Control Plan (MM-Air-1) and SWPPP (MM-Water-9).

Construction activities were observed being completed in accordance with the Dust Control Plan (MM-AIR-1) throughout the reporting period. Stabilized construction entrances have been established at the entryway to each wind turbine string from paved roadways (see photo 1). Stabilized construction entrances include a rock apron that reduces the potential for trac-out along paved roadways. Mechanical street sweepers were also observed being utilized along paved roadways to minimize trac-out (see photo 2). Crews were also observed utilizing water during construction activities associated with placement of underground collection lines to minimize fugitive dust emissions (see photo 3).

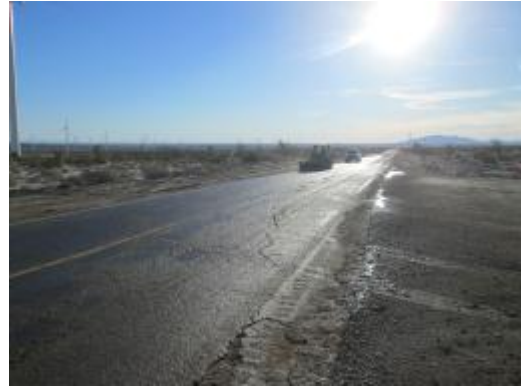
Photo 2: Highway S-2 is swept with a mechanical sweeper on a regular basis to minimize trac-out along the paved Highway in accordance with MM-Air-1.

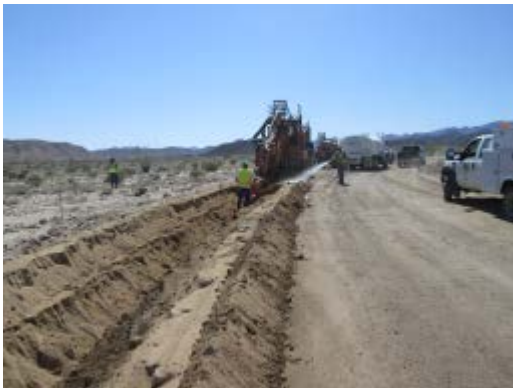
Photo 3: Construction crews utilize water to suppress fugitive dust emissions in accordance with MM-Air-1 during the installation of underground collection lines.

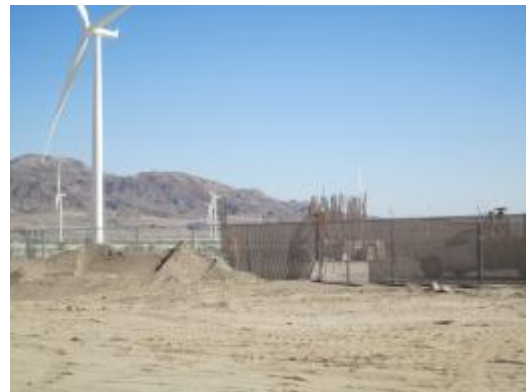
Photo 4: Crews place desert tan colored slats along the perimeter of the laydown yard associated with the O&M facility in accordance with the O&M Screening Plan (MM-VR-4).

A construction crew was observed placing desert tan slats within the chain-link fencing along the perimeter of the O&M Laydown Yard (see photo 4). The desert tan slats are a requirement of the O&M Screening Plan (MM-VR-4) to minimize the potential for direct views from motorists travelling along County Highway S-2 of the Laydown Yard.

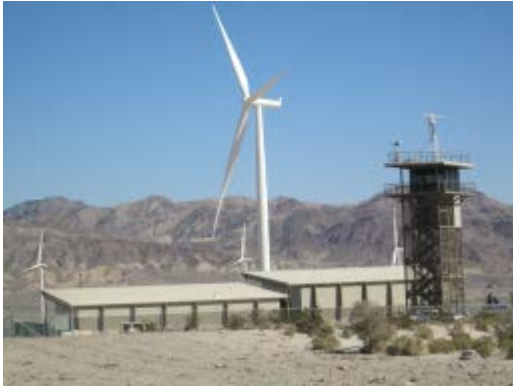
Photo 5: All exposed structural steel associated with the O&M facility is colored "Brush Brown" in accordance with the O&M Surface Treatment Plan (MM-VR-3).

Surface treatment of materials utilized at the O&M facility was observed to be in accordance with the Surface Treatment Plan approved by BLM (MM-VR-3). Building materials are colored "Brush Brown" to blend the O&M structures with the visual environment (see photo 5).

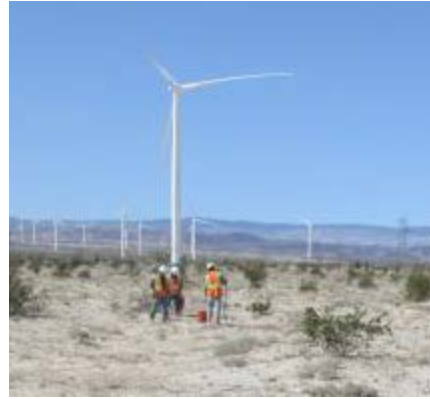
Photo 6: Crews perform weed abatement activities within the approved work limits to remove noxious weeds in accordance with the Integrated Weed Management Plan (MM-veg-1d).

A crew was observed removing noxious weeds in accordance with the Integrated Weed Management Plan (MM-Veg-1d). All work was performed within the approved disturbance limits and was directed by the BLM-approved Weed Control Manager (see photo 6).

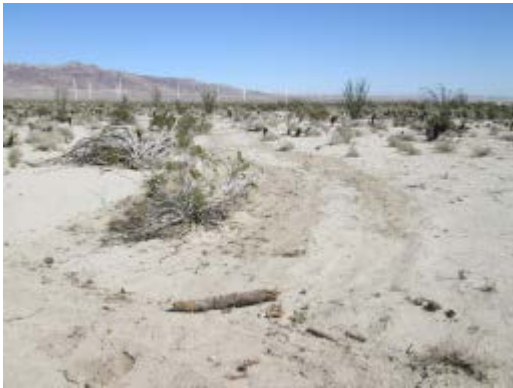
Photo 7: Taglines utilized for turbine assembly authorized under Variance Request #16 are restored in accordance with the Habitat Revegetation Plan (MM-veg-2b).

Crews were observed completing restoration of the tag line routes utilized for turbine assembly in accordance with Variance Request #16 (see photo 7). Crews utilized rakes and shovels to re-contour the tire tracks from tag line work with the existing desert contours in accordance with the Habitat Revegetation Plan (MM-Veg-2b).

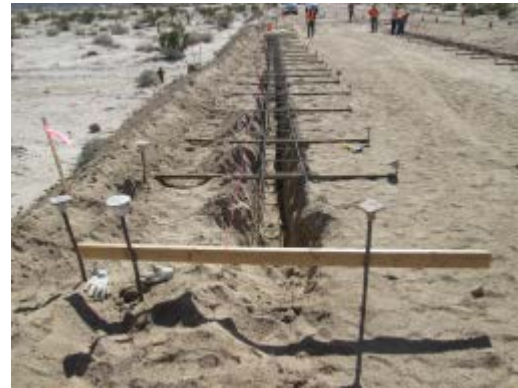
Photo 8: Construction crew slope the ends of open excavations to provide wildlife escape ramps in accordance with MM-Wild-1b.

Biological monitors were observed working with construction crews to ensure that the ends of open excavations were provided at the completion of daily work activities to provide wildlife escape ramps in accordance with MM-Wild-1b (see photo 8).
