BLM Authorized Officer Weekly Report

Project: Ocotillo Wind Energy Facility Project

Weekly Project Update

Reporting Period: 3.18.13 through 3.24.13

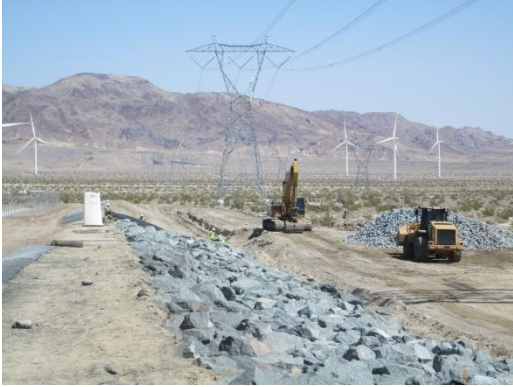
Photo 1: Construction activities continued during this reporting period associated with the berm along the perimeter of the Phase II substation.

Construction activities consisted of building the berm for the Phase II substation (see photo 1), delivery of wind turbine components (see photo 2), erecting wind turbines associated with Phase II and weed abatement activities.

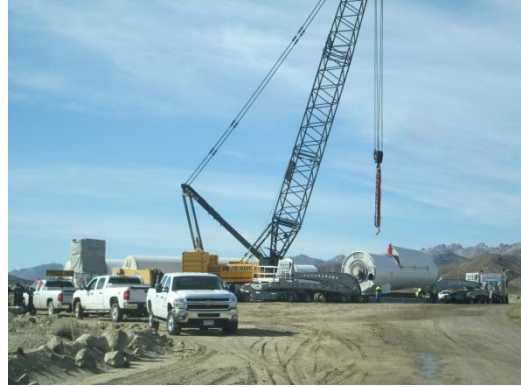
Photo 2: Turbine deliveries continued throughout the reporting period. Construction crews utilize large cranes to unload turbine components from truck trailers.

Transportation deliveries associated with hauling turbine components to the project site continued during this reporting period. Turbine components were delivered to the project site in accordance with the Construction Traffic Management Plan. The turbine components were delivered via the I-8/Ocotillo Imperial Highway exit, and then proceeded along Highway 98. All deliveries were escorted by California Highway Patrol.

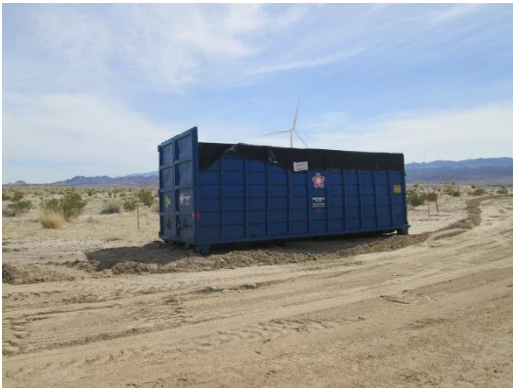
Photo 3: Covers are placed over trash bins in accordance with MM-Wild-1j.

Ocotillo Express LLC has also contracted with a biological consulting firm approved by the BLM to complete day-to-day monitoring of the construction activities in accordance with the ECCMP. ECM's observed trash bins being covered in accordance with MM-Wild-1j and the Raven Control Plan (see photo 3). In accordance with MM-Wild-1b, at the end of each work day, the lead biologist is to inspect all potential wildlife pitfalls to ensure that the construction crew slopes the ends of the excavation to provide wildlife escape ramps. ECM's observed excavations including the appropriate wildlife escape ramps at the end of the work day (see photo 4). ECM's also observed a biological monitor completing sweeps in FTHL habitat in accordance with MM-Wild-1g (see photo 5).

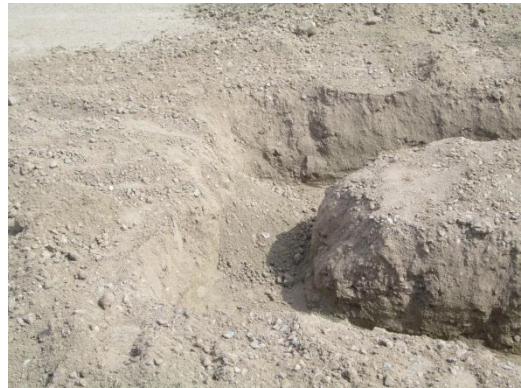
Photo 4: In accordance with MM-Wild-1b, crews place slopes at the ends of the excavations to provide wildlife escape ramps.

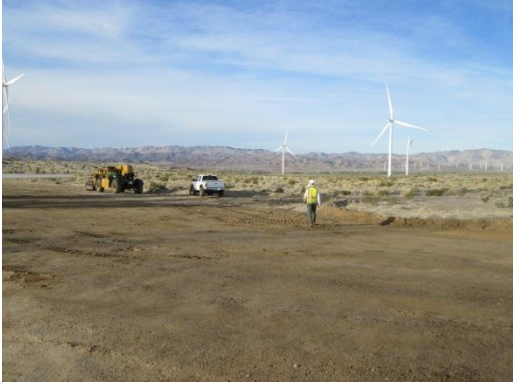
Photo 5: A FTHL permitted biologist conducts sweeps of construction areas in accordance with MM-Wild-1g.

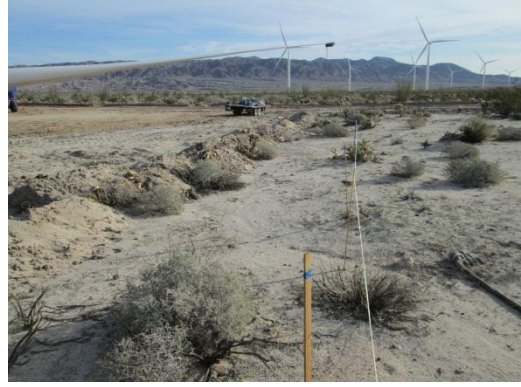
Photo 6: Stakes are utilized to delineate the approved work limits in accordance with MM-Wild-1d.

In accordance with MM-Wild-1d, the boundaries of all areas to be disturbed are delineated with stakes and flagging prior to construction activities. ECM's observed OE LLC working with land surveyors and the biological monitor to ensure all work areas are clearly delineated prior to ground disturbance. The limits of work are monitored by a biological monitor during all ground disturbance activities to ensure construction activities remain within the approved work limits and that the limits are properly delineated (see photo 6).

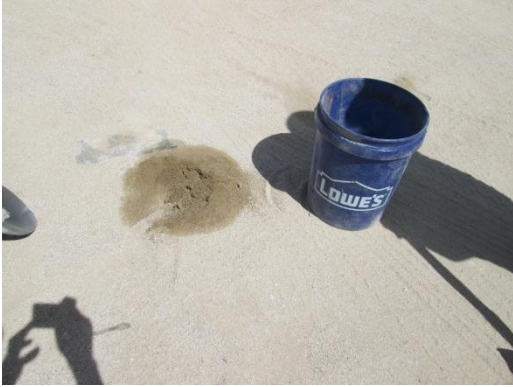
Photo 7: Crews utilize spill kits to remove stained soils in accordance with MM-Water-10.

Crew members were observed removing stained soil along the ROW through use of a shovel and bucket to ensure Good Site Management practices are being implemented in accordance with Section 4.3.4 of the SWPPP (see photo 7). Drip pans have also been observed beneath construction equipment staged along the ROW to minimize the potential for oils to stain soils. ECM's observed hazardous materials onsite being placed in proper containment as specified in the MM-Water-9.

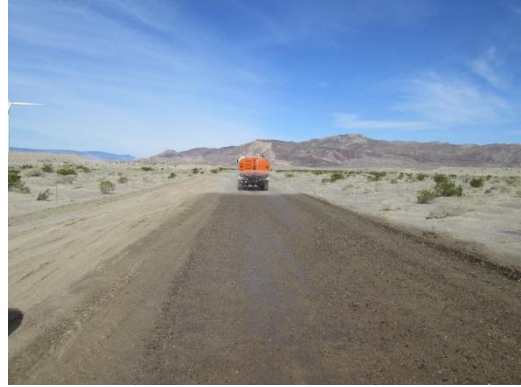
Photo 8: Water trucks are utilized to water down access roads during construction in accordance with MM-Air-1.

Water wagons and water trucks were routinely observed watering down areas of active construction to ensure dust emissions were minimized in accordance with the dust control plan (see photo 8). In addition, construction crews were reminded by the foreman of the posted speed limit on project access roads during weekly construction meetings and during completion of the mandatory Worker Environmental Awareness Program (WEAP) safety training.
