BLM Authorized Officer Weekly Report

Project: Ocotillo Wind Energy Facility Project

Weekly Project Update

Reporting Period: 5.13.13 through 5.19.13

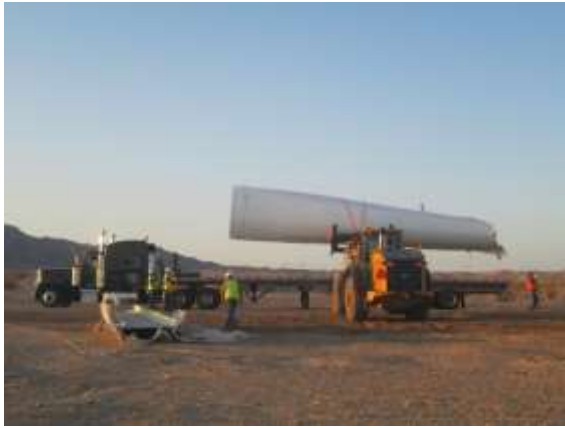
Photo 1: The lead biological and cultural monitor observe construction crews removing a portion of the blade that fell from the wind turbine.

Wind Turbine Blade Incident– During the evening of Wednesday, May 15th a rotor blade from turbine #156 fell to the ground landing near the turbine base. The lead biological and archaeological monitors surveyed the area within and outside of the approved project limits and determined that there were no damages to sensitive environmental resources as the result of this incident. As an exercise of caution, OE LLC suspended operations of all 112 wind turbines pending further inspection and investigation.

On Friday, May 17th the blade was cut into segments by construction crews and transported to the Laydown Yard using tractor trailers under the supervision of the lead biological and cultural monitors (see photo 1) as approved by the BLM. In addition, all debris from the blade was cleared and the disturbed desert surface was raked by the lead biological monitor to return the disturbance areas to pre-disturbance conditions in accordance with MM-Veg-1a.

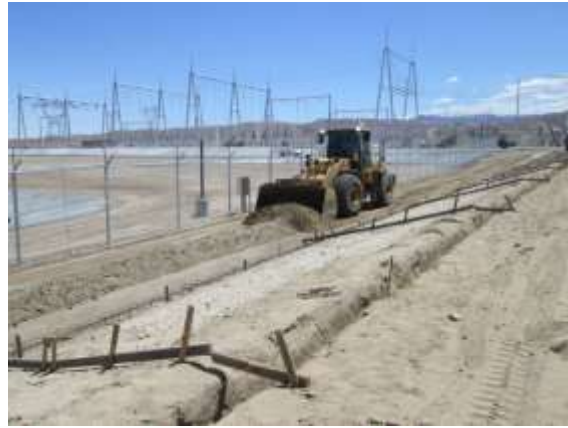
Photo 2: Construction activities associated with the berm along the perimeter of the Phase II substation continued during this reporting period.

Construction activities consisted of paving Dos Cabezas Road, finalizing the berm for the Phase II substation (see photo 2) and constructing an asphalt access road, reclamation activities associated with turbine pad sites, access roads, and the southeast portion of the Laydown Yard, installation of access control gates and signs, and the demobilization of equipment and materials (see photo 3).

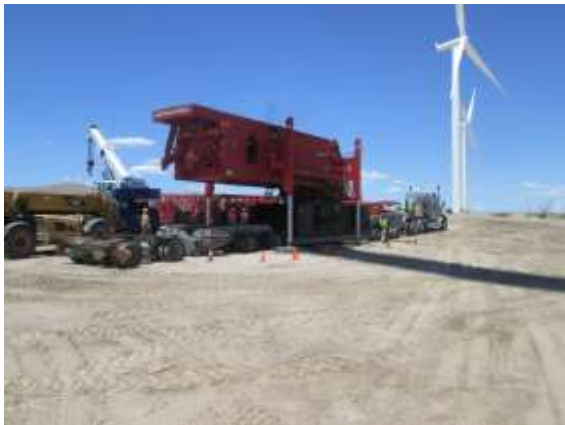
Photo 3: Construction crews continue to demobilize vehicles and equipment from the right-of-way.

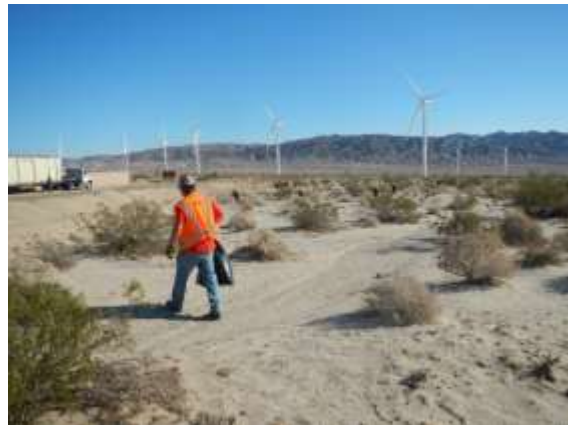
Photo 4: ECMs observed a construction crew member picking up trash in accordance with the Raven Control Plan (MM-Wild-1j).

Ocotillo Express LLC has also contracted with a biological consulting firm approved by the BLM to complete day-to-day monitoring of the construction activities in accordance with the ECCMP. ECM's observed construction crew members picking up trash in accordance with the Raven Control Plan MM-Wild-1j (see photo 4) and secondary containment under portable sanitary facilities in accordance with best management practices identified in the Storm Water Pollution Prevention Plan (SWPPP) MM-Water-9.

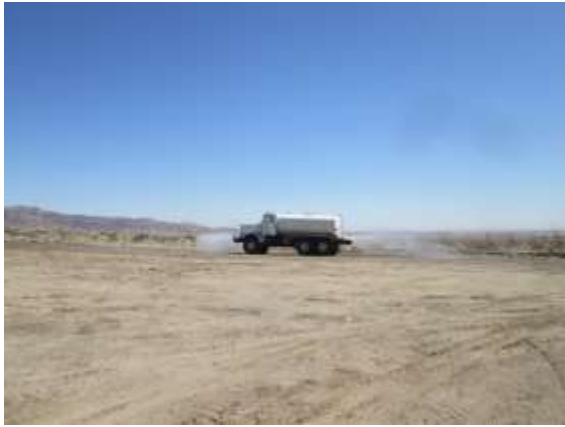
Photo 5: Construction crews water down access roads to prevent fugitive dust in accordance with the Dust Control Plan (MM-Air-1).

Construction activities were observed being completed in accordance with the Dust Control Plan (MM-AIR-1) throughout the reporting period. Water wagons and water trucks were

routinely observed watering down active construction areas and frequently used dirt access roads (see photo 5).

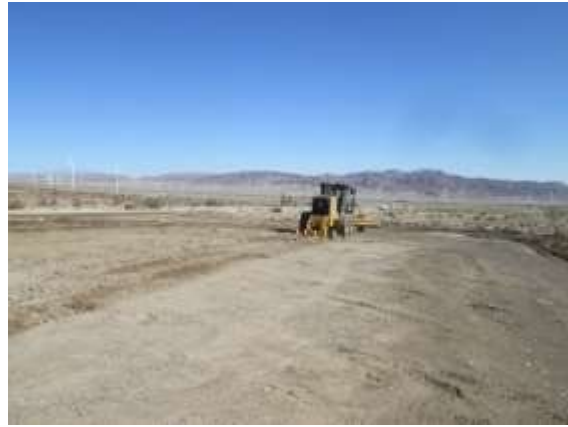
Photo 6: ECM's continued to observe reclamation activities such as soil de-compaction associated with post-construction disturbance areas within the approved work limits.

Construction activities related to site restoration continued this week, including re-vegetation activities at turbine pad sites and along access roads in accordance with Mitigation Measure Veg-2b and the associated Habitat Restoration/Revegetation Plan (HRRP). Re-vegetation activities included de-compacting and replacing topsoil in areas where construction activities are complete (see photo 6) and installing vertical mulch in temporary work areas to help discourage access into reclaimed/revegetated areas and reduce wind speed at ground level (see photo 7). In accordance with Section 4.3.5 of the HRRP, a total of 250 ocotillo (*Fouquieria splendens*) were salvaged prior to ground disturbance and maintained in an off-site nursery. During this reporting period, ECM's observed the Habitat Restoration Specialist directing construction crews to replant live Ocotillo in accordance with section 4.3.5 of the HRRP (see photo 8).

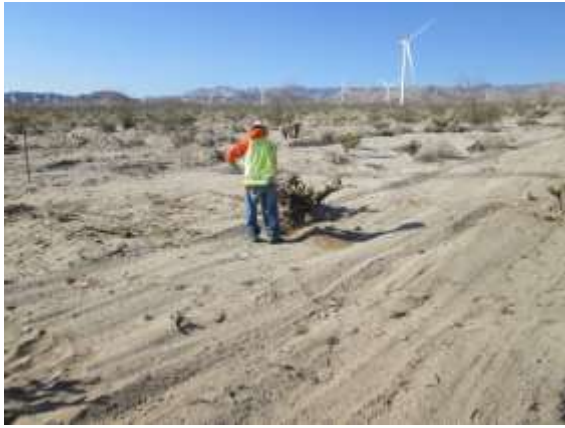
Photo 7: In accordance with Section 4.5.9 of the HRRP, vertical mulch is placed in temporary work areas to reduce wind speed at ground level.

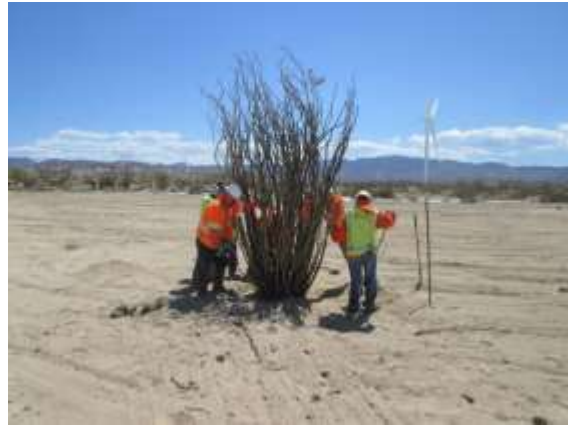
Photo 8: The Habitat Restoration Specialist observed construction crews replanting live ocotillo in accordance with section 4.3.5 of the HRRP.
