BLM Authorized Officer Weekly Report

Project: Ocotillo Wind Energy Facility Project

Weekly Project Update

Reporting Period: 12.3.12 through 12.9.12

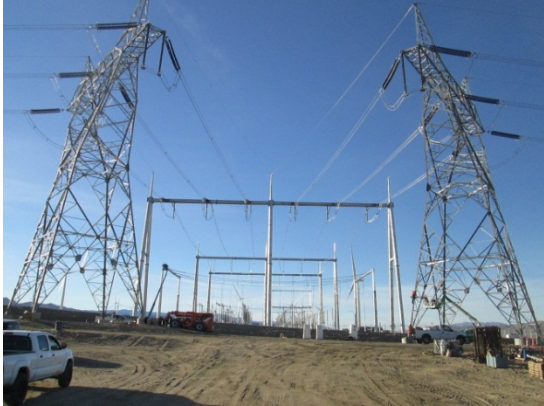
Photo 1: Testing and commissioning of the wind turbines and Substation/Switchyard began during this reporting period.

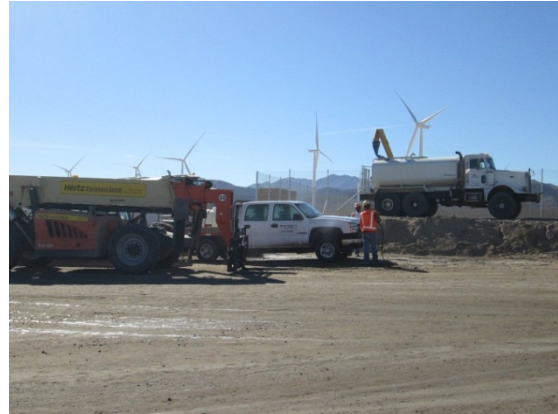
Photo 2: Construction vehicles are washed at the temporary laydown yard in order to minimize the potential for invasive species in accordance with MM Veg-1d and the Integrated Weed Management Plan.

The lead biological monitor was observed conducting regular vehicle inspections at the Laydown Yard to ensure that all vehicles have been washed prior to entering the project site in accordance with the Integrated Weed Management Plan (MM Veg-1d). In the event a vehicle has not been washed a “wash ticket” is issued and the operator of the equipment is required to washout the wheel wells and tires at the wash station located at the laydown yard (see photo 2).

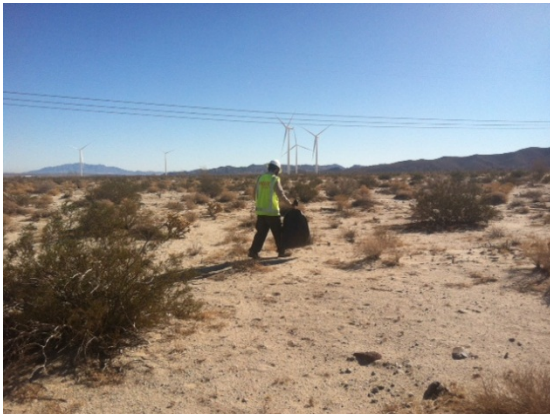
Photo 3: Crews remove trash along the right of way in accordance with the Raven Control Plan (Mitigation Measure Wild-1j)

In accordance with Section 4.1 of the Raven Control Plan, all trash onsite must be kept in covered trash receptacles. Environmental Compliance Monitors observed litter debris from construction crews periodically throughout the reporting period. The observations were reported to the lead environmental monitor and the construction contractor has responded by reminding crews to maintain a clean work site and by designating individuals to pick-up debris at the completion of the work day in accordance with the waste management procedures (see photo 3). Environmental Compliance Monitors also reported dumpsters needing cover to the lead environmental monitor. The dumpsters were covered upon notification being provided to the lead environmental monitor.

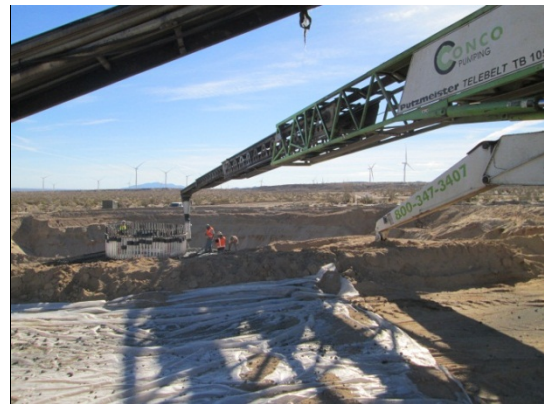
Photo 4: A concrete base pour is completed at a wind turbine foundation using plastic sheets placed along the ground surface to prevent soil contamination per the Storm Water Pollution Prevention Plan and Mitigation Measure Water-10.

Environmental Compliance Monitors observed construction crews completing concrete base pours for wind turbine foundations this week and ensured good housekeeping practices were being implemented during these activities in accordance with the Storm Water Pollution Prevention Plan and Mitigation Measure Water-10. The Environmental Compliance Monitors reported use of plastic sheeting placed on the ground surface during concrete pours (see photo 4) to prevent soil contamination.

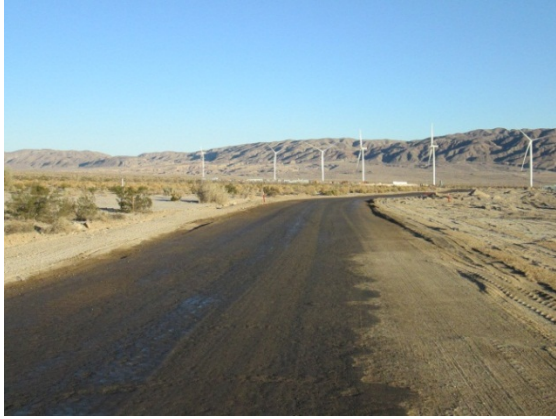
Photo 5: Dos Cabezas road is watered to keep dust suppressed in accordance with the Dust Control Plan (Mitigation Measure Air-1).

Water wagons and water trucks were routinely observed watering down roadways to ensure dust emissions were minimized during construction activities in accordance with Mitigation Measure Air-1 and the dust control plan (see photo 5).

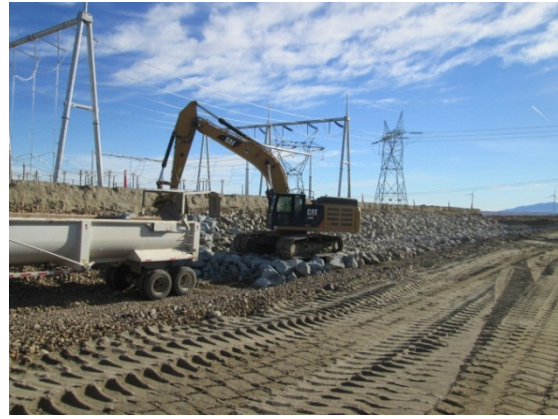
Photo 6: Environmental Compliance Monitors observed crews installing rip-rap around the substation switchyard for flood protection.

Environmental Compliance Monitors observed construction crews installing rip-rap around the 30-acre Substation/Switchyard for flood protection (see photo 6).

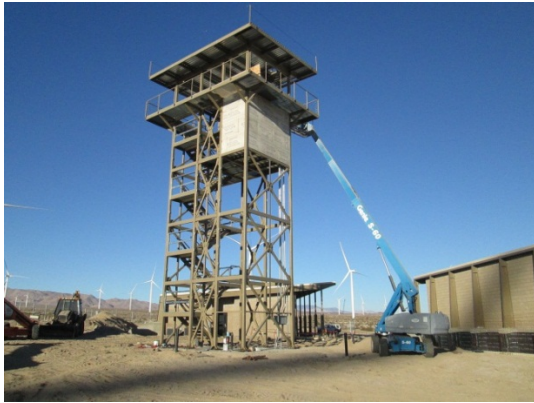
Photo 7: Environmental Compliance Monitors observed crews continuing construction activities at the ABOCC as identified in MM Wild-1p and the associated ABPP and ECP.

As discussed in the “Compliance” section of this report, Environmental Compliance Monitors observed construction progress at the ABOCC (see photo 7). The 50’ ABOCC will include a state of the art Merlin radar system onsite for the life of the project and is specifically tiered to collect data to potentially curtail turbines in order to minimize direct impacts to golden eagles. The system will also be used for data collection purposes for general avian and bat species.

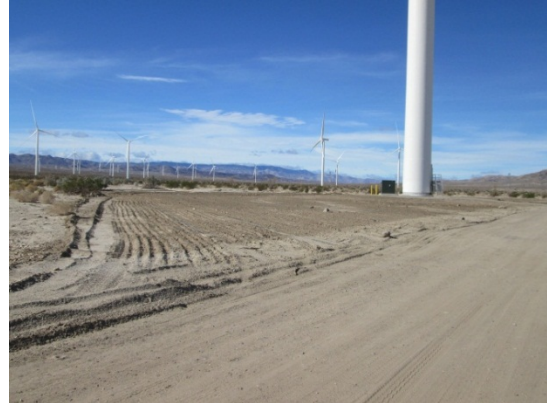
Photo 8: Previously disturbed top soil is used to restore a wind turbine pad site in accordance with Mitigation Measure Veg-2b and the associated Habitat Restoration/Re-vegetation Plan.

Construction activities related to site restoration continued this week, including re-vegetation activities at turbine pad sites in accordance with Mitigation Measure Veg-2b and the associated Habitat Re-vegetation Plan (see photo 8). Re-vegetation activities included de-compacting and replacing topsoil in areas where construction activities are complete and where no further construction traffic is anticipated to occur at the turbine sites. Cultural and biological monitors were present during re-vegetation activities that required ground disturbance in accordance with the ECCMP.
