BLM Authorized Officer Weekly Report

Project: Ocotillo Wind Energy Facility Project

Weekly Project Update

Reporting Period: 12.31.12 through 1.6.13

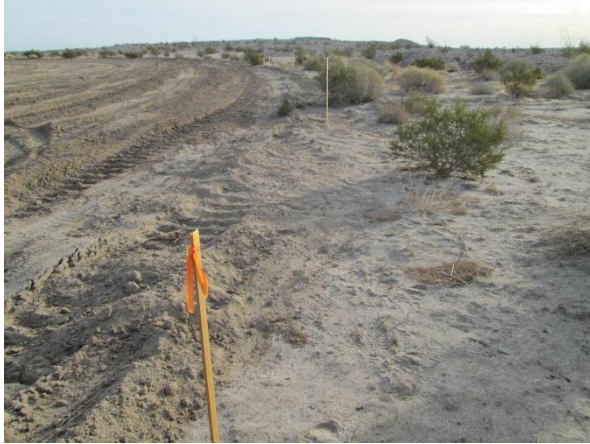
Work Within the Approved Limits (ROW5.d): ECMs observed two instances where stockpiles associated with excavation activities were located within the Right of Way (ROW), but outside of the approved work limits. One instance occurred at a wind turbine pad site where the dirt berm extended approximately two feet beyond the approved disturbance limits. The second instance occurred at the railroad crossing near a turbine site where an excavated soil pile is being stored approximately five feet outside of the approved work limits. In each case, the lead biological monitor was notified to stay within the approved project disturbance limits. No corrective actions were required as the work limits were clearly delineated and the operator went beyond the approved work limits in error (see photo 1).

Photo 1: ECMs observed resolution of soil berms noted outside of the work limits in Weekly Report #34.

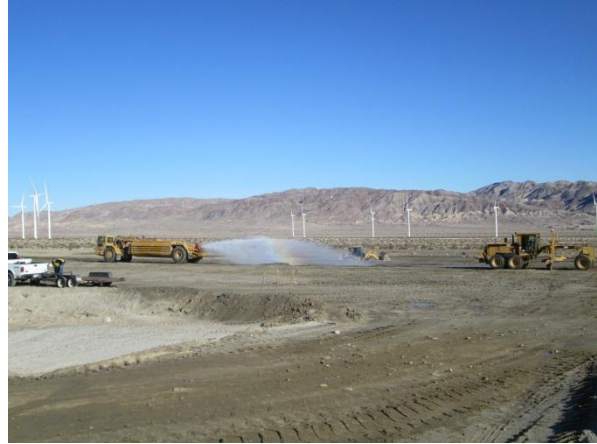
With respect to the continued berm work at the SDG&E substation, biological monitors were observed conducting surveys in accordance with the ECCMP. With respect to the continued phase II grading, ECMs observed water trucks on-site suppressing potential fugitive dust in accordance with MM Air-1 and the Fugitive Dust Control Plan (see photo 2).

Photo 2: Water trucks apply water to the Phase II Substation grading areas in accordance with the Fugitive Dust Control Plan (MM Air-1).

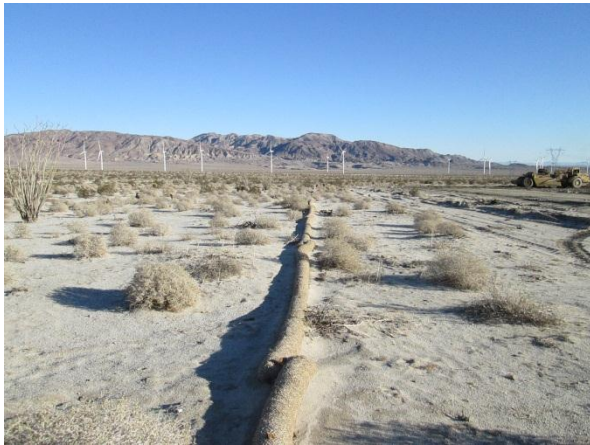
ECMs observed straw wattles installed around the perimeter of grading activities to minimize the potential for erosion in accordance with recommended best management practices identified in the SWPPP (MM WATER-9) (see photo 3). Additionally, ECMs observed the proper storage of hazardous materials within secondary containment at the laydown yard (see photo 4).

Photo 3: Straw wattles are installed along the perimeter of the Phase II Substation Grading in accordance with the SWPPP (MM WATER-9)

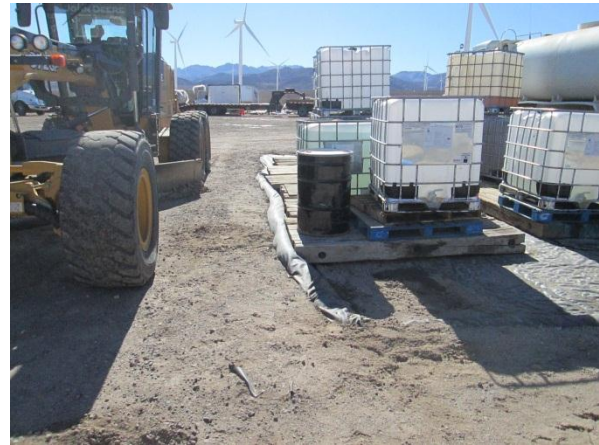
Photo 4: Hazardous materials at the laydown yard are placed within secondary containment in accordance with the SWPPP (MM WATER-9).
