## BLM Authorized Officer Weekly Report

**Project:** Ocotillo Wind Energy Facility Project

### Weekly Project Update

**Reporting Period:** 4.1.13 through 4.7.13

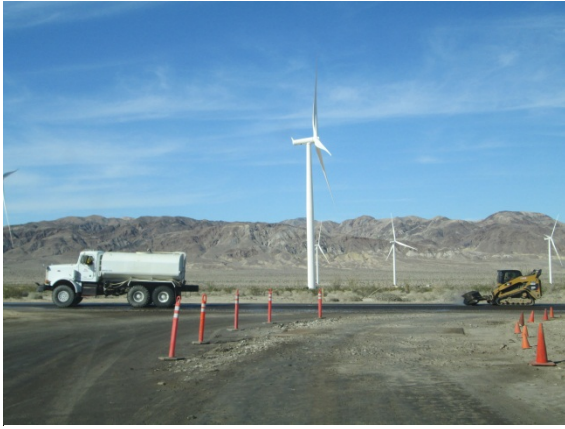
*Vehicle Track-Out (Dust Control Plan – MM-Air-1)* – In accordance with MM- Air-1, vehicle track-out shall not extend 25 feet or more from an active construction area and all vehicle track-out must be removed by the conclusion of each workday. On 3.28.13 an ECM observed vehicle track-out extending beyond 25 feet from the project construction entrance/exit on CA-98. The vehicle track-out was generated by vehicles exiting the project site without driving over the rumble plates and rock apron that have been installed to remove vehicle debris. This observation was immediately reported to the construction contractor. The construction contractor was observed sweeping CA-98 to remove all debris and placing cones along the project site entrance/exit to ensure that vehicles exiting the project site travel over the rumble plates and rock apron (see photo 1). In addition, the construction contractor has assigned

**Photo 1:** Construction crews sweep CA-98 to remove all debris and place cones along the project site entrance/exit to ensure that vehicles exiting the project site travel over the rumble plates and rock apron in accordance with the Dust Control Plan (MM-Air-1).

personnel to monitor and clean vehicle track-out and reminded all construction crew members to use the rumble plates and rock apron when exiting the project site.

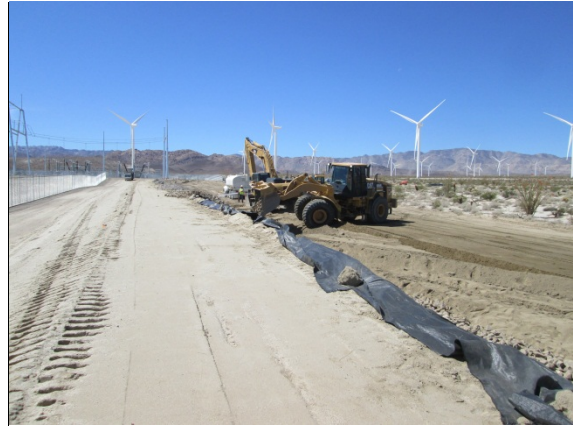
Construction activities consisted of building the berm for the Phase II substation (see photo 2), erecting wind turbines associated with Phase II (see photo 3), weed abatement activities, and reclamation activities associated with turbine access roads and the Laydown Yard.

**Photo 2:** Construction activities associated with the berm along the perimeter of the Phase II substation continued during this reporting period.

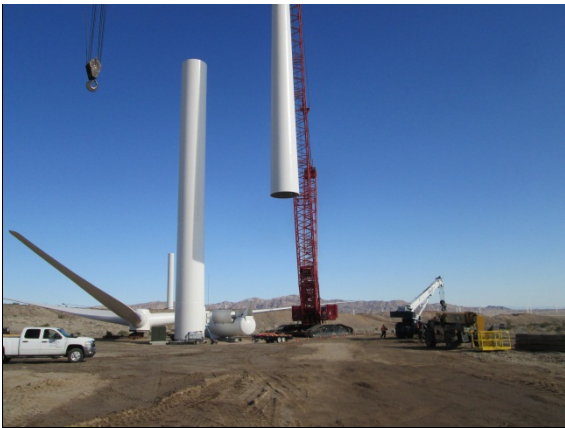
**Photo 3:** Construction crews utilize large cranes to lift the mid-section of the turbine tower for assembly to the base for the phase II turbines in the southeast portion of the project site.

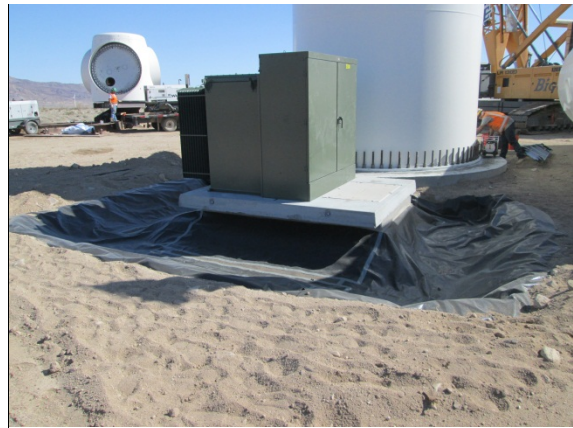
ECM's observed placement of secondary containment at transformers adjacent to each wind turbine base in accordance with the Storm Water Pollution Prevention Plan (SWPPP) MM-Water-9 (see photo 4).

**Photo 4:** ECM's observed the placement of secondary containment around the perimeter of the transformer at each wind turbine pad site in accordance with the SWPPP.

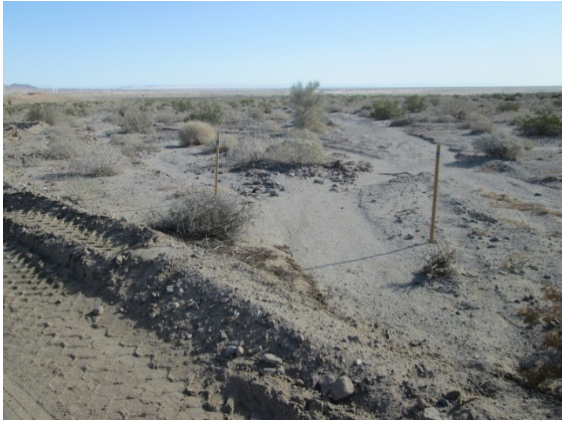
In accordance with MM-Veg-3, ECM's observed jurisdictional drainages delineated with stakes and flags to avoid potential impacts from construction related activities (see photo 5).

**Photo 5:** In accordance with MM-Veg-3, jurisdictional drainages are delineated with stakes and flags.

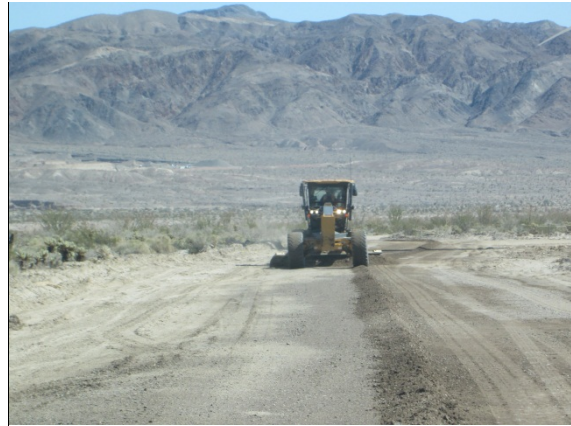
Crews were observed implementing the Habitat Revegetation Plan at wind turbine pad sites, turbine access roads, and at the Laydown Yard in accordance with MM-Veg-2b. Temporary work spaces were observed being decompacted and topsoil that had been salvaged during initial ground was placed within the temporary work limits (see photo 6).

**Photo 6:** In accordance with MM-Veg-2b, crews place topsoil salvaged during initial ground disturbance within the temporary disturbance limits.

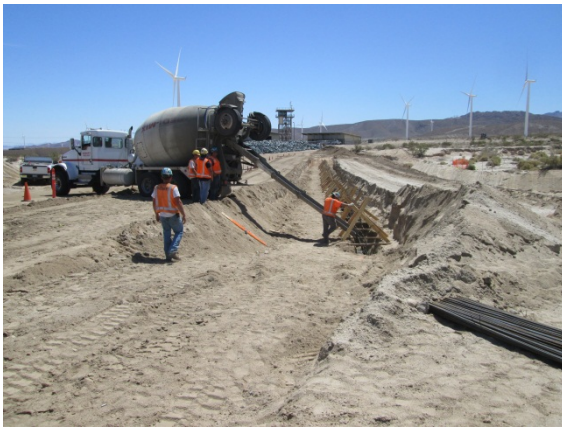
During this reporting period, construction crews were observed constructing a low water crossing on Dos Cabezas road. The low water crossing was being installed to comply with flood protection and design standards as specified by Imperial County (see photo 7).

**Photo 7:** Construction crews construct a low water crossing on Dos Cabezas road.

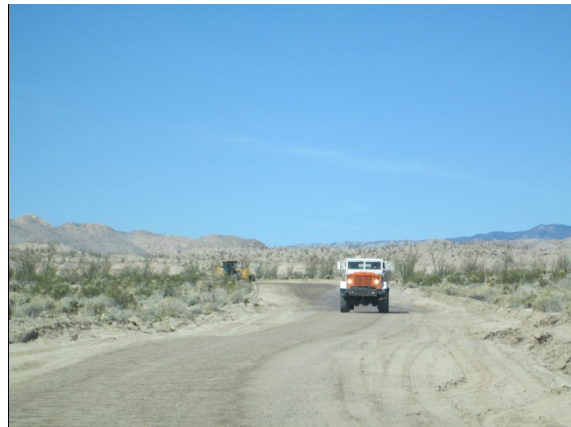
Water wagons and water trucks were routinely observed watering down areas of active construction and restoration activities to ensure dust emissions were minimized in accordance with the dust control plan (MM-Air-1) (see photo 8).

**Photo 8:** Water trucks are utilized to water down construction activities in accordance with MM-Air-1.
