## sBLM Authorized Officer Weekly Report

**Project:** Ocotillo Wind Energy Facility Project

### **Weekly Project Update**

**Reporting Period:** 10.29.12 through 11.04.12

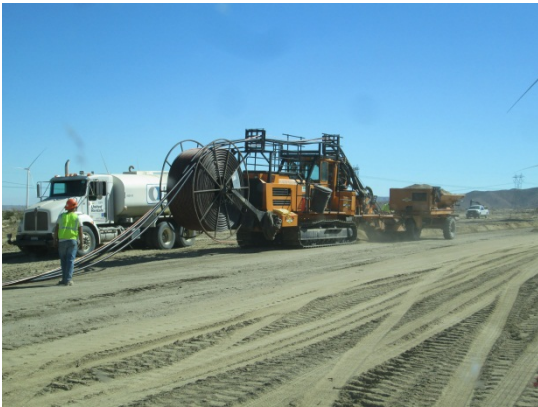
**Photo 1:** ECMs observed crews conducting non- initial disturbance sub-grade disturbance along turbine collection line trenching areas.

OE LLC has contracted with an archeological consulting firm approved by the BLM to complete day-to-day monitoring of the construction activities in accordance with the ECCMP. Archeological monitors were observed completing ongoing monitoring in accordance with the project requirements and establishing ESA's prior to initiating ground disturbance. ECM's also observed archeological monitors and Native American Monitors onsite during initial and non-initial ground disturbing activities, monitoring in accordance with the project requirements (see photo 1).

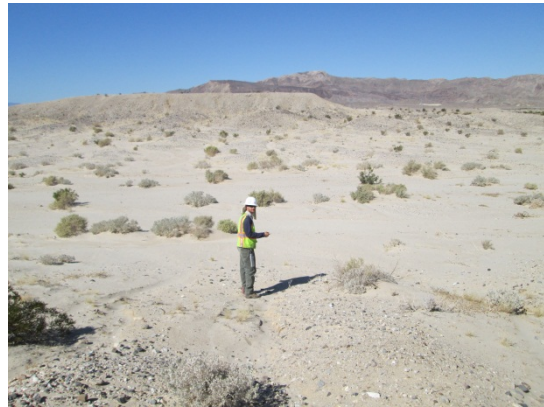
**Photo 2:** The Designated Biologist for the project relocates a Flat- Tailed Horned Lizard (FTHL) during construction activities in accordance with MM-Wild 1b/1g.

During this reporting period, construction activities associated with grading of access roads continued. In accordance with MM-Wild 1b and 1g, ECM's observed the designated biologist relocating Flat-Tailed Horned Lizards (FTHL) during construction activities (see photo 2). MM-Wild 1g requires the relocation of FTHLs within approved work areas. FTHL relocation is conducted under the supervision of the Designated Biologist and by two or more Biological Monitors when construction activities are being conducted in occupied FTHL habitat.

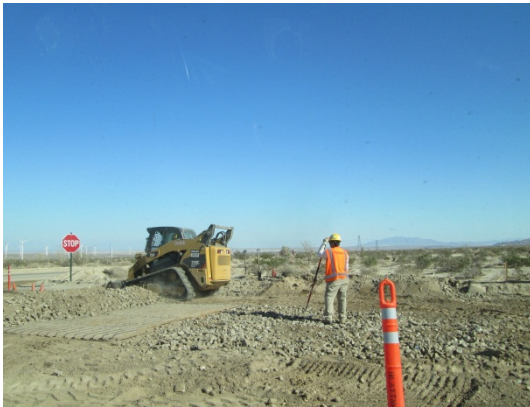
**Photo 3:** Workers repair the stabilized entrance to Dos Cabezas Road.

The stabilized entrance at Dos Cabezas road and access to a turbine pad site was repaired in order to minimize track-out (see photos 3 and 4). Additionally, ECM's observed water wagons and water trucks watering down areas of active grading, trenching, and excavation to ensure dust emissions were minimized during construction activities in accordance with the Dust Control Plan per MM-Air-1 (see photo 5).

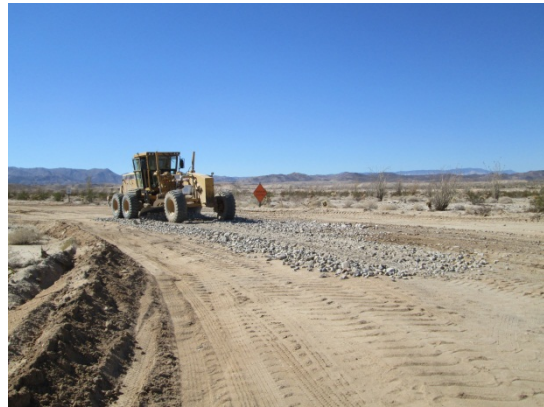
**Photo 4:** ECMs observed repair of a rock apron at an access road to a turbine site. The rock apron was noted as needing repair the previous reporting period.

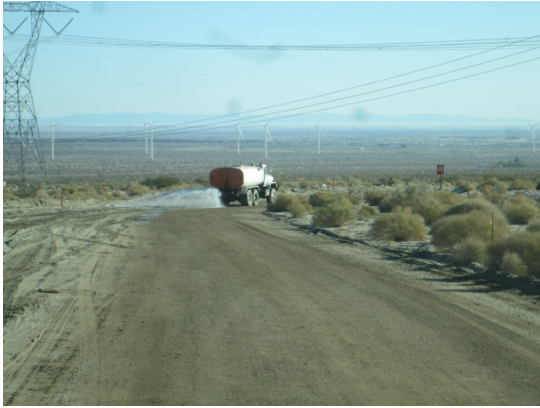
**Photo 5:** ECMs observed water trucks suppressing dust along turbine access roads in accordance with MM-Air-1.

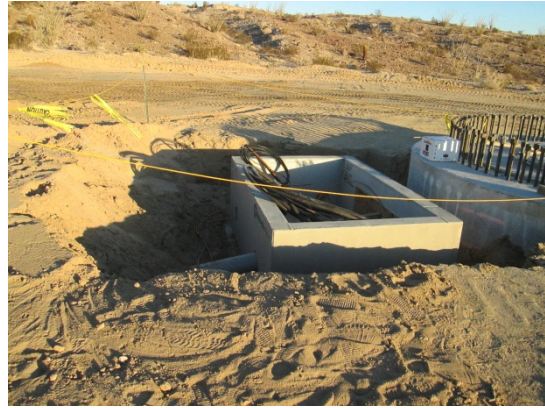
**Photo 6:** An excavation area adjacent to a wind turbine base foundation has sloped edges in accordance with MM-Wild-1m. Sloped edges in excavation areas provide wildlife with an escape ramp to prevent entrapment.

Foundation work, excavations, and electrical installations continued at turbine sites this week. In accordance with MM-Wild-1b, at the end of each work day, the lead biologist is to inspect all potential wildlife pitfalls to ensure that the construction crew slopes the ends of the excavation to provide wildlife escape ramps or completely and securely covers the excavation to prevent wildlife entry. ECM's completed routine inspections to ensure all wildlife pitfalls include wildlife escape ramps and/or have been covered per MM-Wild-1b (see photo 6). In addition, ECM's observed gates to the temporary water pond being shut during periods of minimal activity at the laydown yard (see photo 7).

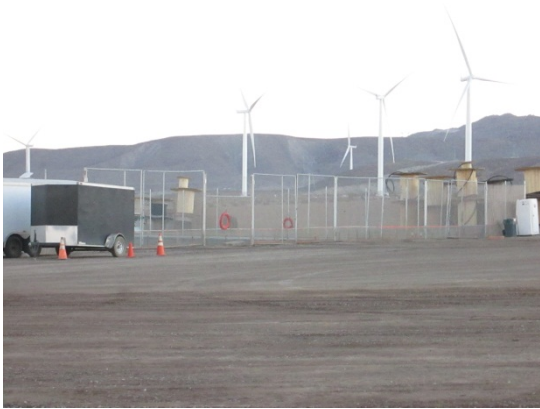
**Photo 7:** Gates to the temporary water pond are closed during periods of minimal activity at the laydown yard.

*Wildlife Mortality:* On Wednesday, October 31<sup>st</sup> a deceased Kit Fox (*Vulpes macrotis*) was found onsite within the manmade temporary water pond at the Laydown Yard. The temporary water pond is currently being used to supply water for construction and restoration activities. The temporary water pond will be in place through May 2013 when the Laydown Yard is anticipated to be reclaimed to pre-construction conditions. The mortality was documented by the lead biological monitor in the Wildlife Relocation and Mortality log and notification was provided to the California Department of Fish and Game (CDFG). In order to prevent the potential for a similar incident occurring, the United States Fish and Wildlife Service (USFWS) and CDFG in conjunction with the BLM identified measures that were provided to OE LLC. These measures include but are not limited to closing the gates to the temporary water pond at all times prior to 9:00 am and after 3:00 pm. Additionally, the gates are to be closed at all times between water truck visits on weekends, holidays, and any other day where activity in the laydown yard would be limited and/or when offices in the laydown yard are not at full staff. The lead environmental monitor and ECM's will be ensuring the measures recommended by CDFG, USFWS and BLM are implemented on a daily basis.

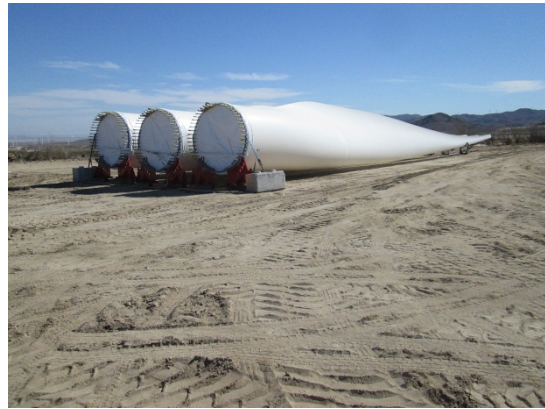
**Photo 8:** ECM's observed turbine part deliveries and staging within the approved work limits.

Construction activities associated with installing the underground line along Highway S2 continued during this reporting period. Crews were observed trenching, placing cable in the excavated trench and backfilling. Turbine deliveries and staging also continued this reporting period (see photo 8). Environmental monitors completed routine inspections of these activities to ensure work was being completed within the approved work limits.
